Manhole Inspection Report

Date:	05/16/2018	Weather:		Coding:	RZMACP
MH#:	M-804-058	Owner:	NA	Len. Surveyed:	10.3
P.O.#:		Surveyor:	Jen Costello	Rim to Invert:	11.4
Customer:		Cert. #:	U-907-5518	Wall Material:	Concrete (reinforced)

Street:	Linda St. 268' North of Hickey St.	Project:	Hobart, IN
City:	Hobart, IN	GPS Northing:	2907088.652
Location:		GPS Easting:	2907088.652
Drain Area:	Northeast	GPS Accuracy:	Sub-Meter
Cover Shape:	Circular	Evidence of Surcharge:	No
Cover Size:	22.5	Potential for Runoff:	None
Comments:

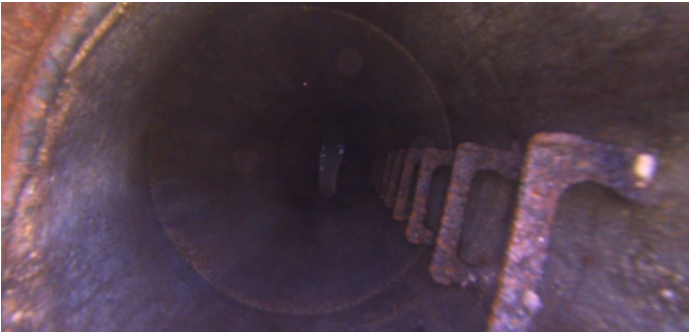
Code: **MGP**
 Description: **General Photo**

Distance (ft): **.0**
 Structural Grade: **0**
 O&M Grade: **0**
 Clock Start/From:
 Clock To:
 1st Value:
 2nd Value:
 Value Percent:
 Step: **NO**
 Remarks: **ACCESS MH**

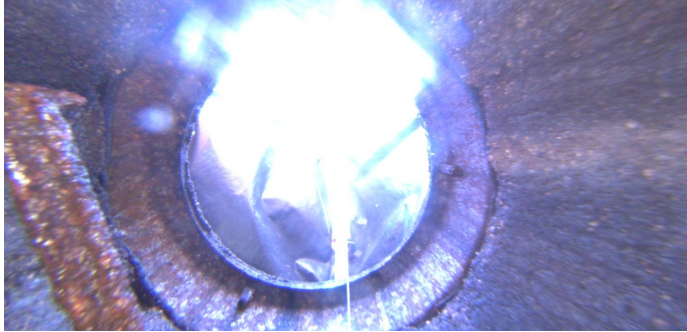
Code:	MGO
Description:	General Observation
Distance (ft):	1.8
Structural Grade:	0
O&M Grade:	0
Clock Start/From:	
Clock To:	
1st Value:	
2nd Value:	
Value Percent:	
Step:	NO
Remarks:	UNDERSIDE OF FRAME

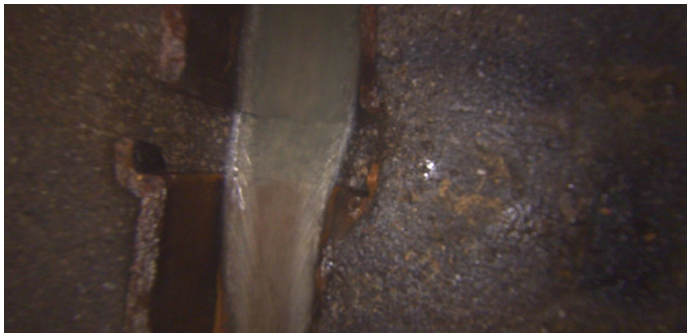
Code:	B
Description:	Broken
Distance (ft):	9.9
Structural Grade:	5
O&M Grade:	0
Clock Start/From:	3
Clock To:	9
1st Value:	
2nd Value:	
Value Percent:	
Step:	NO
Remarks:

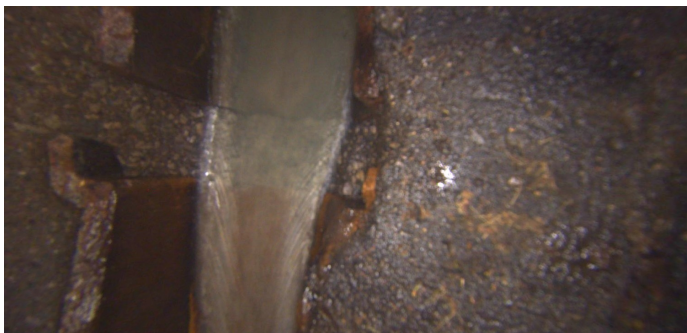
Code:	MGO
Description:	General Observation
Distance (ft):	10.3
Structural Grade:	0
O&M Grade:	0
Clock Start/From:	
Clock To:	
1st Value:	
2nd Value:	
Value Percent:	
Step:	NO
Remarks:	END SURVEY
