Manhole Inspection Report

Date:	05/16/2018	Weather:		Coding:	RZMACP
MH#:	M-804-060	Owner:	NA	Len. Surveyed:	8.4
P.O.#:		Surveyor:	Jen Costello	Rim to Invert:	8.9
Customer:		Cert. #:	U-907-5518	Wall Material:	Concrete (reinforced)

Street:	Linda St. 260' South of South St.	Project:	Hobart, IN
City:	Hobart, IN	GPS Northing:	2907084.478
Location:		GPS Easting:	2907084.478
Drain Area:	Northeast	GPS Accuracy:	Sub-Meter
Cover Shape:	Circular	Evidence of Surcharge:	No
Cover Size:	22.5	Potential for Runoff:	None
Comments:

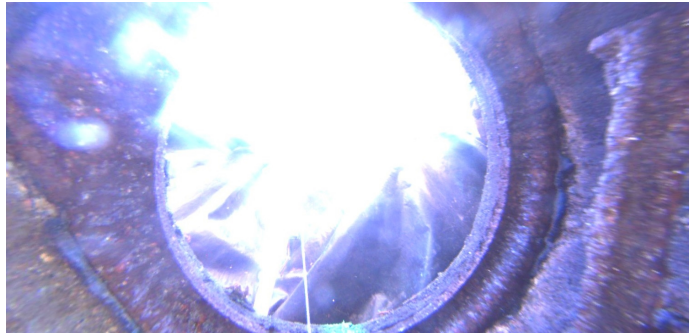
Code: **MGO**
Description: **General Observation**

Distance (ft): **1.4**
Structural Grade: **0**
O&M Grade: **0**
Clock Start/From:
Clock To:
1st Value:
2nd Value:
Value Percent:
Step: **NO**
Remarks: **UNDERSIDE OF FRAME**

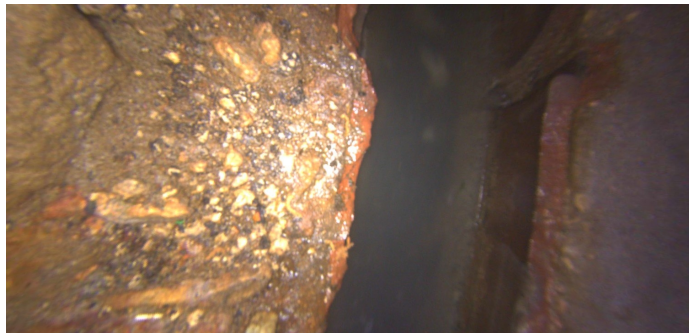
Code: **MGO**
Description: **General Observation**

Distance (ft): **8.4**
Structural Grade: **0**
O&M Grade: **0**
Clock Start/From:
Clock To:
1st Value:
2nd Value:
Value Percent:
Step: **NO**
Remarks: **END SURVEY**

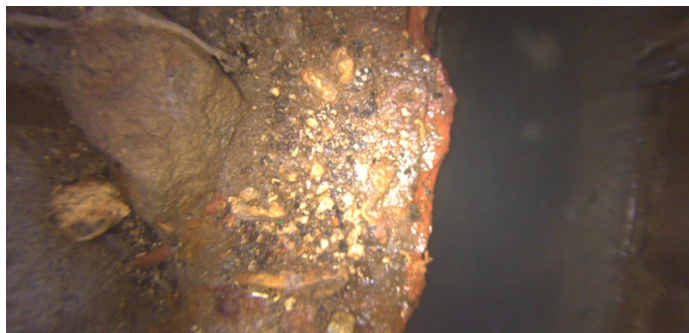
Code: **OBR**
Description: **Obstacle Rocks**

Distance (ft): **8.4**
Structural Grade: **0**
O&M Grade: **2**
Clock Start/From: **8**
Clock To: **9**
1st Value:
2nd Value:
Value Percent: **10.000**
Step: **NO**
Remarks:
