Manhole Inspection Report

Date:	05/16/2018	Weather:		Coding:	RZMACP
MH#:	M-804-061	Owner:	NA	Len. Surveyed:	7.7
P.O.#:		Surveyor:	Jen Costello	Rim to Invert:	7.9
Customer:		Cert. #:	U-907-5518	Wall Material:	Concrete (reinforced)

Street:	Intersection of Linda St. and South S	Project:	Hobart, IN
City:	Hobart, IN	GPS Northing:	2907080.849
Location:		GPS Easting:	2907080.849
Drain Area:	Northeast	GPS Accuracy:	Sub-Meter
Cover Shape:	Circular	Evidence of Surcharge:	No
Cover Size:	22.5	Potential for Runoff:	None
Comments:

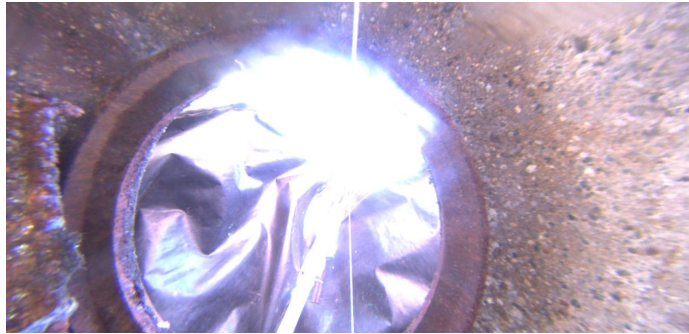
Code:	MGO
Description:	General Observation
Distance (ft):	1.4
Structural Grade:	0
O&M Grade:	0
Clock Start/From:	
Clock To:	
1st Value:	
2nd Value:	
Value Percent:	
Step:	NO
Remarks:	underside of frame

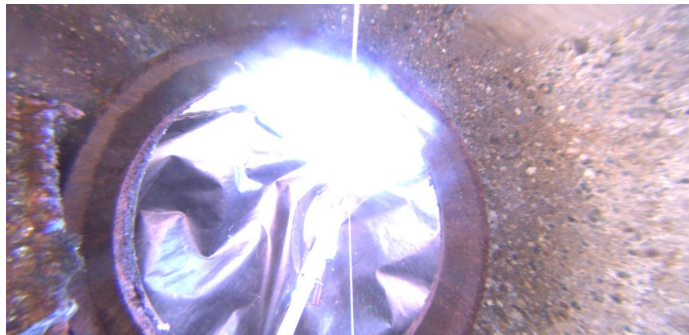
Code:	SAV
Description:	Surface Aggregate Visible
Distance (ft):	1.4
Structural Grade:	3
O&M Grade:	0
Clock Start/From:	12
Clock To:	12
1st Value:	
2nd Value:	
Value Percent:	
Step:	NO
Remarks:

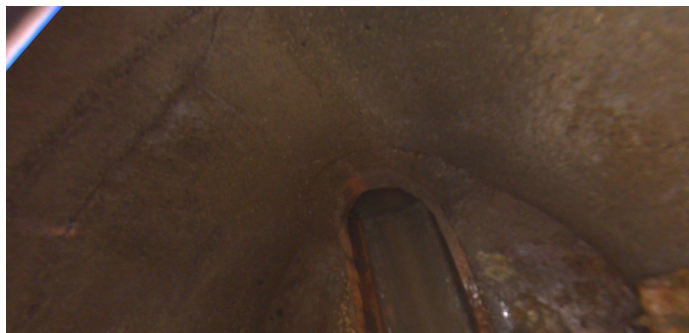
Code:	FC
Description:	Fracture Circumferential
Distance (ft):	4.8
Structural Grade:	2
O&M Grade:	0
Clock Start/From:	9
Clock To:	11
1st Value:	
2nd Value:	
Value Percent:	
Step:	NO
Remarks:

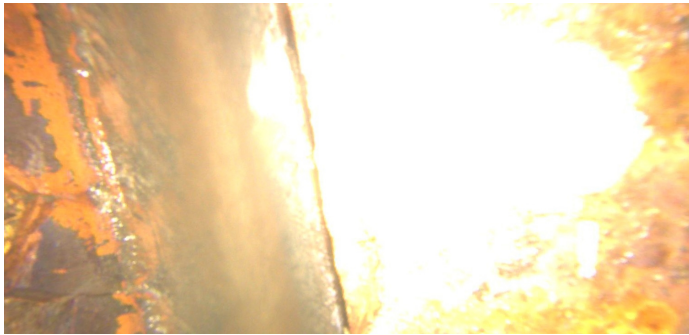
Code:	MGO
Description:	General Observation
Distance (ft):	7.7
Structural Grade:	0
O&M Grade:	0
Clock Start/From:	
Clock To:	
1st Value:	
2nd Value:	
Value Percent:	
Step:	NO
Remarks:	end survey
