# Manhole Inspection Report

Date:	<b>05/15/2018</b>	Weather:		Coding:	<b>RZMACP</b>
MH#:	<b>M-804-062</b>	Owner:	<b>NA</b>	Len. Surveyed:	<b>11.0</b>
P.O.#:		Surveyor:	<b>Jen Costello</b>	Rim to Invert:	<b>12.8</b>
Customer:		Cert. #:	<b>U-907-5518</b>	Wall Material:	<b>Concrete (reinforced)</b>

Street:	<b>Intersection of Hickey St. and Hwy 5</b>	Project:	<b>Hobart, IN</b>
City:	<b>Hobart, IN</b>	GPS Northing:	<b>2909761.676</b>
Location:		GPS Easting:	<b>2909761.676</b>
Drain Area:	<b>Northeast</b>	GPS Accuracy:	<b>Sub-Meter</b>
Cover Shape:	<b>Circular</b>	Evidence of Surcharge:	<b>No</b>
Cover Size:	<b>22.5</b>	Potential for Runoff:	<b>None</b>
Comments:

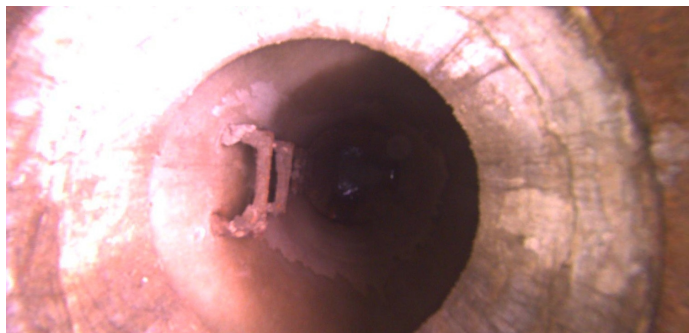
Code: **MGP**  
Description: **General Photo**

Distance (ft): **.0**  
Structural Grade: **0**  
O&M Grade: **0**  
Clock Start/From:  
Clock To:  
1st Value:  
2nd Value:  
Value Percent:  
Step: **NO**  
Remarks: **ACCESS MH**

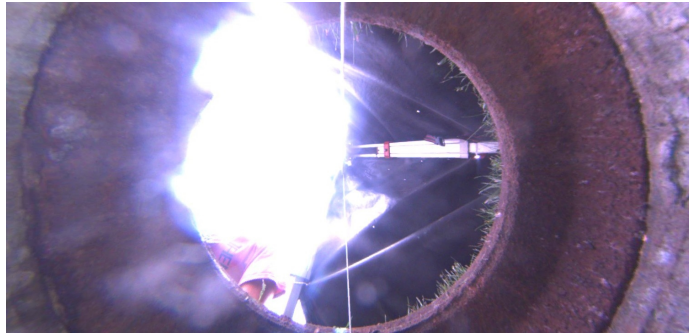
Code: **MGO**  
Description: **General Observation**

Distance (ft): **1.5**  
Structural Grade: **0**  
O&M Grade: **0**  
Clock Start/From:  
Clock To:  
1st Value:  
2nd Value:  
Value Percent:  
Step: **NO**  
Remarks: **UNDERSIDE OF FRAME**

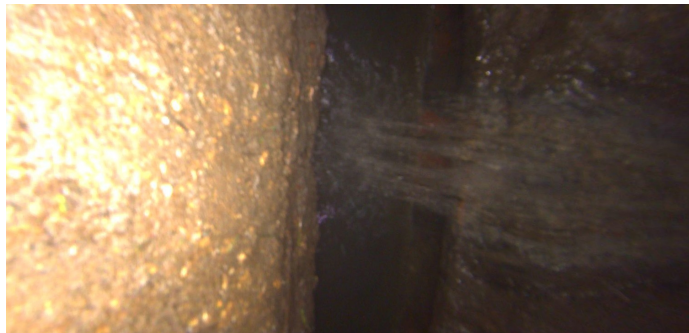
Code: **MGO**  
Description: **General Observation**

Distance (ft): **11.0**  
Structural Grade: **0**  
O&M Grade: **0**  
Clock Start/From:  
Clock To:  
1st Value:  
2nd Value:  
Value Percent:  
Step: **NO**  
Remarks: **END SURVEY**
