Manhole Inspection Report

Date:	05/15/2018	Weather:		Coding:	RZMACP
MH#:	M-804-068	Owner:	NA	Len. Surveyed:	4.6
P.O.#:		Surveyor:	Jen Costello	Rim to Invert:	4.8
Customer:		Cert. #:	U-907-5518	Wall Material:	Concrete (reinforced)

Street:	Liberty St. 280' North of Hickey St.	Project:	Hobart, IN
City:	Hobart, IN	GPS Northing:	2909071.464
Location:		GPS Easting:	2909071.464
Drain Area:	Northeast	GPS Accuracy:	Sub-Meter
Cover Shape:	Circular	Evidence of Surcharge:	No
Cover Size:	22.5	Potential for Runoff:	None
Comments:

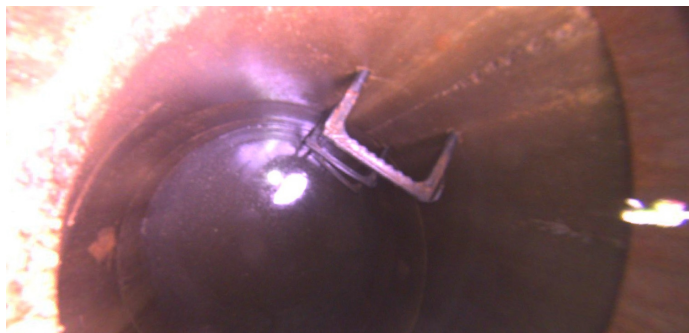
Code: **MGO**
Description: **General Observation**

Distance (ft): **.0**
Structural Grade: **0**
O&M Grade: **0**
Clock Start/From:
Clock To:
1st Value:
2nd Value:
Value Percent:
Step: **NO**
Remarks: **ACCESS MH**

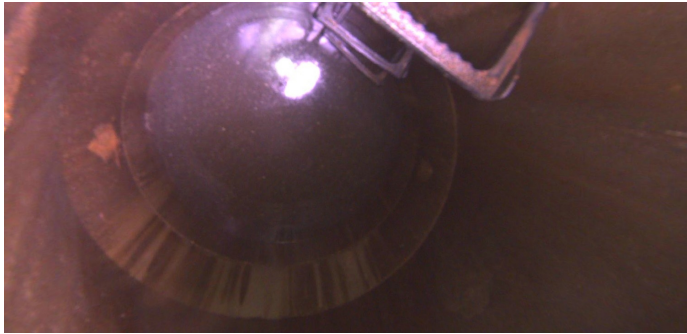
Code: **IS**
Description: **Infil Stain**

Distance (ft): **.7**
Structural Grade: **0**
O&M Grade: **0**
Clock Start/From: **4**
Clock To: **8**
1st Value:
2nd Value:
Value Percent:
Step: **NO**
Remarks:

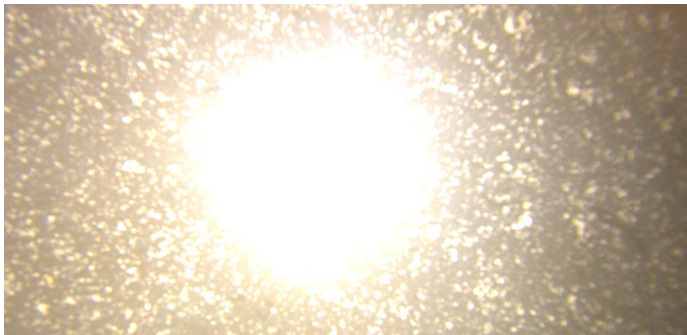
Code: **MSA**
Description: **Abandoned Survey**

Distance (ft): **4.6**
Structural Grade: **0**
O&M Grade: **0**
Clock Start/From:
Clock To:
1st Value:
2nd Value:
Value Percent:
Step: **NO**
Remarks: **BENCH IS SUBMERGED**
