# Manhole Inspection Report

Date:	<b>03/28/2018</b>	Weather:		Coding:	<b>RZMACP</b>
MH#:	<b>M-804-073</b>	Owner:	<b>NA</b>	Len. Surveyed:	<b>6.4</b>
P.O.#:		Surveyor:	<b>John Kuglmaier</b>	Rim to Invert:	<b>7.5</b>
Customer:		Cert. #:	<b>U-1215-07002349</b>	Wall Material:	<b>Concrete (reinforced)</b>

Street:	<b>High St. 163' East of Indiana St.</b>	Project:	<b>Hobart, IN</b>
City:	<b>Hobart, IN</b>	GPS Northing:	<b>0.0</b>
Location:		GPS Easting:	<b>0.0</b>
Drain Area:	<b>Northeast</b>	GPS Accuracy:	<b>Nearest Meter</b>
Cover Shape:	<b>Circular</b>	Evidence of Surcharge:	<b>No</b>
Cover Size:	<b>23.0</b>	Potential for Runoff:	<b>None</b>
Comments:

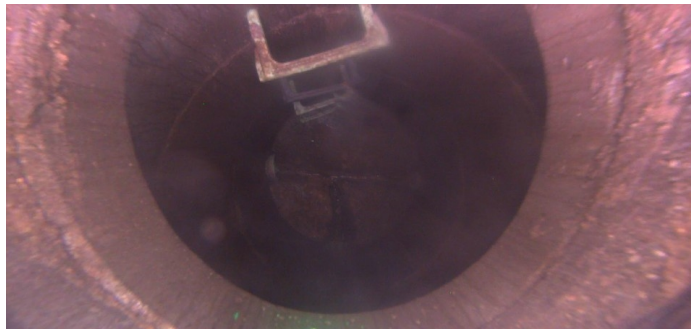
Code: **MGP**  
Description: **General Photo**

Distance (ft): **.0**  
Structural Grade: **0**  
O&M Grade: **0**  
Clock Start/From:  
Clock To:  
1st Value:  
2nd Value:  
Value Percent:  
Step: **NO**  
Remarks:

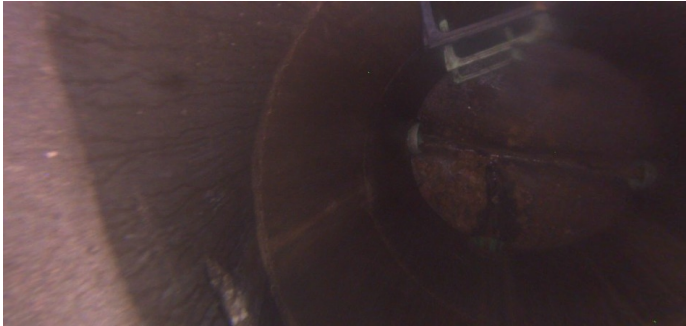
Code: **IS**  
Description: **Infil Stain**

Distance (ft): **1.1**  
Structural Grade: **0**  
O&M Grade: **0**  
Clock Start/From: **8**  
Clock To:  
1st Value:  
2nd Value:  
Value Percent:  
Step: **NO**  
Remarks:

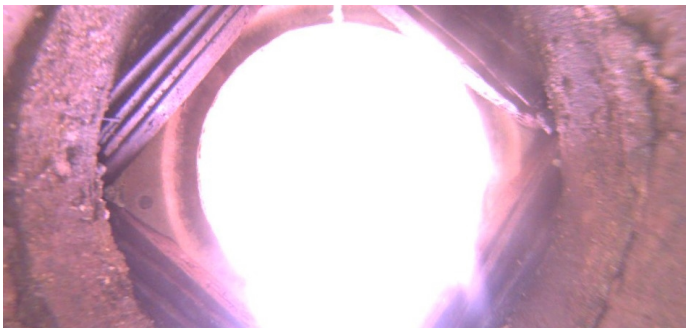
Code: **MGP**  
Description: **General Photo**

Distance (ft): **1.7**  
Structural Grade: **0**  
O&M Grade: **0**  
Clock Start/From:  
Clock To:  
1st Value:  
2nd Value:  
Value Percent:  
Step: **NO**  
Remarks:

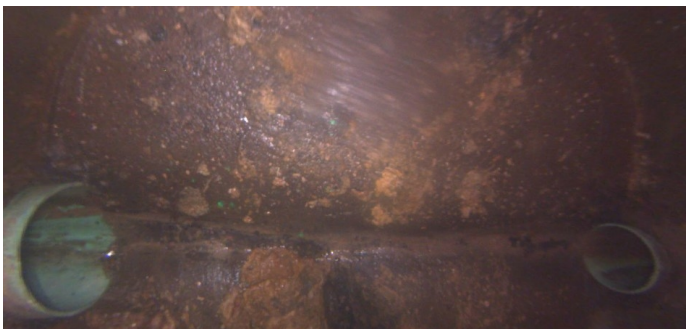
Code: **MGO**  
Description: **General Observation**

Distance (ft): **5.5**  
Structural Grade: **0**  
O&M Grade: **0**  
Clock Start/From:  
Clock To:  
1st Value:  
2nd Value:  
Value Percent:  
Step: **NO**  
Remarks: **Ins. Comp.**
