# Manhole Inspection Report

Date:	<b>05/16/2018</b>	Weather:		Coding:	<b>RZMACP</b>
MH#:	<b>M-804-075</b>	Owner:	<b>NA</b>	Len. Surveyed:	<b>10.0</b>
P.O.#:		Surveyor:	<b>Jen Costello</b>	Rim to Invert:	<b>10.6</b>
Customer:		Cert. #:	<b>U-907-5518</b>	Wall Material:	<b>Concrete (reinforced)</b>

Street:	<b>On Linda St. 531' South of South St.</b>	Project:	<b>Hobart, IN</b>
City:	<b>Hobart, IN</b>	GPS Northing:	<b>2907093.461</b>
Location:		GPS Easting:	<b>2907093.461</b>
Drain Area:	<b>Northeast</b>	GPS Accuracy:	<b>Sub-Meter</b>
Cover Shape:	<b>Circular</b>	Evidence of Surcharge:	<b>No</b>
Cover Size:	<b>22.5</b>	Potential for Runoff:	<b>None</b>
Comments:

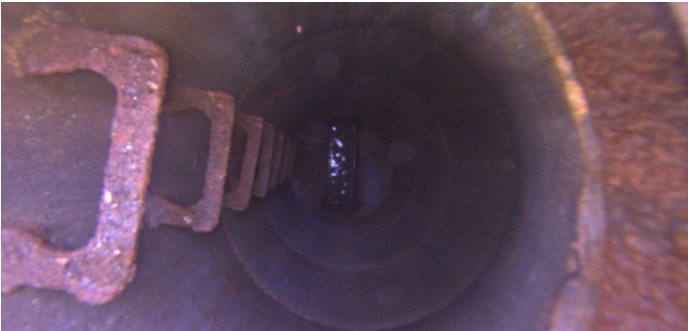
MGP

General Photo

ACCESS MH

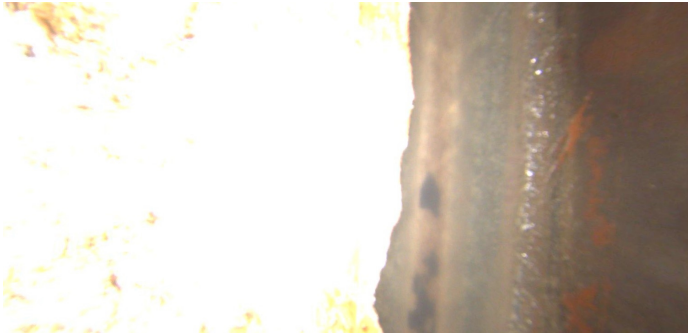
Code: **MGO**  
Description: **General Observation**

Distance (ft): **10.0**  
Structural Grade: **0**  
O&M Grade: **0**  
Clock Start/From:  
Clock To:  
1st Value:  
2nd Value:  
Value Percent:  
Step: **NO**  
Remarks: **END SURVEY**
