# Manhole Inspection Report

Date:	05/06/2018	Weather:		Coding:	RZMACP
MH#:	M-804-077	Owner:	NA	Len. Surveyed:	16.2
P.O.#:		Surveyor:	Jen Costello	Rim to Invert:	18.3
Customer:		Cert. #:	U-907-5518	Wall Material:	Concrete (reinforced)

Street:	Linda St. and Home Ave. To the East.	Project:	Hobart, IN
City:	Hobart, IN	GPS Northing:	2907136.183
Location:		GPS Easting:	2907136.183
Drain Area:	Northeast	GPS Accuracy:	Sub-Meter
Cover Shape:	Circular	Evidence of Surcharge:	No
Cover Size:	22.5	Potential for Runoff:	None
Comments:

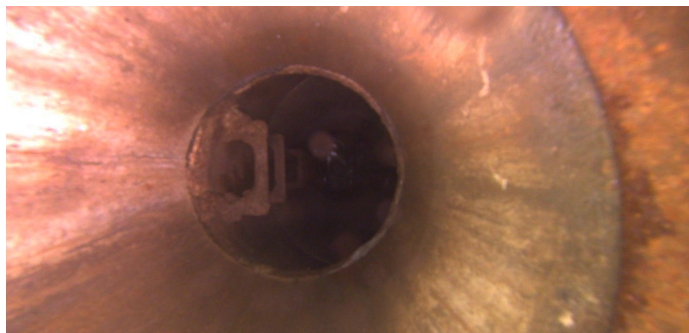
Code: **MGP**  
Description: **General Photo**

Distance (ft): **.0**  
Structural Grade: **0**  
O&M Grade: **0**  
Clock Start/From:  
Clock To:  
1st Value:  
2nd Value:  
Value Percent:  
Step: **NO**  
Remarks: **ACCESS MH**

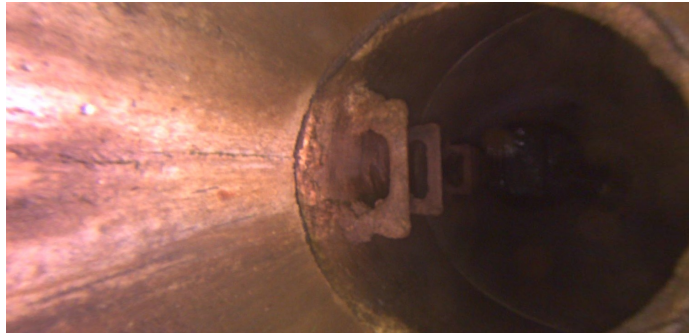
Code: **CL**  
Description: **Crack Longitudinal**

Distance (ft): **1.2**  
Structural Grade: **2**  
O&M Grade: **0**  
Clock Start/From: **9**  
Clock To:  
1st Value:  
2nd Value:  
Value Percent:  
Step: **NO**  
Remarks:

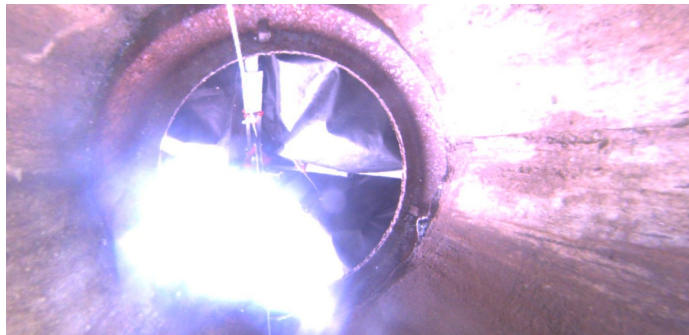
Code: **MGO**  
Description: **General Observation**

Distance (ft): **2.7**  
Structural Grade: **0**  
O&M Grade: **0**  
Clock Start/From:  
Clock To:  
1st Value:  
2nd Value:  
Value Percent:  
Step: **NO**  
Remarks: **UNDERSIDE OF FRAME**

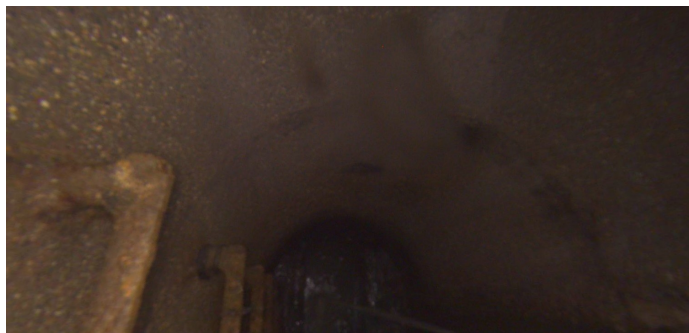
Code: **SAV**  
Description: **Surface Aggregate Visible**

Distance (ft): **9.2**  
Structural Grade: **3**  
O&M Grade: **0**  
Clock Start/From: **12**  
Clock To: **12**  
1st Value:  
2nd Value:  
Value Percent:  
Step: **NO**  
Remarks:

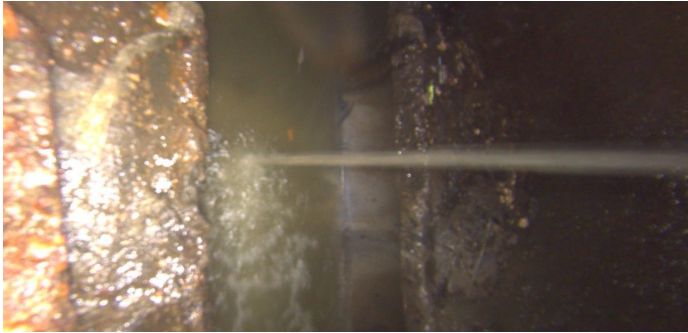
Code:	<b>MGO</b>
Description:	<b>General Observation</b>
Distance (ft):	<b>16.2</b>
Structural Grade:	<b>0</b>
O&M Grade:	<b>0</b>
Clock Start/From:	
Clock To:	
1st Value:	
2nd Value:	
Value Percent:	
Step:	<b>NO</b>
Remarks:	<b>END SURVEY</b>
