# Manhole Inspection Report

Date:	<b>05/07/2018</b>	Weather:		Coding:	<b>RZMACP</b>
MH#:	<b>M-804-079</b>	Owner:	<b>NA</b>	Len. Surveyed:	<b>2.2</b>
P.O.#:		Surveyor:	<b>Jen Costello</b>	Rim to Invert:	<b>2.4</b>
Customer:		Cert. #:	<b>U-907-5518</b>	Wall Material:	<b>Concrete (reinforced)</b>

Street:	<b>Jackson St. 159' West of Hwy 51.</b>	Project:	<b>Hobart, IN</b>
City:	<b>Hobart, IN</b>	GPS Northing:	<b>2909595.007</b>
Location:		GPS Easting:	<b>2909595.007</b>
Drain Area:	<b>South</b>	GPS Accuracy:	<b>Sub-Meter</b>
Cover Shape:	<b>Circular</b>	Evidence of Surcharge:	<b>No</b>
Cover Size:	<b>22.5</b>	Potential for Runoff:	<b>None</b>
Comments:

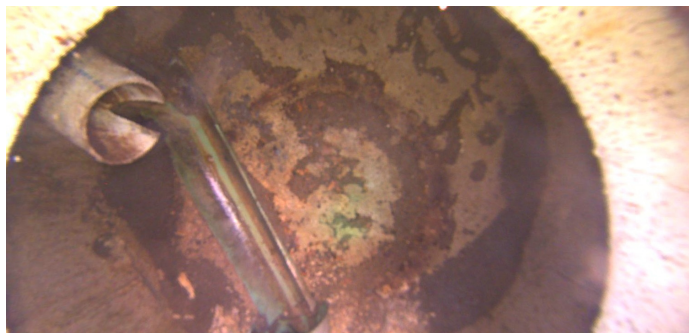
Code: **MGP**  
Description: **General Photo**

Distance (ft): **.0**  
Structural Grade: **0**  
O&M Grade: **0**  
Clock Start/From:  
Clock To:  
1st Value:  
2nd Value:  
Value Percent:  
Step: **NO**  
Remarks: **ACCESS MH**

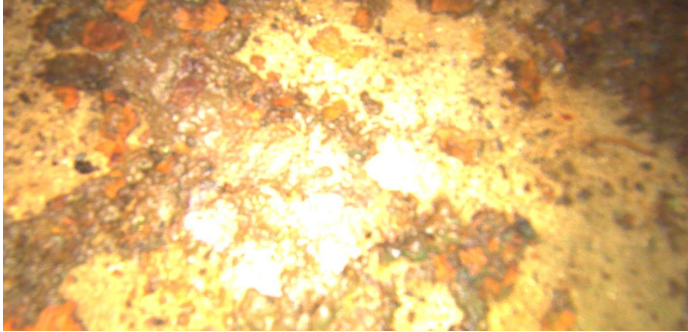
Code:	<b>MGO</b>
Description:	<b>General Observation</b>
Distance (ft):	<b>2.2</b>
Structural Grade:	<b>0</b>
O&M Grade:	<b>0</b>
Clock Start/From:	
Clock To:	
1st Value:	
2nd Value:	
Value Percent:	
Step:	<b>NO</b>
Remarks:	<b>END SURVEY</b>
