Manhole Inspection Report

Date:	05/09/2018	Weather:		Coding:	RZMACP
MH#:	M-805-004	Owner:	NA	Len. Surveyed:	8.5
P.O.#:		Surveyor:	Jen Costello	Rim to Invert:	8.9
Customer:		Cert. #:	U-907-5518	Wall Material:	Concrete (reinforced)

Street:	225' South of 5th St. and West of Ho	Project:	Hobart, IN
City:	Hobart, IN	GPS Northing:	2909619.091
Location:		GPS Easting:	2909619.091
Drain Area:	Southeast	GPS Accuracy:	Sub-Meter
Cover Shape:	Circular	Evidence of Surcharge:	No
Cover Size:	22.5	Potential for Runoff:	None
Comments:

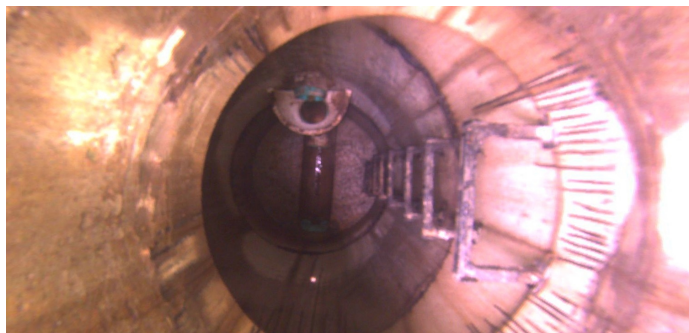
Code: **MGP**
Description: **General Photo**

Distance (ft): **.0**
Structural Grade: **0**
O&M Grade: **0**
Clock Start/From:
Clock To:
1st Value:
2nd Value:
Value Percent:
Step: **NO**
Remarks: **ACCESS MH**

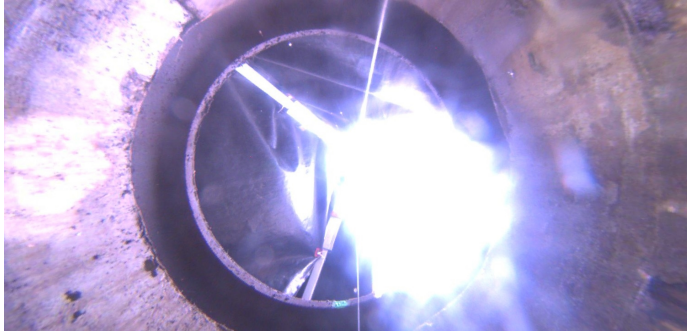
Code: **MGO**
Description: **General Observation**

Distance (ft): **1.7**
Structural Grade: **0**
O&M Grade: **0**
Clock Start/From:
Clock To:
1st Value:
2nd Value:
Value Percent:
Step: **NO**
Remarks: **END SURVEY**

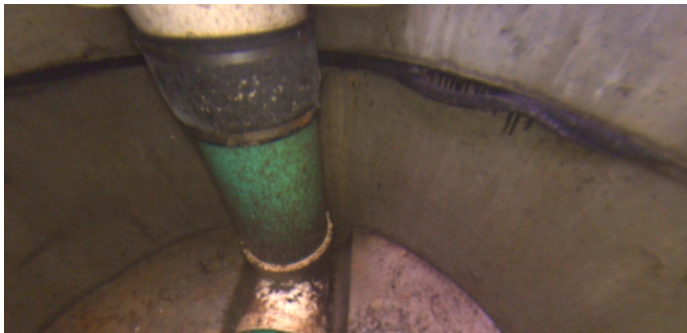
Code: **OBP**
Description: **Obstacle External Pipe or Cable**

Distance (ft): **6.5**
Structural Grade: **0**
O&M Grade: **2**
Clock Start/From: **12**
Clock To:
1st Value:
2nd Value:
Value Percent: **10.000**
Step: **NO**
Remarks:

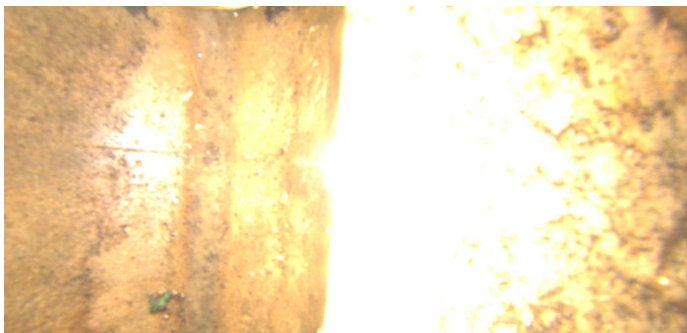
Code: **MGO**
Description: **General Observation**

Distance (ft): **8.5**
Structural Grade: **0**
O&M Grade: **0**
Clock Start/From:
Clock To:
1st Value:
2nd Value:
Value Percent:
Step: **NO**
Remarks: **END SURVEY**
