Manhole Inspection Report

Date:	05/09/2018	Weather:		Coding:	RZMACP
MH#:	M-805-008	Owner:	NA	Len. Surveyed:	8.4
P.O.#:		Surveyor:	Jen Costello	Rim to Invert:	9.0
Customer:		Cert. #:	U-907-5518	Wall Material:	Concrete (reinforced)

Street:	219' South of 5th St. East of Liberty	Project:	Hobart, IN
City:	Hobart, IN	GPS Northing:	2909285.663
Location:		GPS Easting:	2909285.663
Drain Area:	Southeast	GPS Accuracy:	Sub-Meter
Cover Shape:	Circular	Evidence of Surcharge:	No
Cover Size:	22.5	Potential for Runoff:	None
Comments:

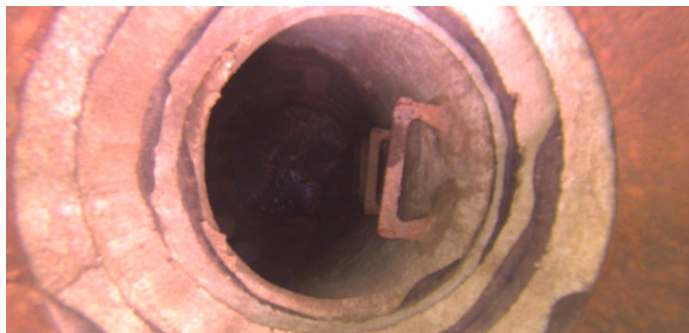
Code: **MGP**
Description: **General Photo**

Distance (ft): **.0**
Structural Grade: **0**
O&M Grade: **0**
Clock Start/From:
Clock To:
1st Value:
2nd Value:
Value Percent:
Step: **NO**
Remarks: **ACCESS MH**

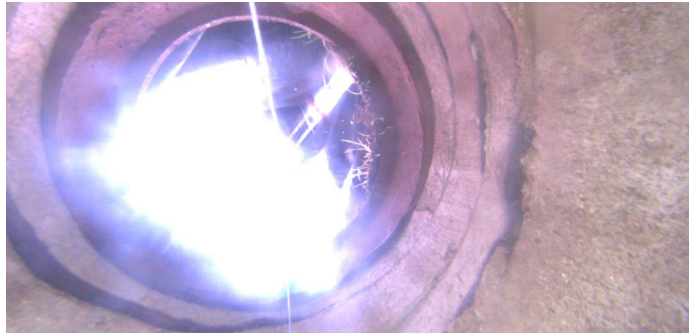
Code:	MGO
Description:	General Observation
Distance (ft):	2.6
Structural Grade:	0
O&M Grade:	0
Clock Start/From:	
Clock To:	
1st Value:	
2nd Value:	
Value Percent:	
Step:	NO
Remarks:	UNDERSIDE OF FRAME

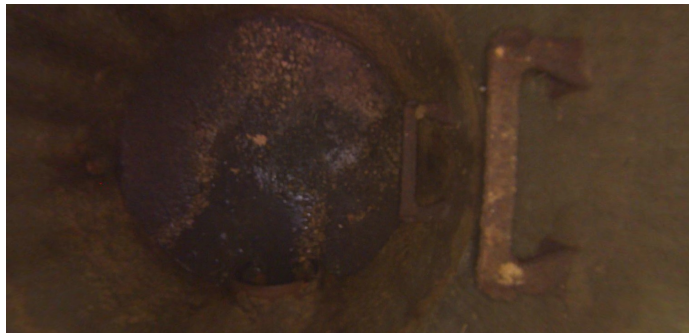
Code:	IS
Description:	Infil Stain
Distance (ft):	5.0
Structural Grade:	0
O&M Grade:	0
Clock Start/From:	6
Clock To:	12
1st Value:	
2nd Value:	
Value Percent:	
Step:	NO
Remarks:

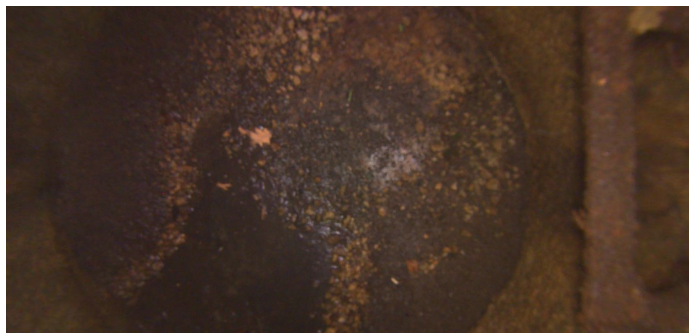
Code:	DSGV
Description:	Deposits Settled Gravel
Distance (ft):	6.8
Structural Grade:	0
O&M Grade:	2
Clock Start/From:	12
Clock To:	12
1st Value:	
2nd Value:	
Value Percent:	5.000
Step:	NO
Remarks:

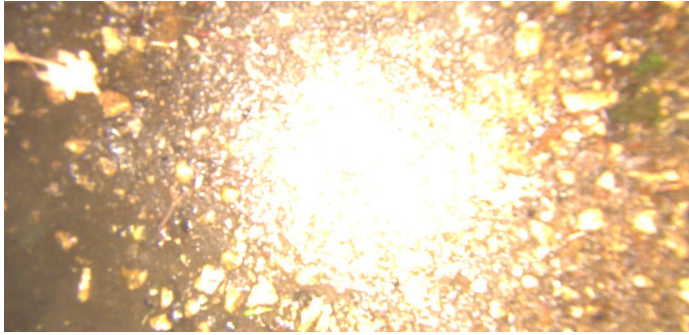
Code:	MGO
Description:	General Observation
Distance (ft):	8.4
Structural Grade:	0
O&M Grade:	0
Clock Start/From:	
Clock To:	
1st Value:	
2nd Value:	
Value Percent:	
Step:	NO
Remarks:	END SURVEY
