# Manhole Inspection Report

Date:	05/09/2018	Weather:		Coding:	RZMACP
MH#:	M-805-010	Owner:	NA	Len. Surveyed:	10.3
P.O.#:		Surveyor:	Jen Costello	Rim to Invert:	10.4
Customer:		Cert. #:	U-907-5518	Wall Material:	Concrete (reinforced)

Street:	250' North of 5th St. East of Liberty	Project:	Hobart, IN
City:	Hobart, IN	GPS Northing:	2909290.257
Location:		GPS Easting:	2909290.257
Drain Area:	Southeast	GPS Accuracy:	Sub-Meter
Cover Shape:	Circular	Evidence of Surcharge:	No
Cover Size:	24.0	Potential for Runoff:	None
Comments:

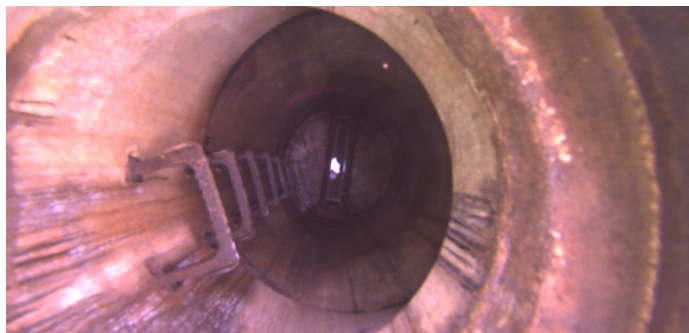
Code: **MGP**  
Description: **General Photo**

Distance (ft): **.0**  
Structural Grade: **0**  
O&M Grade: **0**  
Clock Start/From:  
Clock To:  
1st Value:  
2nd Value:  
Value Percent:  
Step: **NO**  
Remarks: **ACCESS MH**

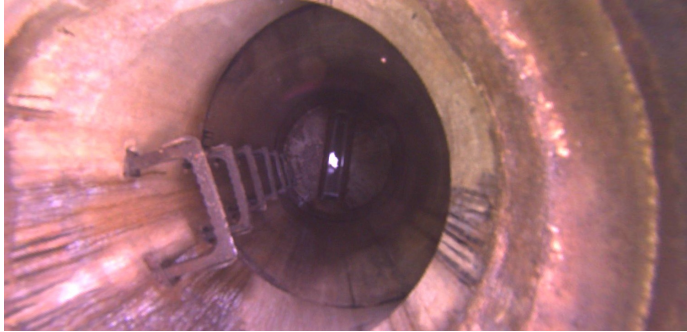
Code: **IS**  
Description: **Infil Stain**

Distance (ft): **.0**  
Structural Grade: **0**  
O&M Grade: **0**  
Clock Start/From: **3**  
Clock To: **9**  
1st Value:  
2nd Value:  
Value Percent:  
Step: **NO**  
Remarks:

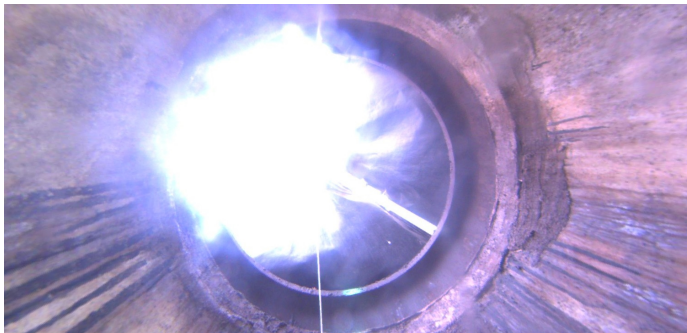
Code: **MGO**  
Description: **General Observation**

Distance (ft): **2.2**  
Structural Grade: **0**  
O&M Grade: **0**  
Clock Start/From:  
Clock To:  
1st Value:  
2nd Value:  
Value Percent:  
Step: **NO**  
Remarks: **UNDERSIDE OF FRAME**

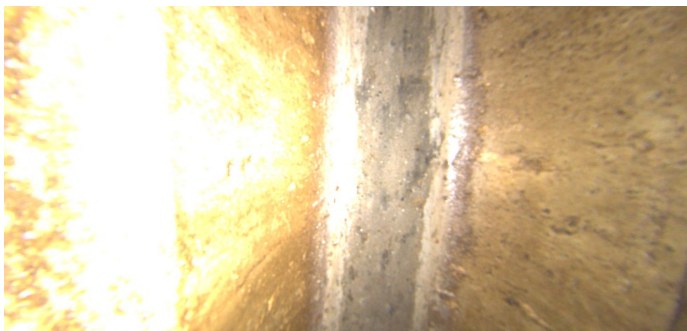
Code: **MGO**  
Description: **General Observation**

Distance (ft): **10.3**  
Structural Grade: **0**  
O&M Grade: **0**  
Clock Start/From:  
Clock To:  
1st Value:  
2nd Value:  
Value Percent:  
Step: **NO**  
Remarks: **END SURVEY**
