Manhole Inspection Report

Date:	05/09/2018	Weather:		Coding:	RZMACP
MH#:	M-805-011	Owner:	NA	Len. Surveyed:	5.9
P.O.#:		Surveyor:	Jen Costello	Rim to Invert:	6.1
Customer:		Cert. #:	U-907-5518	Wall Material:	Concrete (reinforced)

Street:	537' North of 5th St. East of Liberty	Project:	Hobart, IN
City:	Hobart, IN	GPS Northing:	2909270.639
Location:		GPS Easting:	2909270.639
Drain Area:	Southeast	GPS Accuracy:	Sub-Meter
Cover Shape:	Circular	Evidence of Surcharge:	No
Cover Size:	24.0	Potential for Runoff:	None
Comments:

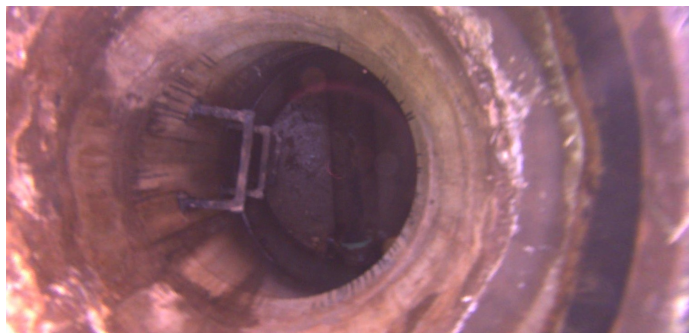
Code: **MGP**
Description: **General Photo**

Distance (ft): **.0**
Structural Grade: **0**
O&M Grade: **0**
Clock Start/From:
Clock To:
1st Value:
2nd Value:
Value Percent:
Step: **NO**
Remarks: **ACCESS MH**

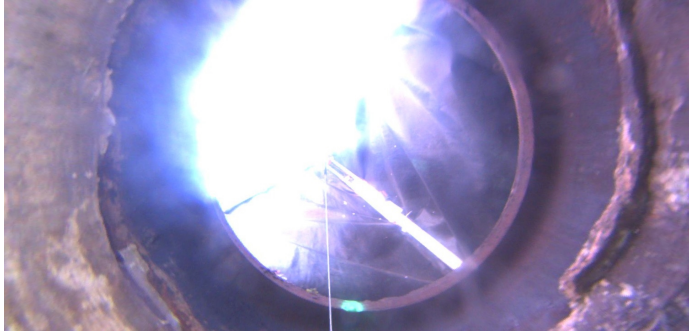
Code:	MGO
Description:	General Observation
Distance (ft):	1.9
Structural Grade:	0
O&M Grade:	0
Clock Start/From:	
Clock To:	
1st Value:	
2nd Value:	
Value Percent:	
Step:	NO
Remarks:	UNDERSIDE OF FRAME

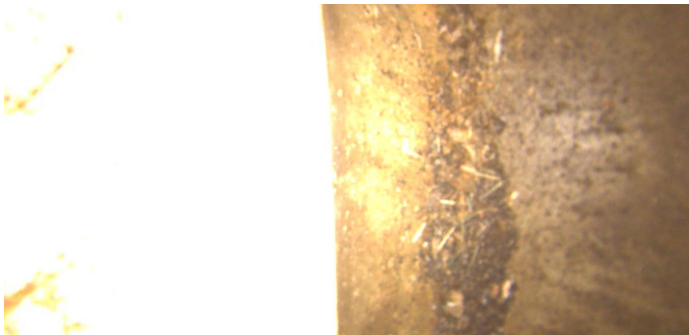
Code:	MGO
Description:	General Observation
Distance (ft):	5.9
Structural Grade:	0
O&M Grade:	0
Clock Start/From:	
Clock To:	
1st Value:	
2nd Value:	
Value Percent:	
Step:	NO
Remarks:	END SURVEY
