# Manhole Inspection Report

Date:	<b>05/09/2018</b>	Weather:		Coding:	<b>RZMACP</b>
MH#:	<b>M-805-012</b>	Owner:	<b>NA</b>	Len. Surveyed:	<b>7.6</b>
P.O.#:		Surveyor:	<b>Jen Costello</b>	Rim to Invert:	<b>8.3</b>
Customer:		Cert. #:	<b>U-907-5518</b>	Wall Material:	<b>Concrete (reinforced)</b>

Street:	<b>238' South of 5th St. East of Liberty</b>	Project:	<b>Hobart, IN</b>
City:	<b>Hobart, IN</b>	GPS Northing:	<b>2908959.662</b>
Location:		GPS Easting:	<b>2908959.662</b>
Drain Area:	<b>Southeast</b>	GPS Accuracy:	<b>Sub-Meter</b>
Cover Shape:	<b>Circular</b>	Evidence of Surcharge:	<b>No</b>
Cover Size:	<b>22.5</b>	Potential for Runoff:	<b>None</b>
Comments:

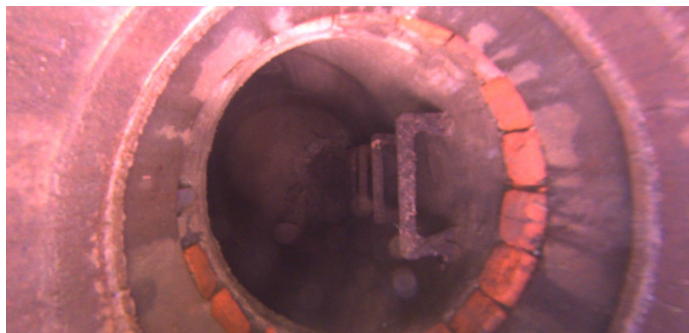
Code: **MGP**  
Description: **General Photo**

Distance (ft): **.0**  
Structural Grade: **0**  
O&M Grade: **0**  
Clock Start/From:  
Clock To:  
1st Value:  
2nd Value:  
Value Percent:  
Step: **NO**  
Remarks: **ACCESS MH**

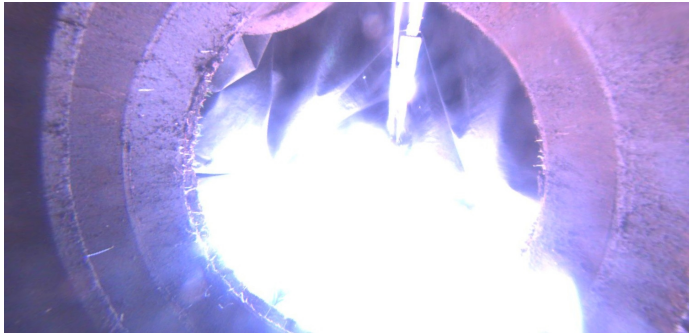
Code:	<b>MGO</b>
Description:	<b>General Observation</b>
Distance (ft):	<b>1.5</b>
Structural Grade:	<b>0</b>
O&M Grade:	<b>0</b>
Clock Start/From:	
Clock To:	
1st Value:	
2nd Value:	
Value Percent:	
Step:	<b>NO</b>
Remarks:	<b>UNDERSIDE OF FRAME</b>

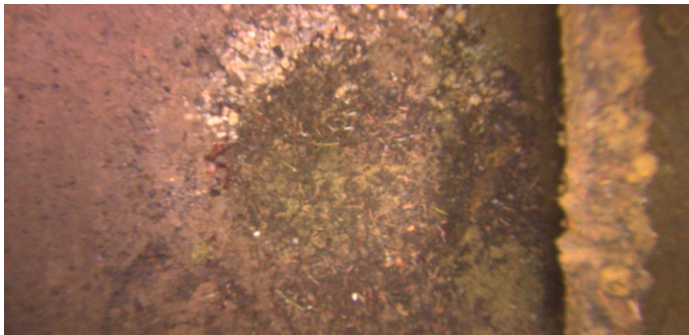
Code:	<b>DSF</b>
Description:	<b>Deposits Settled Fine</b>
Distance (ft):	<b>7.4</b>
Structural Grade:	<b>0</b>
O&M Grade:	<b>2</b>
Clock Start/From:	<b>2</b>
Clock To:	<b>3</b>
1st Value:	
2nd Value:	
Value Percent:	<b>5.000</b>
Step:	<b>NO</b>
Remarks:
