# Manhole Inspection Report

Date:	<b>09/30/2022</b>	Weather:		Coding:	<b>RZMACP</b>
MH#:	<b>M-805-015</b>	Owner:	<b>NA</b>	Len. Surveyed:	<b>8.0</b>
P.O.#:		Surveyor:	<b>Jen Costello</b>	Rim to Invert:	<b>9.0</b>
Customer:		Cert. #:	<b>U-907-5518</b>	Wall Material:	<b>Concrete (cast in place)</b>

Street:	<b>357' North of 5th St. East of Liberty</b>	Project:	<b>Hobart, IN</b>
City:	<b>Hobart, IN</b>	GPS Northing:	<b>2288792.212</b>
Location:	<b>Alley</b>	GPS Easting:	<b>2908950.734</b>
Drain Area:	<b>Southeast</b>	GPS Accuracy:	<b>Sub-Meter</b>
Cover Shape:	<b>Circular</b>	Evidence of Surcharge:	<b>Yes</b>
Cover Size:	<b>24.0</b>	Potential for Runoff:	<b>None</b>
Comments:

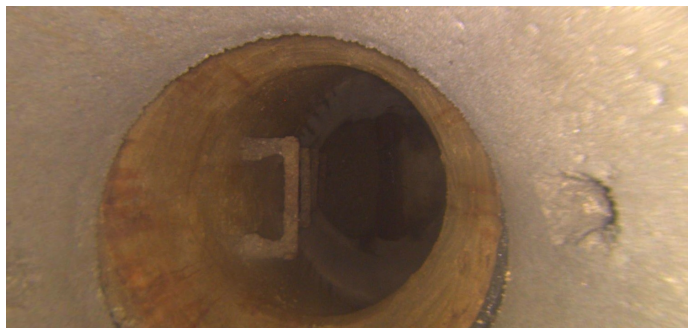
Code: **MGO**  
Description: **General Observation**

Distance (ft): **.0**  
Structural Grade: **0**  
O&M Grade: **0**  
Clock Start/From:  
Clock To:  
1st Value:  
2nd Value:  
Value Percent:  
Step: **NO**  
Remarks: **access mh**

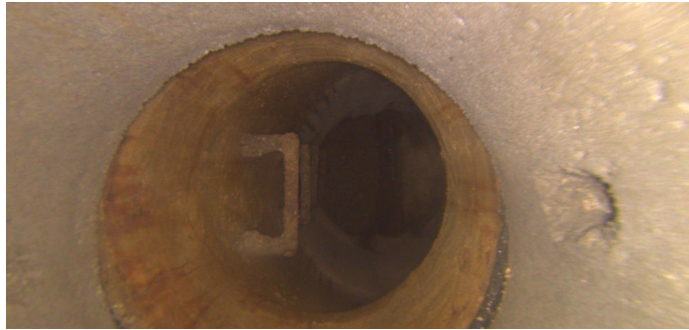
Code: **SRI**  
Description: **Surface Roughness Increased**

Distance (ft): **.0**  
Structural Grade: **1**  
O&M Grade: **0**  
Clock Start/From: **12**  
Clock To: **12**  
1st Value:  
2nd Value:  
Value Percent:  
Step: **NO**  
Remarks:

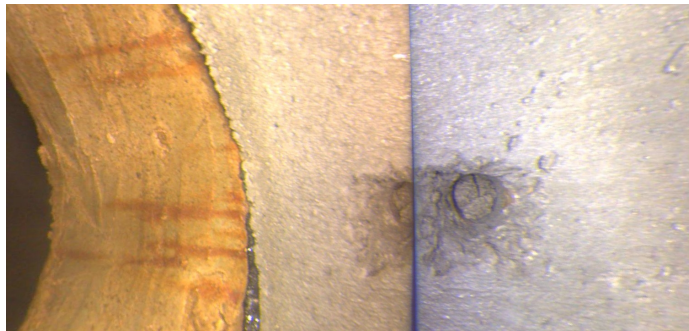
Code: **MGO**  
Description: **General Observation**

Distance (ft): **.9**  
Structural Grade: **0**  
O&M Grade: **0**  
Clock Start/From:  
Clock To:  
1st Value:  
2nd Value:  
Value Percent:  
Step: **NO**  
Remarks: **lifthole**

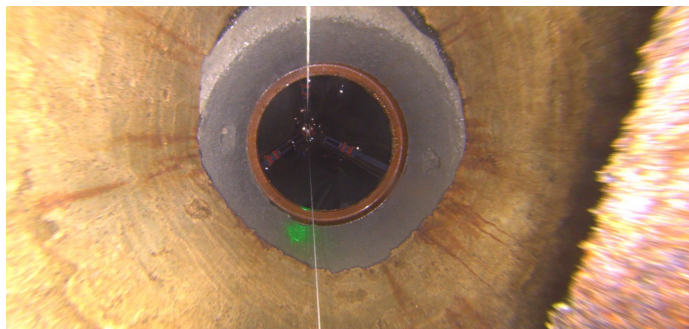
Code: **MGO**  
Description: **General Observation**

Distance (ft): **2.9**  
Structural Grade: **0**  
O&M Grade: **0**  
Clock Start/From:  
Clock To:  
1st Value:  
2nd Value:  
Value Percent:  
Step: **NO**  
Remarks: **underside of frame**

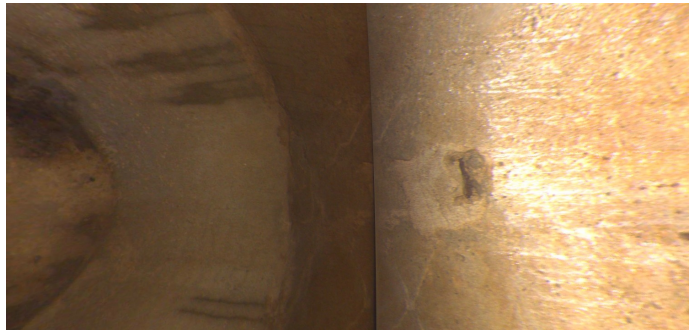
Code: **SRC**  
Description: **Surface Reinforcement Corroded**

Distance (ft): **3.5**  
Structural Grade: **5**  
O&M Grade: **0**  
Clock Start/From: **3**  
Clock To:  
1st Value:  
2nd Value:  
Value Percent:  
Step: **NO**  
Remarks:

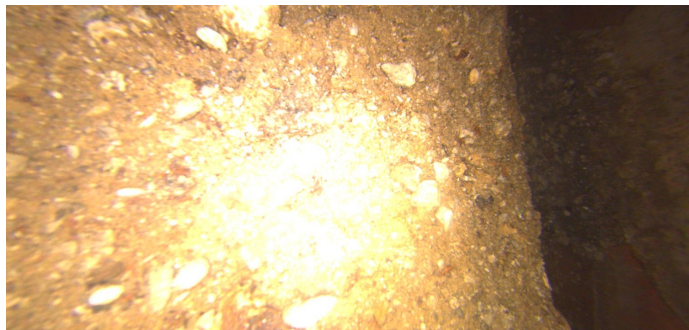
Code: **DSGV**  
Description: **Deposits Settled Gravel**

Distance (ft): **8.0**  
Structural Grade: **0**  
O&M Grade: **2**  
Clock Start/From: **12**  
Clock To: **12**  
1st Value:  
2nd Value:  
Value Percent: **5.000**  
Step: **NO**  
Remarks:

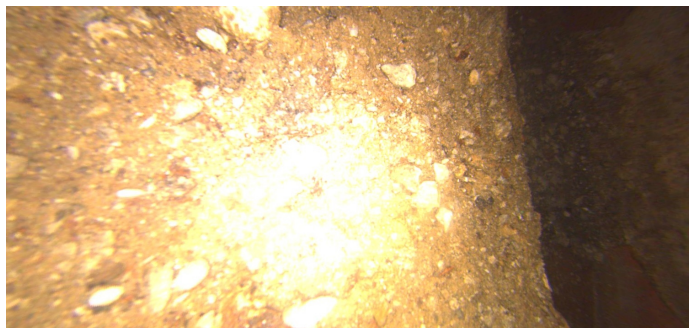
Code: **SRI**  
Description: **Surface Roughness Increased**

Distance (ft): **8.0**  
Structural Grade: **1**  
O&M Grade: **0**  
Clock Start/From: **12**  
Clock To: **12**  
1st Value:  
2nd Value:  
Value Percent:  
Step: **NO**  
Remarks:

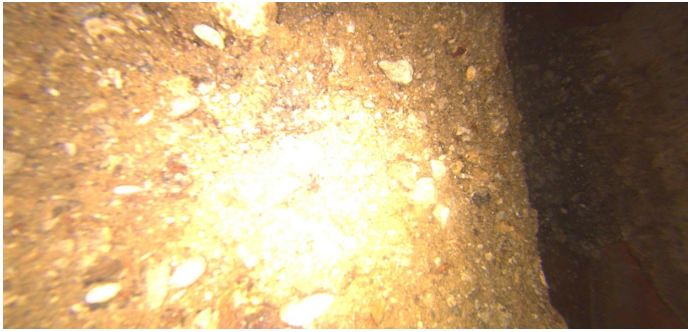
Code:	<b>MGO</b>
Description:	<b>General Observation</b>
Distance (ft):	<b>8.0</b>
Structural Grade:	<b>0</b>
O&M Grade:	<b>0</b>
Clock Start/From:	
Clock To:	
1st Value:	
2nd Value:	
Value Percent:	
Step:	<b>NO</b>
Remarks:	<b>end of survey</b>
