Manhole Inspection Report

Date:	05/09/2018	Weather:		Coding:	RZMACP
MH#:	M-805-016	Owner:	NA	Len. Surveyed:	4.2
P.O.#:		Surveyor:	Jen Costello	Rim to Invert:	4.7
Customer:		Cert. #:	U-907-5518	Wall Material:	Concrete (reinforced)

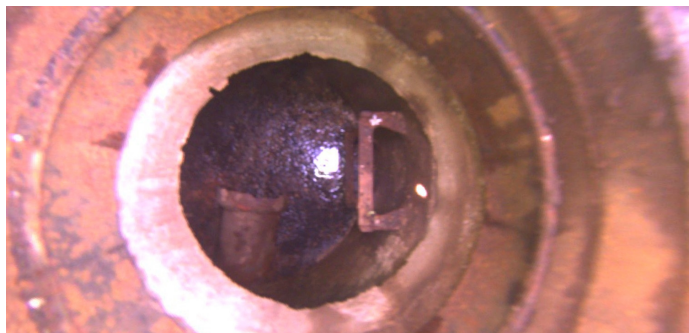
Code: **MGP**
Description: **General Photo**

Distance (ft): **.0**
Structural Grade: **0**
O&M Grade: **0**
Clock Start/From:
Clock To:
1st Value:
2nd Value:
Value Percent:
Step: **NO**
Remarks: **ACCESS MH**

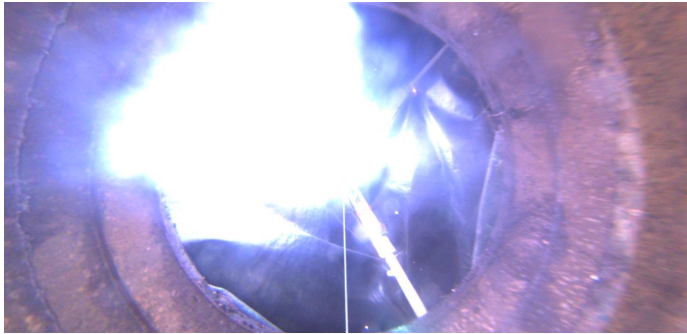
Code:	MGO
Description:	General Observation
Distance (ft):	1.5
Structural Grade:	0
O&M Grade:	0
Clock Start/From:	
Clock To:	
1st Value:	
2nd Value:	
Value Percent:	
Step:	NO
Remarks:	UNDERSIDE OF FRAME

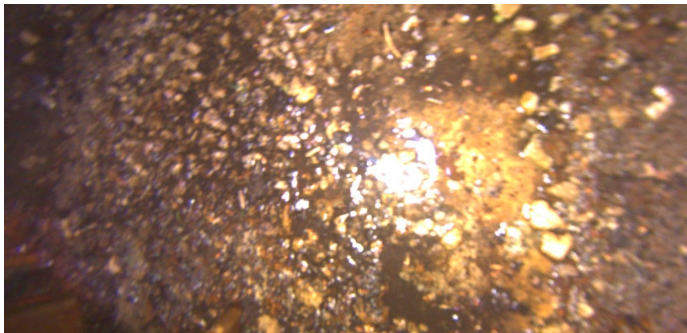
Code:	DSGV
Description:	Deposits Settled Gravel
Distance (ft):	4.2
Structural Grade:	0
O&M Grade:	2
Clock Start/From:	12
Clock To:	12
1st Value:	
2nd Value:	
Value Percent:	10.000
Step:	NO
Remarks:
