Manhole Inspection Report

Date:	05/09/2018	Weather:		Coding:	RZMACP
MH#:	M-805-019	Owner:	NA	Len. Surveyed:	9.7
P.O.#:		Surveyor:	Jen Costello	Rim to Invert:	10.6
Customer:		Cert. #:	U-907-5518	Wall Material:	Concrete (reinforced)

Street:	198' North of 5th St. West of Liberty	Project:	Hobart, IN
City:	Hobart, IN	GPS Northing:	2908617.337
Location:		GPS Easting:	2908617.337
Drain Area:	Southeast	GPS Accuracy:	Sub-Meter
Cover Shape:	Circular	Evidence of Surcharge:	No
Cover Size:	22.5	Potential for Runoff:	None
Comments:

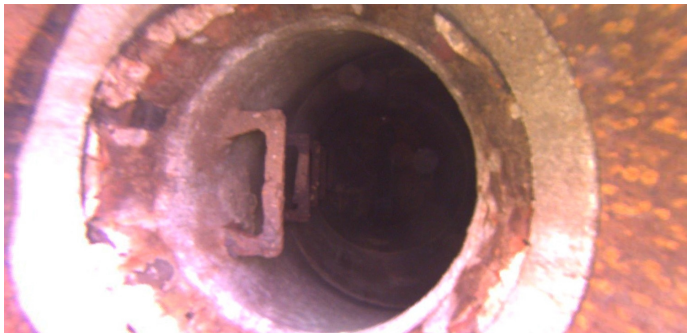
Code: **MGP**
Description: **General Photo**

Distance (ft): **.0**
Structural Grade: **0**
O&M Grade: **0**
Clock Start/From:
Clock To:
1st Value:
2nd Value:
Value Percent:
Step: **NO**
Remarks: **ACCESS MH**

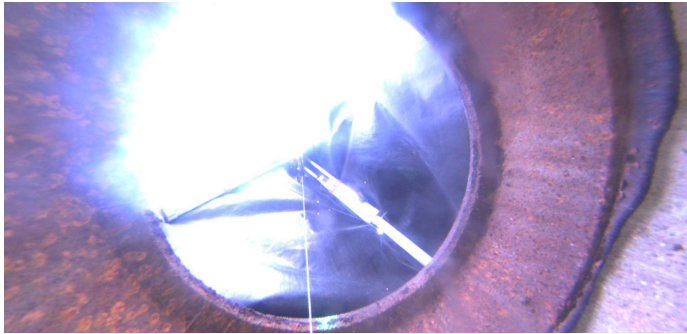
Code: **MGO**
Description: **General Observation**

Distance (ft): **1.4**
Structural Grade: **0**
O&M Grade: **0**
Clock Start/From:
Clock To:
1st Value:
2nd Value:
Value Percent:
Step: **NO**
Remarks: **UNDERSIDE OF FRAME**

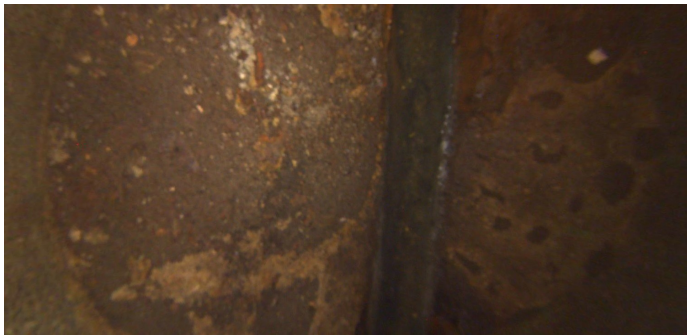
Code: **DSF**
Description: **Deposits Settled Fine**

Distance (ft): **8.6**
Structural Grade: **0**
O&M Grade: **2**
Clock Start/From: **12**
Clock To: **12**
1st Value:
2nd Value:
Value Percent: **5.000**
Step: **NO**
Remarks:

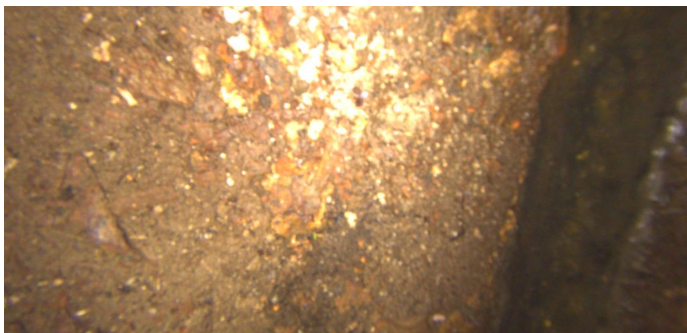
Code: **MGO**
Description: **General Observation**

Distance (ft): **9.7**
Structural Grade: **0**
O&M Grade: **0**
Clock Start/From:
Clock To:
1st Value:
2nd Value:
Value Percent:
Step: **NO**
Remarks: **END SURVEY**
