Manhole Inspection Report

Date:	05/10/2018	Weather:		Coding:	RZMACP
MH#:	M-805-025	Owner:	NA	Len. Surveyed:	7.1
P.O.#:		Surveyor:	Jen Costello	Rim to Invert:	7.4
Customer:		Cert. #:	U-907-5518	Wall Material:	Concrete (reinforced)

Street:	551' North of 5th St. West of Joliet S	Project:	Hobart, IN
City:	Hobart, IN	GPS Northing:	2908289.35
Location:		GPS Easting:	2908289.35
Drain Area:	Southeast	GPS Accuracy:	Sub-Meter
Cover Shape:	Circular	Evidence of Surcharge:	No
Cover Size:	22.5	Potential for Runoff:	None
Comments:

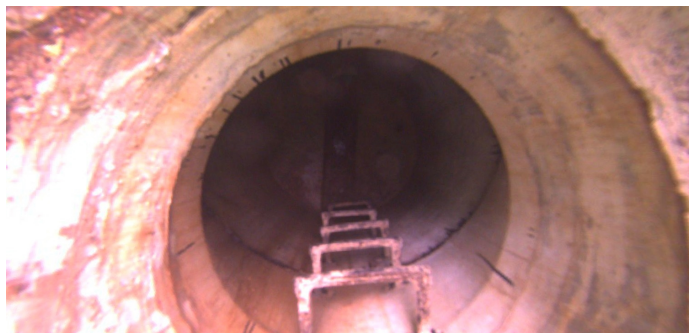
Code: **MGP**
Description: **General Photo**

Distance (ft): **.0**
Structural Grade: **0**
O&M Grade: **0**
Clock Start/From:
Clock To:
1st Value:
2nd Value:
Value Percent:
Step: **NO**
Remarks: **ACCESS MH**

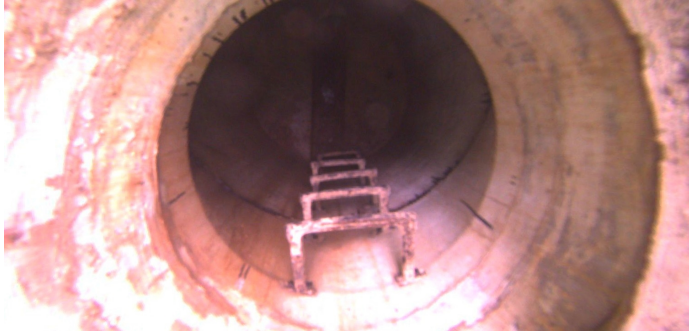
Code: **MGP**
Description: **General Photo**

Distance (ft): **.0**
Structural Grade: **0**
O&M Grade: **0**
Clock Start/From:
Clock To:
1st Value:
2nd Value:
Value Percent:
Step: **NO**
Remarks: **ACCESS MH**

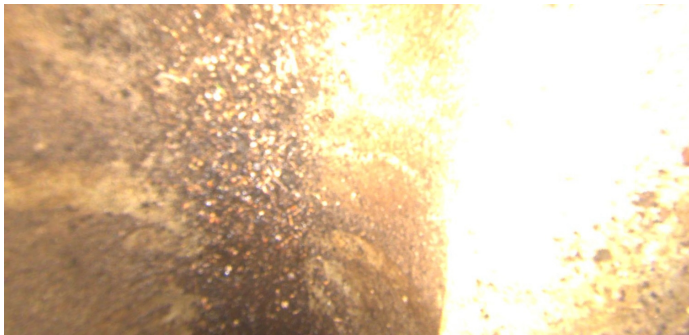
Code: **MGO**
Description: **General Observation**

Distance (ft): **7.1**
Structural Grade: **0**
O&M Grade: **0**
Clock Start/From:
Clock To:
1st Value:
2nd Value:
Value Percent:
Step: **NO**
Remarks: **END SURVEY**
