# Manhole Inspection Report

| MH#: | M-805-034 | Owner: | NA | Len. Surveyed: | 17.3 |

| Street: | Indiana St. 357' South of 4th St. | Project: | Hobart, IN |

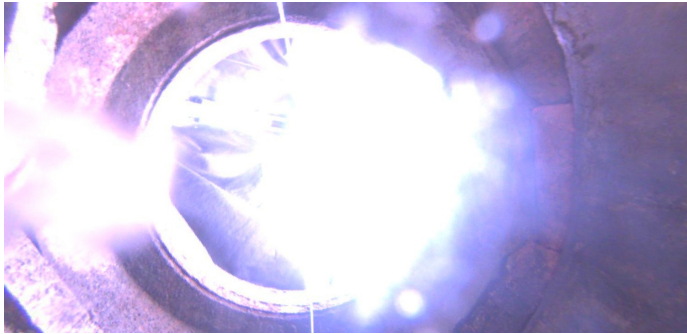
Code: **MGO**  
Description: **General Observation**

Distance (ft): **2.4**  
Structural Grade: **0**  
O&M Grade: **0**  
Clock Start/From:  
Clock To:  
1st Value:  
2nd Value:  
Value Percent:  
Step: **NO**  
Remarks: **undersde of frame**

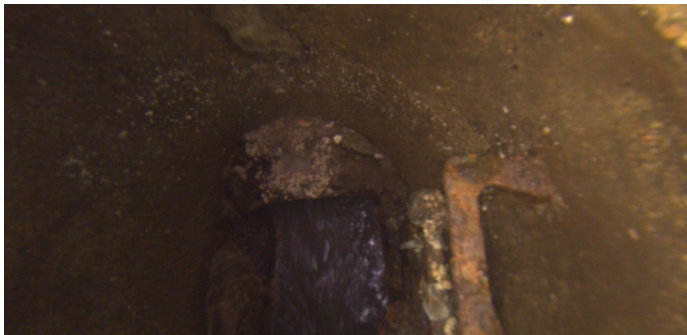
Code: **SAV**  
Description: **Surface Aggregate Visible**

Distance (ft): **14.3**  
Structural Grade: **3**  
O&M Grade: **0**  
Clock Start/From: **10**  
Clock To: **2**  
1st Value:  
2nd Value:  
Value Percent:  
Step: **NO**  
Remarks:

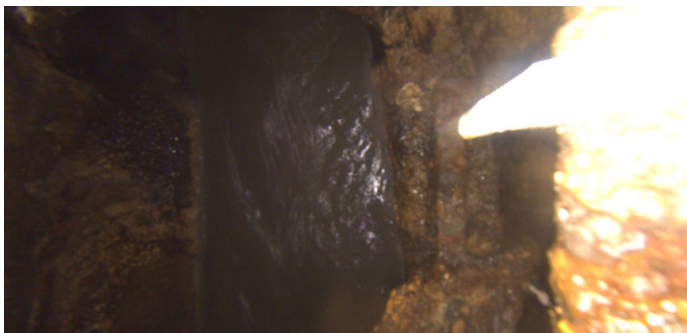
Code: **MGO**  
Description: **General Observation**

Distance (ft): **17.3**  
Structural Grade: **0**  
O&M Grade: **0**  
Clock Start/From:  
Clock To:  
1st Value:  
2nd Value:  
Value Percent:  
Step: **NO**  
Remarks: **end survey**
