# Manhole Inspection Report

Date:	<b>05/07/2018</b>	Weather:		Coding:	<b>RZMACP</b>
MH#:	<b>M-805-037</b>	Owner:	<b>NA</b>	Len. Surveyed:	<b>5.5</b>
P.O.#:		Surveyor:	<b>Jen Costello</b>	Rim to Invert:	<b>6.2</b>
Customer:		Cert. #:	<b>U-907-5518</b>	Wall Material:	<b>Concrete (reinforced)</b>

Street:	<b>Intersection of Devonshire St. and Li</b>	Project:	<b>Hobart, IN</b>
City:	<b>Hobart, IN</b>	GPS Northing:	<b>2909092.05</b>
Location:		GPS Easting:	<b>2909092.05</b>
Drain Area:	<b>South</b>	GPS Accuracy:	<b>Sub-Meter</b>
Cover Shape:	<b>Circular</b>	Evidence of Surcharge:	<b>No</b>
Cover Size:	<b>22.5</b>	Potential for Runoff:	<b>None</b>
Comments:

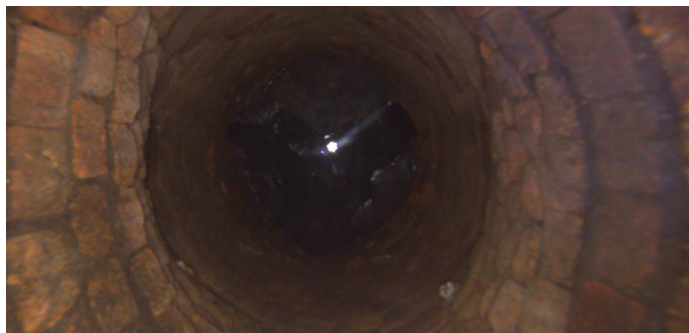
Code: **MGP**  
Description: **General Photo**

Distance (ft): **.0**  
Structural Grade: **0**  
O&M Grade: **0**  
Clock Start/From:  
Clock To:  
1st Value:  
2nd Value:  
Value Percent:  
Step: **NO**  
Remarks: **ACCESS MH**

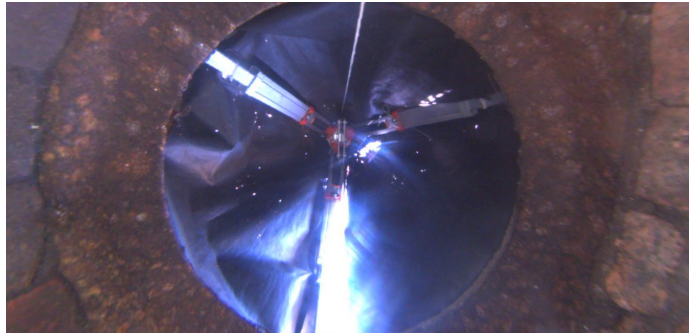
Code:	<b>MGO</b>
Description:	<b>General Observation</b>
Distance (ft):	<b>1.9</b>
Structural Grade:	<b>0</b>
O&M Grade:	<b>0</b>
Clock Start/From:	
Clock To:	
1st Value:	
2nd Value:	
Value Percent:	
Step:	<b>NO</b>
Remarks:	<b>UNDERSIDE OF FRAME</b>

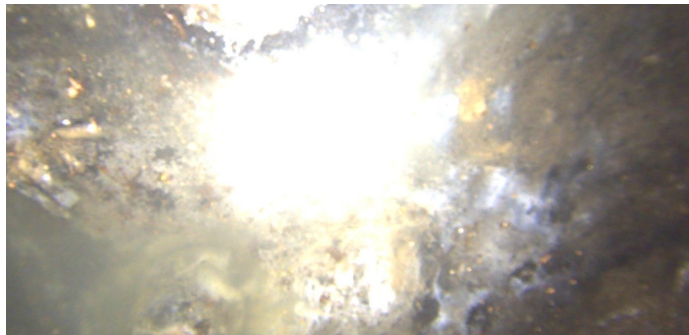
Code:	<b>MGO</b>
Description:	<b>General Observation</b>
Distance (ft):	<b>5.5</b>
Structural Grade:	<b>0</b>
O&M Grade:	<b>0</b>
Clock Start/From:	
Clock To:	
1st Value:	
2nd Value:	
Value Percent:	
Step:	<b>NO</b>
Remarks:	<b>END SURVEY</b>
