Manhole Inspection Report

Date:	05/07/2018	Weather:		Coding:	RZMACP
MH#:	M-805-039	Owner:	NA	Len. Surveyed:	7.2
P.O.#:		Surveyor:	Jen Costello	Rim to Invert:	7.9
Customer:		Cert. #:	U-907-5518	Wall Material:	Concrete (reinforced)

Street:	Intersection of Joliet St. and Devons	Project:	Hobart, IN
City:	Hobart, IN	GPS Northing:	2908776.134
Location:		GPS Easting:	2908776.134
Drain Area:	South	GPS Accuracy:	Sub-Meter
Cover Shape:	Circular	Evidence of Surcharge:	No
Cover Size:	22.5	Potential for Runoff:	None
Comments:

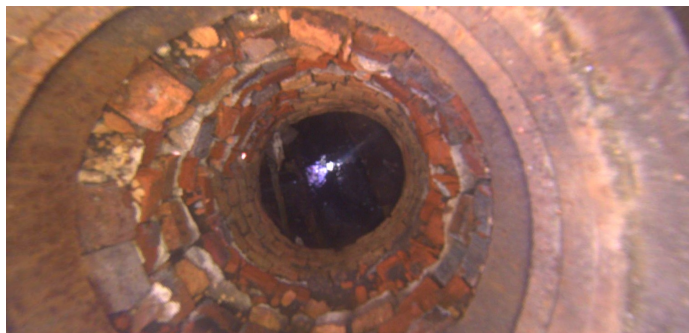
Code: **MGP**
Description: **General Photo**

Distance (ft): **.0**
Structural Grade: **0**
O&M Grade: **0**
Clock Start/From:
Clock To:
1st Value:
2nd Value:
Value Percent:
Step: **NO**
Remarks: **access MH**

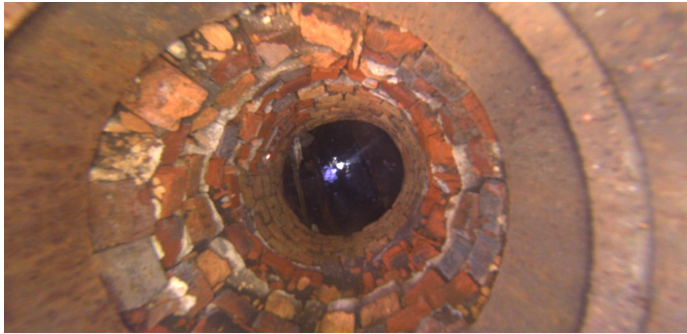
Code: **DB**
Description: **Displaced Brick**

Distance (ft): **.4**
Structural Grade: **3**
O&M Grade: **0**
Clock Start/From: **12**
Clock To: **12**
1st Value:
2nd Value:
Value Percent:
Step: **NO**
Remarks:

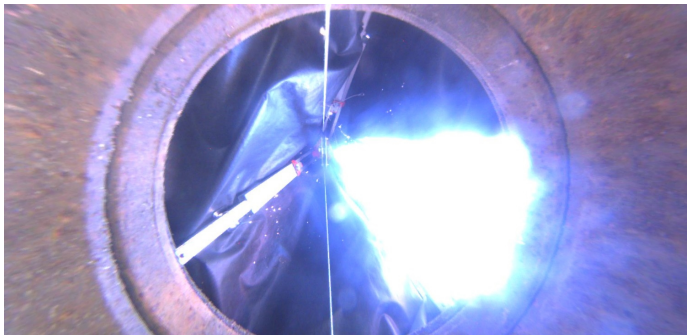
Code: **MGO**
Description: **General Observation**

Distance (ft): **1.6**
Structural Grade: **0**
O&M Grade: **0**
Clock Start/From:
Clock To:
1st Value:
2nd Value:
Value Percent:
Step: **NO**
Remarks: **END SURVEY**

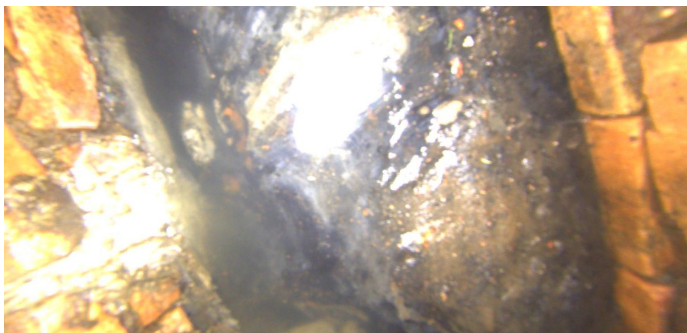
Code: **MGO**
Description: **General Observation**

Distance (ft): **7.2**
Structural Grade: **0**
O&M Grade: **0**
Clock Start/From:
Clock To:
1st Value:
2nd Value:
Value Percent:
Step: **NO**
Remarks: **END SURVEY**
