Manhole Inspection Report

Date:	05/04/2018	Weather:		Coding:	RZMACP
MH#:	M-805-045	Owner:	NA	Len. Surveyed:	6.5
P.O.#:		Surveyor:	Jen Costello	Rim to Invert:	6.7
Customer:		Cert. #:	U-907-5518	Wall Material:	Brick

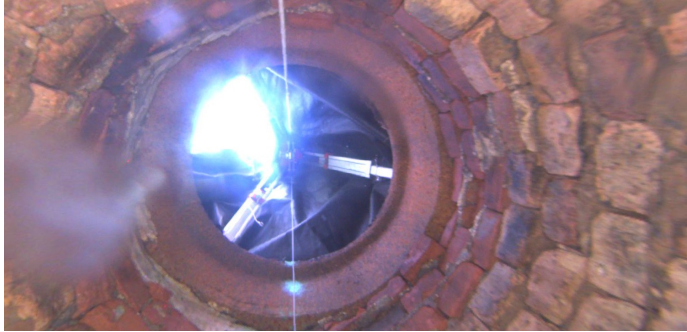
Code:	MGO
Description:	General Observation
Distance (ft):	3.3
Structural Grade:	0
O&M Grade:	0
Clock Start/From:	
Clock To:	
1st Value:	
2nd Value:	
Value Percent:	
Step:	NO
Remarks:	UNDERSIDE OF FRAME

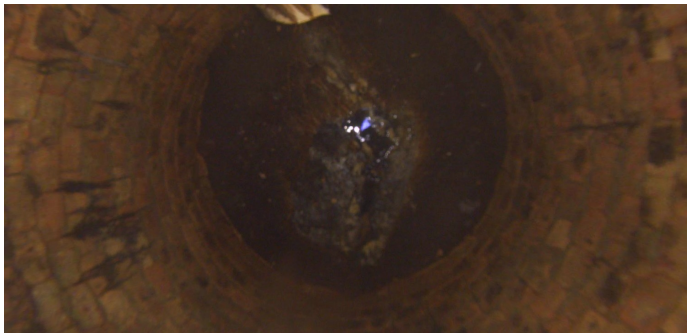
Code:	RFB
Description:	Roots Fine Barrel
Distance (ft):	3.3
Structural Grade:	0
O&M Grade:	2
Clock Start/From:	8
Clock To:	10
1st Value:	
2nd Value:	
Value Percent:	
Step:	NO
Remarks:

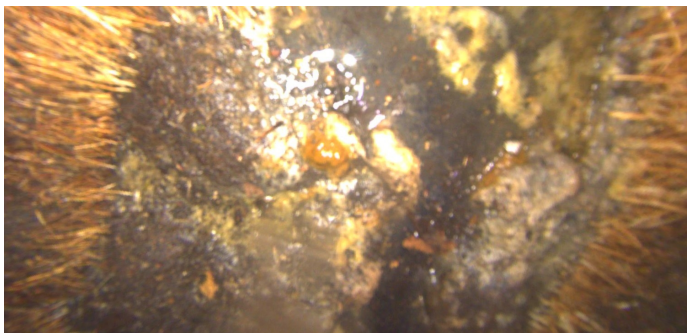
Code:	MGO
Description:	General Observation
Distance (ft):	6.5
Structural Grade:	0
O&M Grade:	0
Clock Start/From:	
Clock To:	
1st Value:	
2nd Value:	
Value Percent:	
Step:	NO
Remarks:	END SURVEY
