Manhole Inspection Report

Date:	05/03/2018	Weather:		Coding:	RZMACP
MH#:	M-805-047	Owner:	NA	Len. Surveyed:	4.5
P.O.#:		Surveyor:	Jen Costello	Rim to Invert:	5.4
Customer:		Cert. #:	U-907-5518	Wall Material:	Brick

Street:	3rd St. 203' North of Franklin St.	Project:	Hobart, IN
City:	Hobart, IN	GPS Northing:	41.53316116
Location:		GPS Easting:	-87.24859619
Drain Area:	South	GPS Accuracy:	Nearest Meter
Cover Shape:	Circular	Evidence of Surcharge:	No
Cover Size:	22.5	Potential for Runoff:	None
Comments:

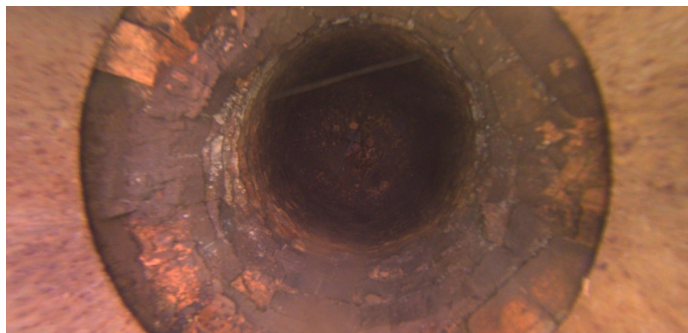
Code: **MGP**
Description: **General Photo**

Distance (ft): **.0**
Structural Grade: **0**
O&M Grade: **0**
Clock Start/From:
Clock To:
1st Value:
2nd Value:
Value Percent:
Step: **NO**
Remarks: **ACCESS MH**

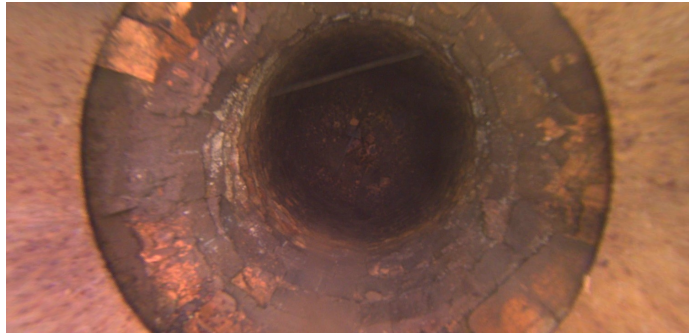
Code: **DB**
Description: **Displaced Brick**

Distance (ft): **.0**
Structural Grade: **3**
O&M Grade: **0**
Clock Start/From: **8**
Clock To: **10**
1st Value:
2nd Value:
Value Percent:
Step: **NO**
Remarks:

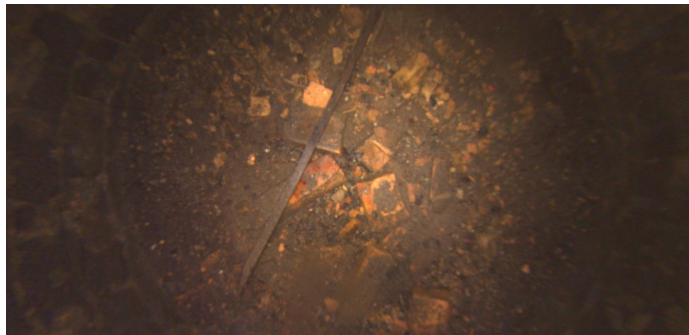
Code: **DB**
Description: **Displaced Brick**

Distance (ft): **3.8**
Structural Grade: **3**
O&M Grade: **0**
Clock Start/From: **12**
Clock To: **12**
1st Value:
2nd Value:
Value Percent:
Step: **NO**
Remarks:

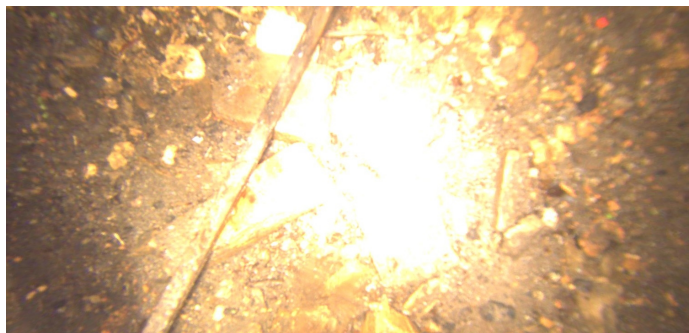
Code: **MGO**
Description: **General Observation**

Distance (ft): **4.5**
Structural Grade: **0**
O&M Grade: **0**
Clock Start/From:
Clock To:
1st Value:
2nd Value:
Value Percent:
Step: **NO**
Remarks: **END SURVEY**

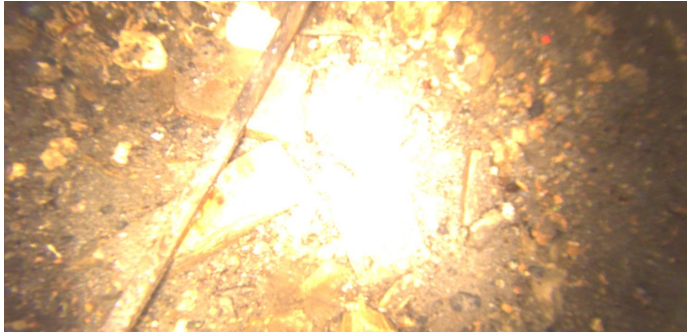
Code: **MGO**
Description: **General Observation**

Distance (ft): **4.5**
Structural Grade: **0**
O&M Grade: **0**
Clock Start/From:
Clock To:
1st Value:
2nd Value:
Value Percent:
Step: **NO**
Remarks: **END SURVEY**
