# Manhole Inspection Report

Date:	05/03/2018	Weather:		Coding:	RZMACP
MH#:	M-805-047	Owner:	NA	Len. Surveyed:	8.5
P.O.#:		Surveyor:	Jen Costello	Rim to Invert:	9.3
Customer:		Cert. #:	U-907-5518	Wall Material:	Brick

Street:	3rd St. 203' North of Franklin St.	Project:	Hobart, IN
City:	Hobart, IN	GPS Northing:	41.53372192
Location:		GPS Easting:	-87.2485199
Drain Area:	South	GPS Accuracy:	Nearest Meter
Cover Shape:	Circular	Evidence of Surcharge:	No
Cover Size:	22.5	Potential for Runoff:	None
Comments:

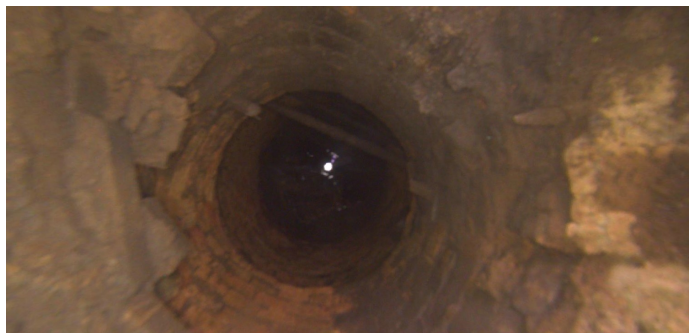
Code: **MGP**  
Description: **General Photo**

Distance (ft): **.0**  
Structural Grade: **0**  
O&M Grade: **0**  
Clock Start/From:  
Clock To:  
1st Value:  
2nd Value:  
Value Percent:  
Step: **NO**  
Remarks: **ACCESS MH**

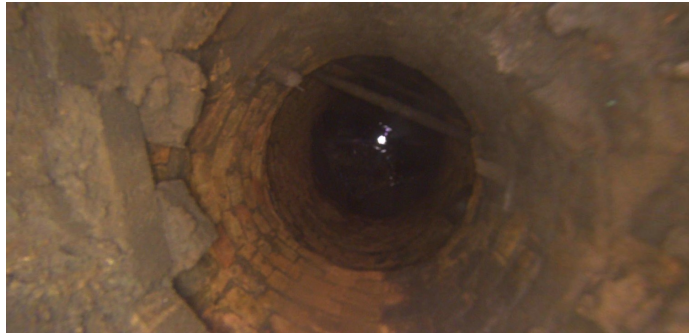
Code: **DB**  
Description: **Displaced Brick**

Distance (ft): **.3**  
Structural Grade: **3**  
O&M Grade: **0**  
Clock Start/From: **8**  
Clock To: **10**  
1st Value:  
2nd Value:  
Value Percent:  
Step: **NO**  
Remarks:

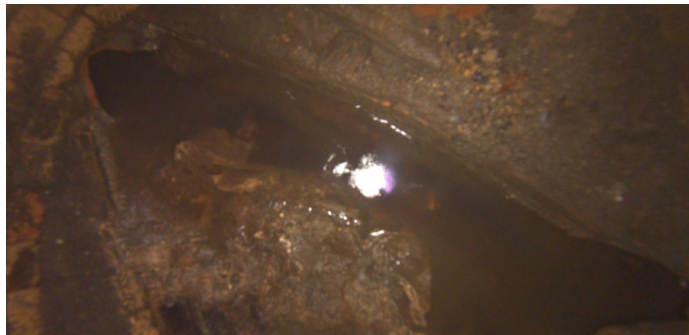
Code: **DSF**  
Description: **Deposits Settled Fine**

Distance (ft): **7.3**  
Structural Grade: **0**  
O&M Grade: **2**  
Clock Start/From: **12**  
Clock To: **12**  
1st Value:  
2nd Value:  
Value Percent: **5.000**  
Step: **NO**  
Remarks:

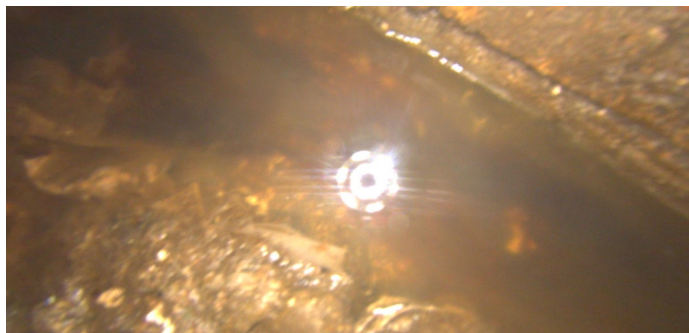
Code: **MGO**  
Description: **General Observation**

Distance (ft): **8.5**  
Structural Grade: **0**  
O&M Grade: **0**  
Clock Start/From:  
Clock To:  
1st Value:  
2nd Value:  
Value Percent:  
Step: **NO**  
Remarks: **END SURVEY**
