Manhole Inspection Report

Date:	05/06/2018	Weather:		Coding:	RZMACP
MH#:	M-805-049	Owner:	NA	Len. Surveyed:	10.1
P.O.#:		Surveyor:	Jen Costello	Rim to Invert:	10.8
Customer:		Cert. #:	U-907-5518	Wall Material:	Concrete (reinforced)

Street:	Intersection of Georgiana St. and H	Project:	Hobart, IN
City:	Hobart, IN	GPS Northing:	2907581.363
Location:		GPS Easting:	2907581.363
Drain Area:	South	GPS Accuracy:	Sub-Meter
Cover Shape:	Circular	Evidence of Surcharge:	No
Cover Size:	22.5	Potential for Runoff:	None
Comments:

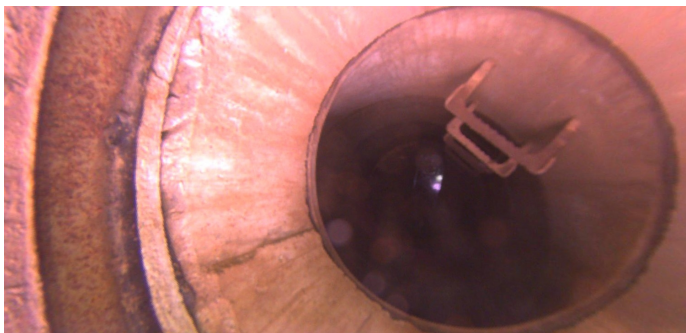
Code: **CM**
Description: **Crack Multiple**

Distance (ft): **.0**
Structural Grade: **3**
O&M Grade: **0**
Clock Start/From: **9**
Clock To: **10**
1st Value:
2nd Value:
Value Percent:
Step: **NO**
Remarks:

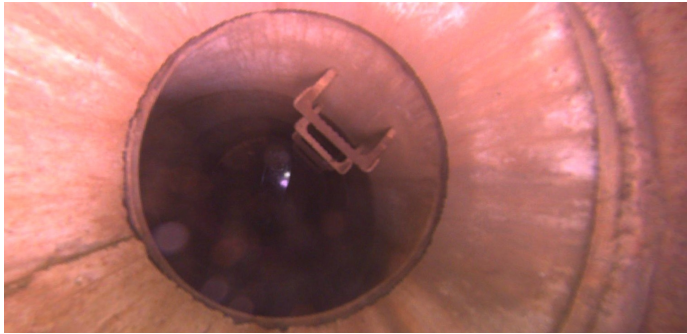
Code: **MGO**
Description: **General Observation**

Distance (ft): **.0**
Structural Grade: **0**
O&M Grade: **0**
Clock Start/From:
Clock To:
1st Value:
2nd Value:
Value Percent:
Step: **NO**
Remarks: **UNDERSIDE OF FRAME**

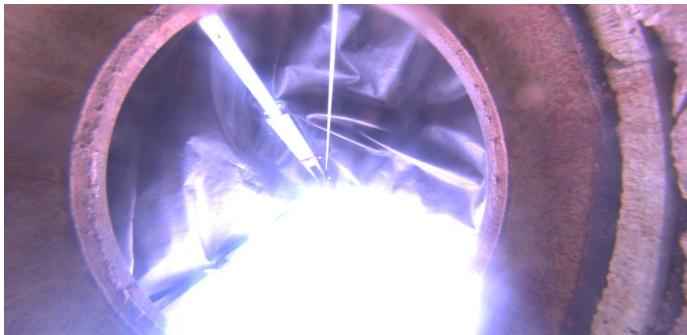
Code: **MGO**
Description: **General Observation**

Distance (ft): **1.3**
Structural Grade: **0**
O&M Grade: **0**
Clock Start/From:
Clock To:
1st Value:
2nd Value:
Value Percent:
Step: **NO**
Remarks: **UNDERSIDE OF FRAME**

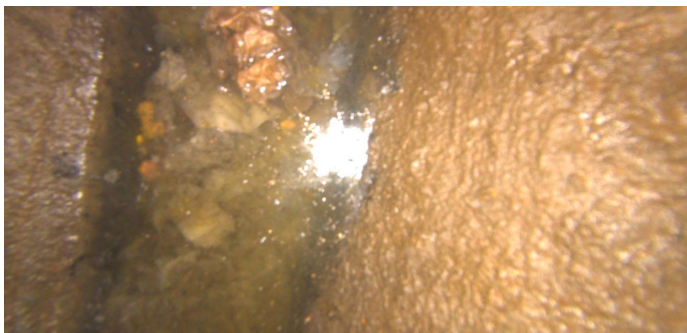
Code: **MGO**
Description: **General Observation**

Distance (ft): **10.1**
Structural Grade: **0**
O&M Grade: **0**
Clock Start/From:
Clock To:
1st Value:
2nd Value:
Value Percent:
Step: **NO**
Remarks: **END SURVEY**
