Manhole Inspection Report

Date:	05/06/2018	Weather:		Coding:	RZMACP
MH#:	M-805-050	Owner:	NA	Len. Surveyed:	6.6
P.O.#:		Surveyor:	Jen Costello	Rim to Invert:	7.2
Customer:		Cert. #:	U-907-5518	Wall Material:	Brick

Street:	Georgiana St. 268' East of Linda St.	Project:	Hobart, IN
City:	Hobart, IN	GPS Northing:	2907334.392
Location:		GPS Easting:	2907334.392
Drain Area:	South	GPS Accuracy:	Sub-Meter
Cover Shape:	Circular	Evidence of Surcharge:	No
Cover Size:	22.5	Potential for Runoff:	None
Comments:

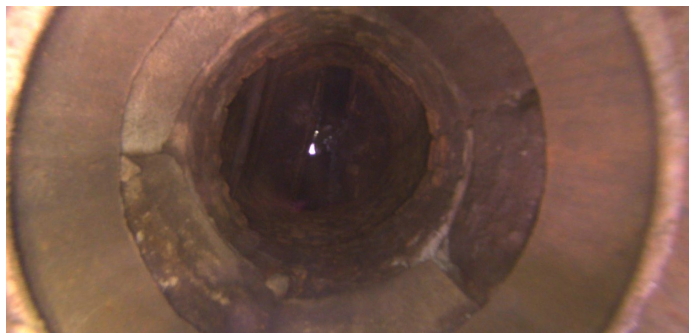
Code: **MGP**
Description: **General Photo**

Distance (ft): **.0**
Structural Grade: **0**
O&M Grade: **0**
Clock Start/From:
Clock To:
1st Value:
2nd Value:
Value Percent:
Step: **NO**
Remarks: **ACCESS MH**

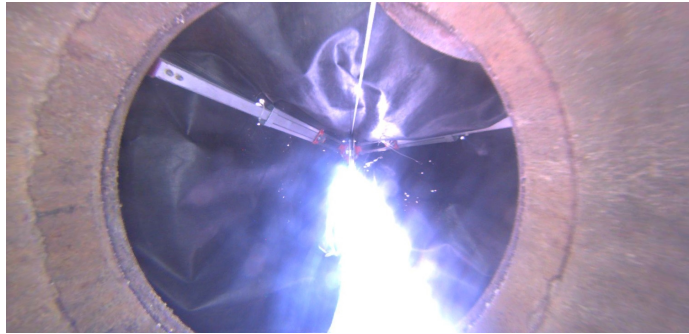
Code:	MGO
Description:	General Observation
Distance (ft):	1.4
Structural Grade:	0
O&M Grade:	0
Clock Start/From:	
Clock To:	
1st Value:	
2nd Value:	
Value Percent:	
Step:	NO
Remarks:	UNDERSIDE OF FRAME

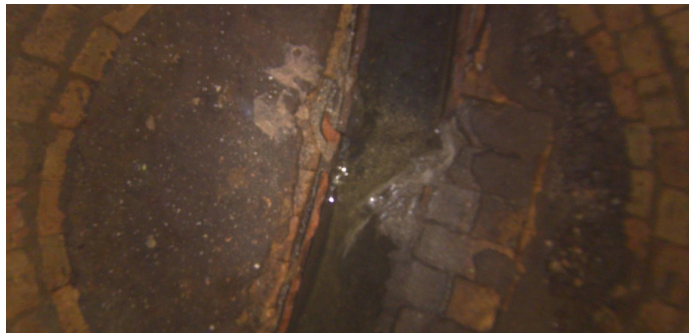
Code:	DSF
Description:	Deposits Settled Fine
Distance (ft):	5.5
Structural Grade:	0
O&M Grade:	2
Clock Start/From:	12
Clock To:	12
1st Value:	
2nd Value:	
Value Percent:	5.000
Step:	NO
Remarks:

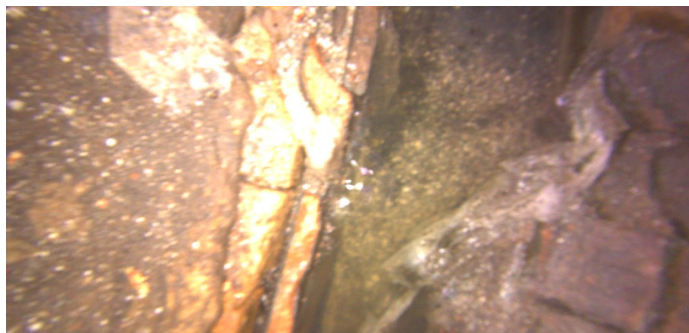
Code:	MGO
Description:	General Observation
Distance (ft):	6.6
Structural Grade:	0
O&M Grade:	0
Clock Start/From:	
Clock To:	
1st Value:	
2nd Value:	
Value Percent:	
Step:	NO
Remarks:	END SURVEY
