Manhole Inspection Report

Date:	05/06/2018	Weather:		Coding:	RZMACP
MH#:	M-805-051	Owner:	NA	Len. Surveyed:	5.4
P.O.#:		Surveyor:	Jen Costello	Rim to Invert:	6.0
Customer:		Cert. #:	U-907-5518	Wall Material:	Brick

Street:	Intersection of Linda St. and Georgia	Project:	Hobart, IN
City:	Hobart, IN	GPS Northing:	2907090.909
Location:		GPS Easting:	2907090.909
Drain Area:	South	GPS Accuracy:	Sub-Meter
Cover Shape:	Circular	Evidence of Surcharge:	No
Cover Size:	22.5	Potential for Runoff:	None
Comments:

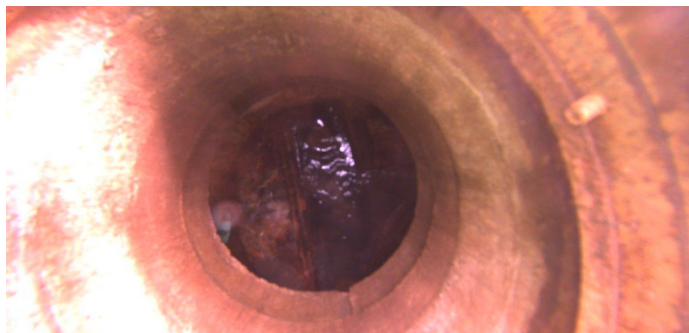
Code: **MGP**
Description: **General Photo**

Distance (ft): **.0**
Structural Grade: **0**
O&M Grade: **0**
Clock Start/From:
Clock To:
1st Value:
2nd Value:
Value Percent:
Step: **NO**
Remarks: **access MH**

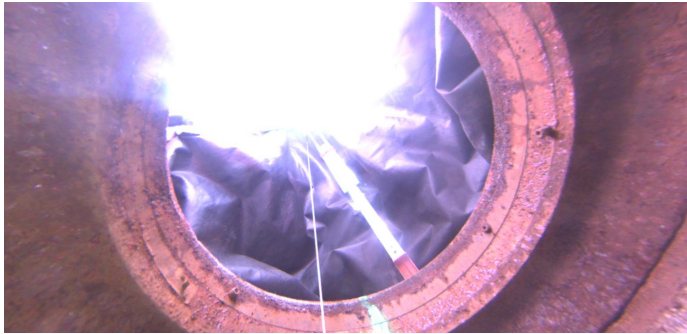
Code:	MGO
Description:	General Observation
Distance (ft):	1.4
Structural Grade:	0
O&M Grade:	0
Clock Start/From:	
Clock To:	
1st Value:	
2nd Value:	
Value Percent:	
Step:	NO
Remarks:	UNDERSIDE OF FRAME

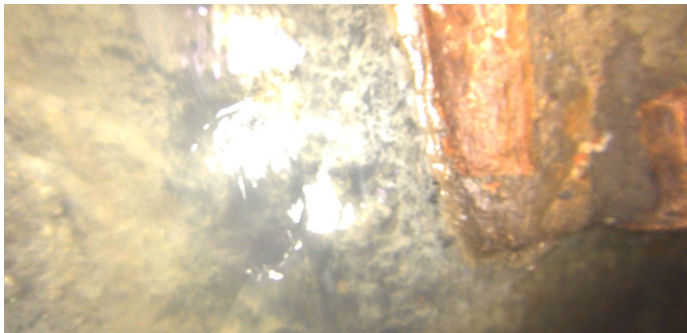
Code:	MGO
Description:	General Observation
Distance (ft):	5.4
Structural Grade:	0
O&M Grade:	0
Clock Start/From:	
Clock To:	
1st Value:	
2nd Value:	
Value Percent:	
Step:	NO
Remarks:	END SURVEY
