# Manhole Inspection Report

Date:	<b>05/04/2018</b>	Weather:		Coding:	<b>RZMACP</b>
MH#:	<b>M-805-053</b>	Owner:	<b>NA</b>	Len. Surveyed:	<b>7.7</b>
P.O.#:		Surveyor:	<b>Jen Costello</b>	Rim to Invert:	<b>7.5</b>
Customer:		Cert. #:	<b>U-907-5518</b>	Wall Material:	<b>Brick</b>

Street:	<b>Intersection of 3rd St. and Linda St.</b>	Project:	<b>Hobart, IN</b>
City:	<b>Hobart, IN</b>	GPS Northing:	<b>2907078.241</b>
Location:		GPS Easting:	<b>2907078.241</b>
Drain Area:	<b>South</b>	GPS Accuracy:	<b>Sub-Meter</b>
Cover Shape:	<b>Circular</b>	Evidence of Surcharge:	<b>No</b>
Cover Size:	<b>22.5</b>	Potential for Runoff:	<b>None</b>
Comments:

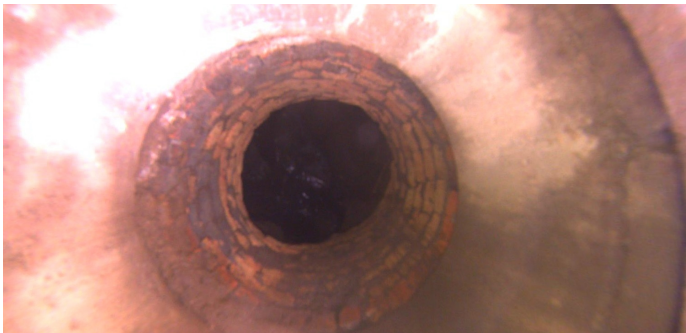
Code:	<b>MGP</b>
Description:	<b>General Photo</b>

Distance (ft):	.0
Structural Grade:	0
O&M Grade:	0
Clock Start/From:	
Clock To:	
1st Value:	
2nd Value:	
Value Percent:	
Step:	NO
Remarks:	AC

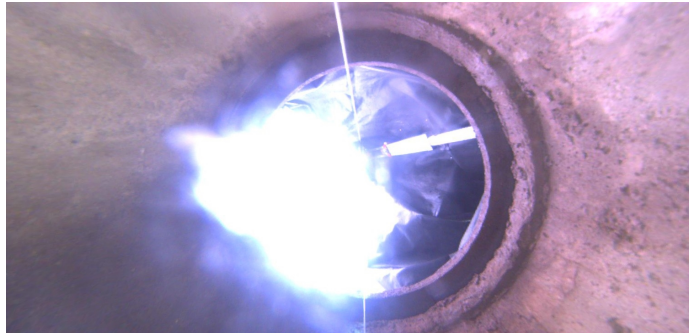
Code:	<b>MGO</b>
Description:	<b>General Observation</b>
Distance (ft):	<b>2.0</b>
Structural Grade:	<b>0</b>
O&M Grade:	<b>0</b>
Clock Start/From:	
Clock To:	
1st Value:	
2nd Value:	
Value Percent:	
Step:	<b>NO</b>
Remarks:	<b>UNDERSIDE OF FRAME</b>

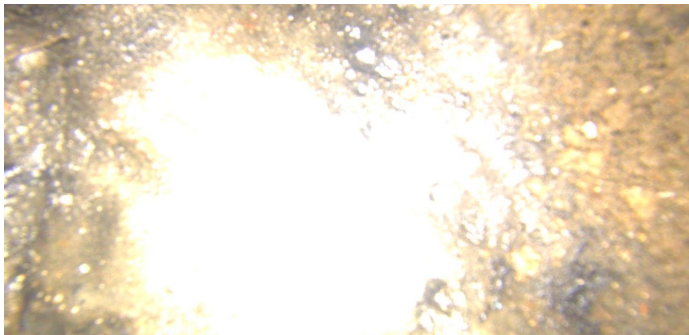
Code:	<b>MGO</b>
Description:	<b>General Observation</b>
Distance (ft):	<b>7.7</b>
Structural Grade:	<b>0</b>
O&M Grade:	<b>0</b>
Clock Start/From:	
Clock To:	
1st Value:	
2nd Value:	
Value Percent:	
Step:	<b>NO</b>
Remarks:	<b>END SURVEY</b>
