Manhole Inspection Report

Date:	05/06/2018	Weather:		Coding:	RZMACP
MH#:	M-805-055.2	Owner:	NA	Len. Surveyed:	3.7
P.O.#:		Surveyor:	Jen Costello	Rim to Invert:	4.0
Customer:		Cert. #:	U-907-5518	Wall Material:	Brick

Street:	71' South of Cleveland Ave. and Wes	Project:	Hobart, IN
City:	Hobart, IN	GPS Northing:	2907412.128
Location:		GPS Easting:	2907412.128
Drain Area:	South	GPS Accuracy:	Sub-Meter
Cover Shape:	Circular	Evidence of Surcharge:	No
Cover Size:	22.5	Potential for Runoff:	None
Comments:

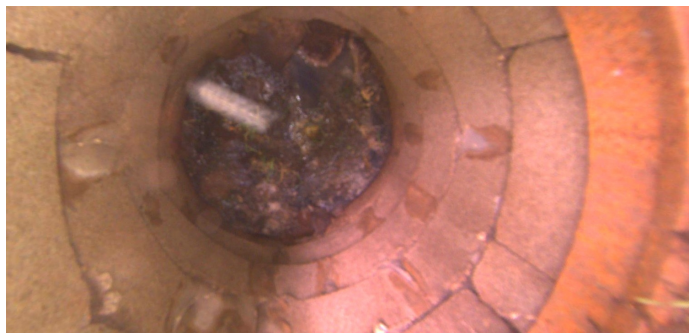
Code: **MGP**
Description: **General Photo**

Distance (ft): **.0**
Structural Grade: **0**
O&M Grade: **0**
Clock Start/From:
Clock To:
1st Value:
2nd Value:
Value Percent:
Step: **NO**
Remarks: **ACCESS MH**

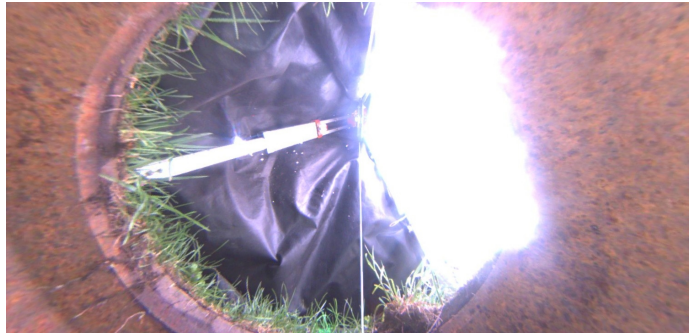
Code:	MGO
Description:	General Observation
Distance (ft):	1.2
Structural Grade:	0
O&M Grade:	0
Clock Start/From:	
Clock To:	
1st Value:	
2nd Value:	
Value Percent:	
Step:	NO
Remarks:	UNDERSIDE OF FRAME

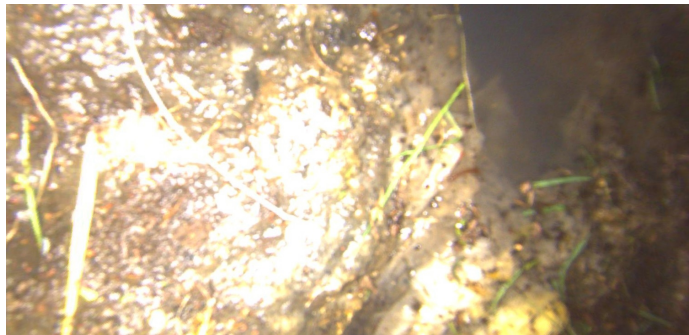
Code:	DSF
Description:	Deposits Settled Fine
Distance (ft):	3.7
Structural Grade:	0
O&M Grade:	2
Clock Start/From:	12
Clock To:	12
1st Value:	
2nd Value:	
Value Percent:	10.000
Step:	NO
Remarks:

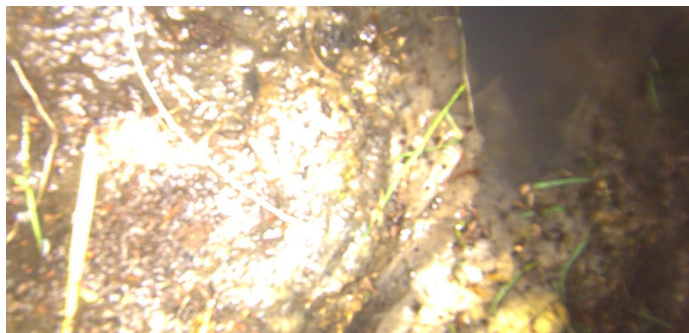
Code:	MGO
Description:	General Observation
Distance (ft):	3.7
Structural Grade:	0
O&M Grade:	0
Clock Start/From:	
Clock To:	
1st Value:	
2nd Value:	
Value Percent:	
Step:	NO
Remarks:	END SURVEY
