Manhole Inspection Report

Date:	05/05/2018	Weather:		Coding:	RZMACP
MH#:	M-805-055	Owner:	NA	Len. Surveyed:	8.8
P.O.#:		Surveyor:	Jen Costello	Rim to Invert:	9.5
Customer:		Cert. #:	U-907-5518	Wall Material:	Brick

Street:	Lillian St. and Linda St. to the East.	Project:	Hobart, IN
City:	Hobart, IN	GPS Northing:	2907547.201
Location:		GPS Easting:	2907547.201
Drain Area:	South	GPS Accuracy:	Sub-Meter
Cover Shape:	Circular	Evidence of Surcharge:	No
Cover Size:	22.5	Potential for Runoff:	None
Comments:

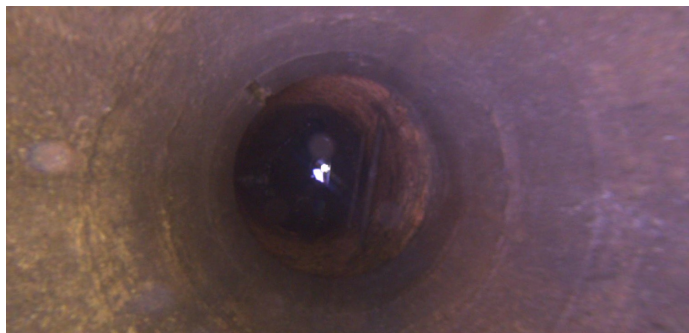
Code: **MGP**
Description: **General Photo**

Distance (ft): **.0**
Structural Grade: **0**
O&M Grade: **0**
Clock Start/From:
Clock To:
1st Value:
2nd Value:
Value Percent:
Step: **NO**
Remarks: **ACCESS MH**

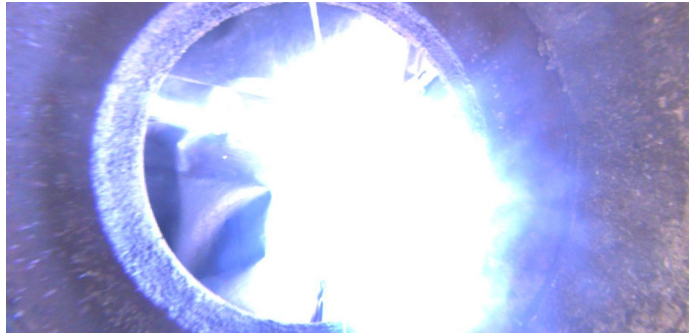
Code:	MGO
Description:	General Observation
Distance (ft):	1.8
Structural Grade:	0
O&M Grade:	0
Clock Start/From:	
Clock To:	
1st Value:	
2nd Value:	
Value Percent:	
Step:	NO
Remarks:	UNDERSIDE OF FRAME

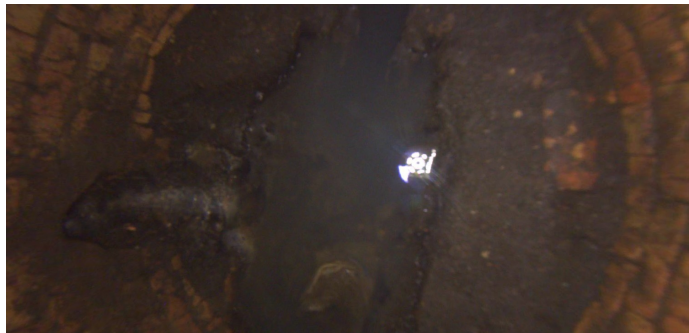
Code:	DSF
Description:	Deposits Settled Fine
Distance (ft):	7.0
Structural Grade:	0
O&M Grade:	2
Clock Start/From:	12
Clock To:	12
1st Value:	
2nd Value:	
Value Percent:	5.000
Step:	NO
Remarks:

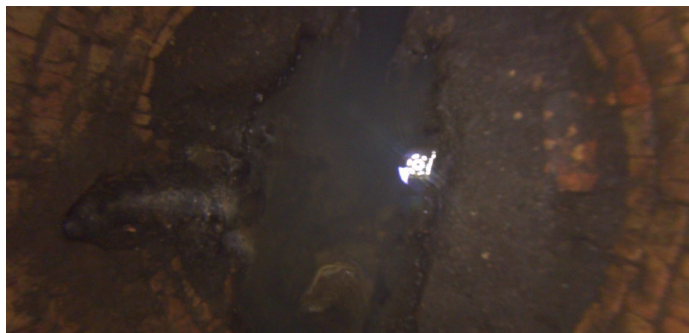
Code:	OBR
Description:	Obstacle Rocks
Distance (ft):	7.0
Structural Grade:	0
O&M Grade:	2
Clock Start/From:	3
Clock To:	
1st Value:	
2nd Value:	
Value Percent:	5.000
Step:	NO
Remarks:

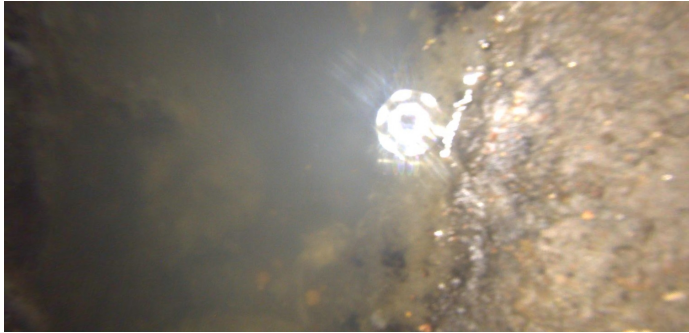
Code:	MGO
Description:	General Observation
Distance (ft):	8.8
Structural Grade:	0
O&M Grade:	0
Clock Start/From:	
Clock To:	
1st Value:	
2nd Value:	
Value Percent:	
Step:	NO
Remarks:	END SURVEY
