# Manhole Inspection Report

Date:	<b>05/07/2018</b>	Weather:		Coding:	<b>RZMACP</b>
MH#:	<b>M-805-057</b>	Owner:	<b>NA</b>	Len. Surveyed:	<b>8.2</b>
P.O.#:		Surveyor:	<b>Jen Costello</b>	Rim to Invert:	<b>9.0</b>
Customer:		Cert. #:	<b>U-907-5518</b>	Wall Material:	<b>Concrete (reinforced)</b>

Street:	<b>Intersection of Lillian St. and Ohio St</b>	Project:	<b>Hobart, IN</b>
City:	<b>Hobart, IN</b>	GPS Northing:	<b>2908300.908</b>
Location:		GPS Easting:	<b>2908300.908</b>
Drain Area:	<b>South</b>	GPS Accuracy:	<b>Sub-Meter</b>
Cover Shape:	<b>Circular</b>	Evidence of Surcharge:	<b>No</b>
Cover Size:	<b>22.5</b>	Potential for Runoff:	<b>None</b>
Comments:

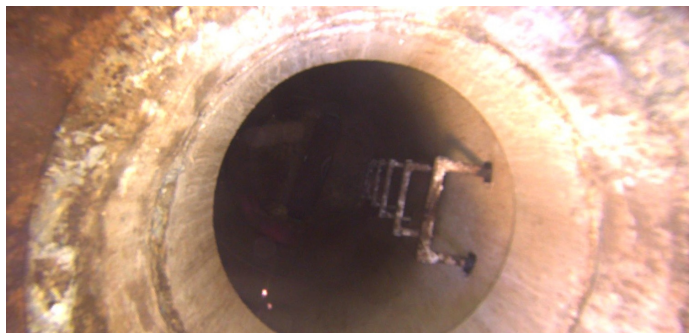
Code: **MGP**  
Description: **General Photo**

Distance (ft): **.0**  
Structural Grade: **0**  
O&M Grade: **0**  
Clock Start/From:  
Clock To:  
1st Value:  
2nd Value:  
Value Percent:  
Step: **NO**  
Remarks: **ACCESS MH**

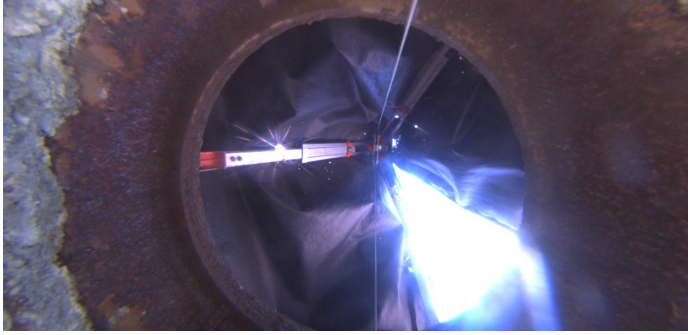
Code:	<b>MGO</b>
Description:	<b>General Observation</b>
Distance (ft):	<b>1.3</b>
Structural Grade:	<b>0</b>
O&M Grade:	<b>0</b>
Clock Start/From:	
Clock To:	
1st Value:	
2nd Value:	
Value Percent:	
Step:	<b>NO</b>
Remarks:	<b>UNDERSIDE OF FRAME</b>
