Manhole Inspection Report

Date:	05/07/2018	Weather:		Coding:	RZMACP
MH#:	M-805-060	Owner:	NA	Len. Surveyed:	9.0
P.O.#:		Surveyor:	Jen Costello	Rim to Invert:	10.2
Customer:		Cert. #:	U-907-5518	Wall Material:	Concrete (reinforced)

Street:	Intersection of Devonshire St. and O	Project:	Hobart, IN
City:	Hobart, IN	GPS Northing:	2908377.36
Location:		GPS Easting:	2908377.36
Drain Area:	South	GPS Accuracy:	Sub-Meter
Cover Shape:	Circular	Evidence of Surcharge:	No
Cover Size:	22.5	Potential for Runoff:	None
Comments:

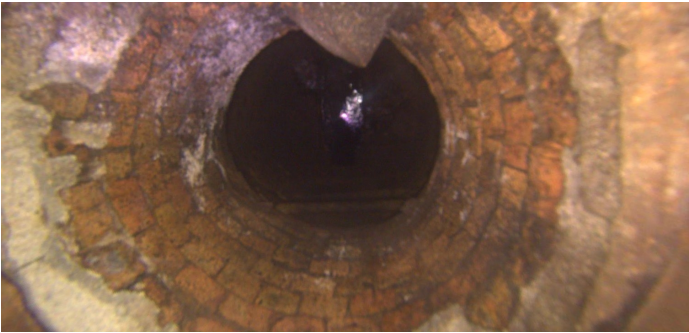
Code: **MGP**
Description: **General Photo**

Distance (ft): **.0**
Structural Grade: **0**
O&M Grade: **0**
Clock Start/From:
Clock To:
1st Value:
2nd Value:
Value Percent:
Step: **NO**
Remarks: **ACCESS MH**

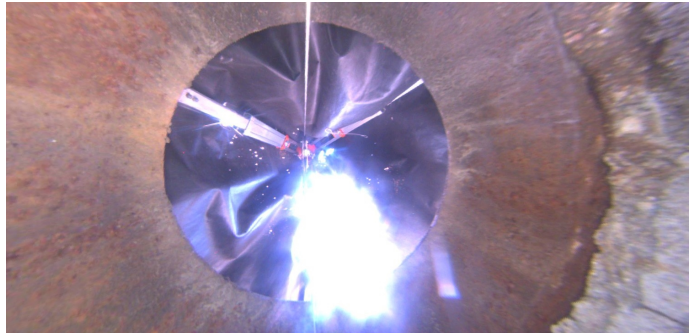
Code: **MGO**
Description: **General Observation**

Distance (ft): **1.4**
Structural Grade: **0**
O&M Grade: **0**
Clock Start/From:
Clock To:
1st Value:
2nd Value:
Value Percent:
Step: **NO**
Remarks: **UNDERSIDE OF FRAME**

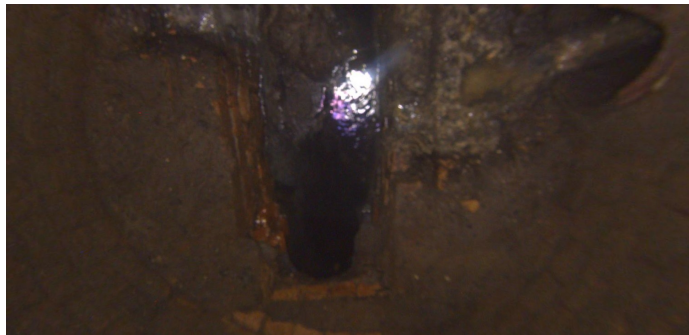
Code: **DSF**
Description: **Deposits Settled Fine**

Distance (ft): **7.0**
Structural Grade: **0**
O&M Grade: **2**
Clock Start/From: **12**
Clock To: **12**
1st Value:
2nd Value:
Value Percent: **5.000**
Step: **NO**
Remarks:

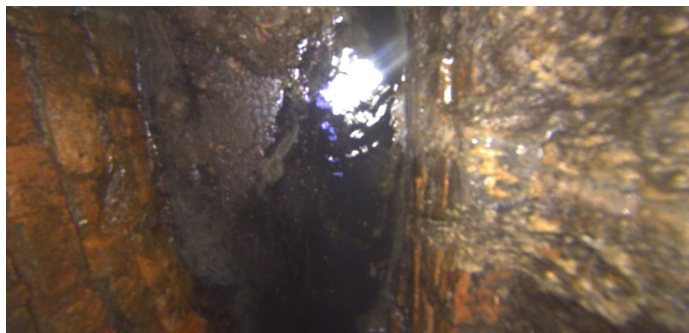
Code: **MGO**
Description: **General Observation**

Distance (ft): **9.0**
Structural Grade: **0**
O&M Grade: **0**
Clock Start/From:
Clock To:
1st Value:
2nd Value:
Value Percent:
Step: **NO**
Remarks: **END SURVEY**
