Manhole Inspection Report

Date:	05/07/2018	Weather:		Coding:	RZMACP
MH#:	M-805-061	Owner:	NA	Len. Surveyed:	3.2
P.O.#:		Surveyor:	Jen Costello	Rim to Invert:	7.8
Customer:		Cert. #:	U-907-5518	Wall Material:	Brick

Street:	Ohio St. 208' South of Cleveland Ave	Project:	Hobart, IN
City:	Hobart, IN	GPS Northing:	2908387.46
Location:		GPS Easting:	2908387.46
Drain Area:	South	GPS Accuracy:	Sub-Meter
Cover Shape:	Circular	Evidence of Surcharge:	No
Cover Size:	22.5	Potential for Runoff:	None
Comments:

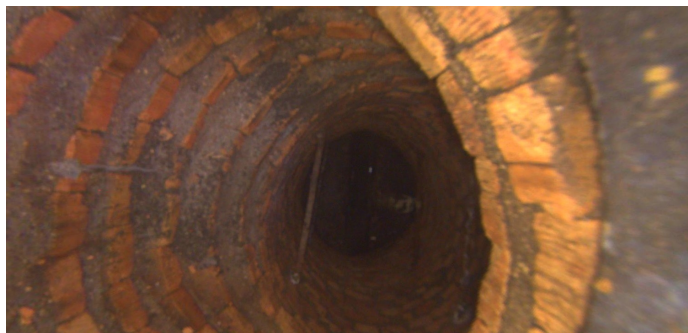
Code: **MGP**
Description: **General Photo**

Distance (ft): **.0**
Structural Grade: **0**
O&M Grade: **0**
Clock Start/From:
Clock To:
1st Value:
2nd Value:
Value Percent:
Step: **NO**
Remarks: **access MH**

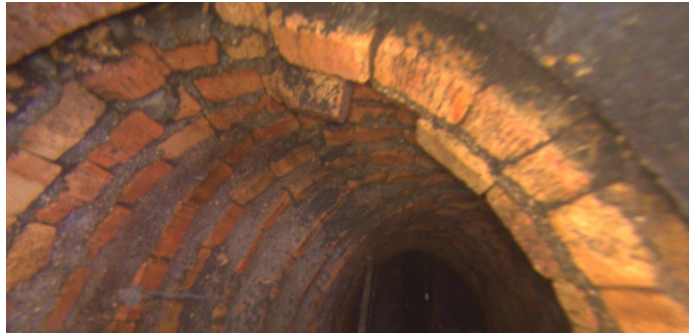
Code: **DB**
Description: **Displaced Brick**

Distance (ft): **.0**
Structural Grade: **3**
O&M Grade: **0**
Clock Start/From: **12**
Clock To:
1st Value:
2nd Value:
Value Percent:
Step: **NO**
Remarks:

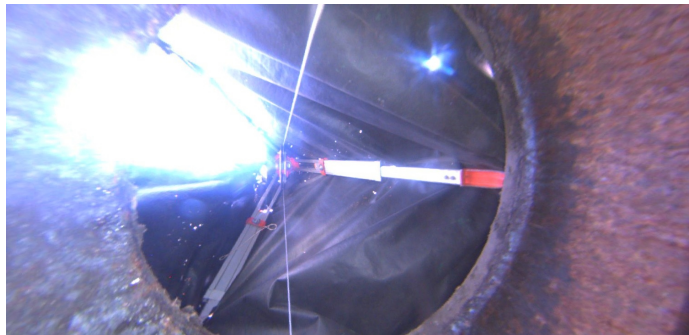
Code: **MGO**
Description: **General Observation**

Distance (ft): **.8**
Structural Grade: **0**
O&M Grade: **0**
Clock Start/From:
Clock To:
1st Value:
2nd Value:
Value Percent:
Step: **NO**
Remarks: **UNDERSIDE OF FRAME**

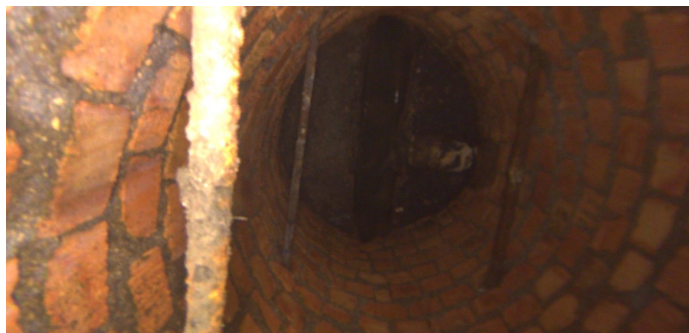
Code: **MSA**
Description: **Abandoned Survey**

Distance (ft): **3.2**
Structural Grade: **0**
O&M Grade: **0**
Clock Start/From:
Clock To:
1st Value:
2nd Value:
Value Percent:
Step: **NO**
Remarks: **CAUGHT ON STEP**
