# Manhole Inspection Report

Date:	05/06/2018	Weather:		Coding:	RZMACP
MH#:	M-805-065	Owner:	NA	Len. Surveyed:	2.2
P.O.#:		Surveyor:	`	Rim to Invert:	3.1
Customer:		Cert. #:	U-907-5518	Wall Material:	Concrete (reinforced)

Street:	On North St. 218' West of S. Indiana	Project:	Hobart, IN
City:	Hobart, IN	GPS Northing:	2907759.722
Location:		GPS Easting:	2907759.722
Drain Area:	South	GPS Accuracy:	Sub-Meter
Cover Shape:	Circular	Evidence of Surcharge:	No
Cover Size:	22.5	Potential for Runoff:	None
Comments:

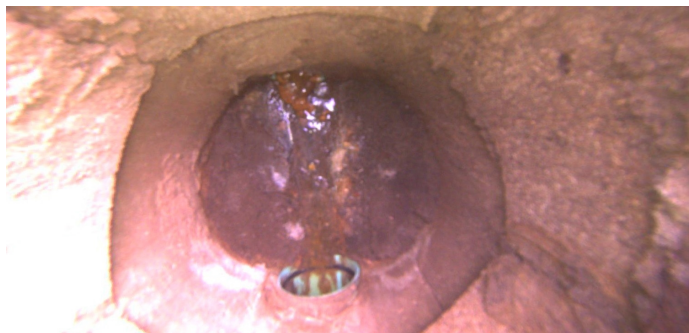
Code: **MGP**  
Description: **General Photo**

Distance (ft): **.0**  
Structural Grade: **0**  
O&M Grade: **0**  
Clock Start/From:  
Clock To:  
1st Value:  
2nd Value:  
Value Percent:  
Step: **NO**  
Remarks: **access mh**

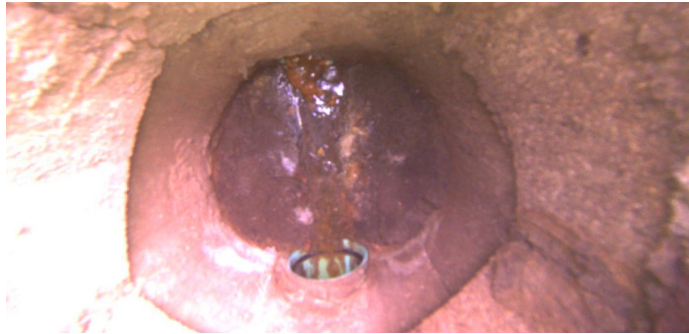
Code: **SAV**  
Description: **Surface Aggregate Visible**

Distance (ft): **.0**  
Structural Grade: **3**  
O&M Grade: **0**  
Clock Start/From: **12**  
Clock To: **12**  
1st Value:  
2nd Value:  
Value Percent:  
Step: **NO**  
Remarks:

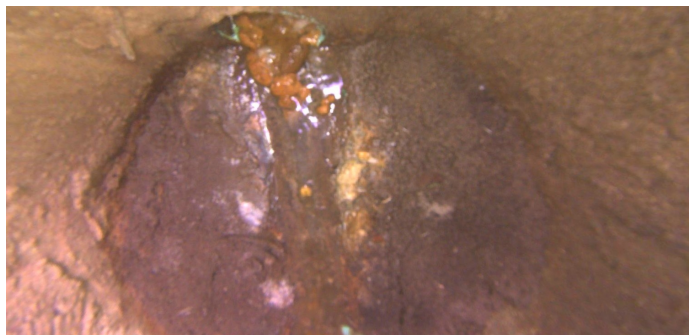
Code: **DSF**  
Description: **Deposits Settled Fine**

Distance (ft): **1.2**  
Structural Grade: **0**  
O&M Grade: **2**  
Clock Start/From: **12**  
Clock To: **12**  
1st Value:  
2nd Value:  
Value Percent: **5.000**  
Step: **NO**  
Remarks:

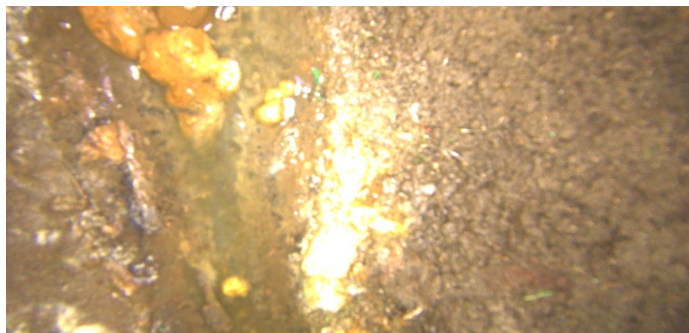
Code: **MGO**  
Description: **General Observation**

Distance (ft): **2.2**  
Structural Grade: **0**  
O&M Grade: **0**  
Clock Start/From:  
Clock To:  
1st Value:  
2nd Value:  
Value Percent:  
Step: **NO**  
Remarks: **end survey**
