# Manhole Inspection Report

Date:	<b>05/07/2018</b>	Weather:		Coding:	<b>RZMACP</b>
MH#:	<b>M-805-066</b>	Owner:	<b>NA</b>	Len. Surveyed:	<b>2.9</b>
P.O.#:		Surveyor:	<b>Jen Costello</b>	Rim to Invert:	<b>2.9</b>
Customer:		Cert. #:	<b>U-907-5518</b>	Wall Material:	<b>Brick</b>

Street:	<b>656' South of Cleveland Ave. 150' W</b>	Project:	<b>Hobart, IN</b>
City:	<b>Hobart, IN</b>	GPS Northing:	<b>2909614.458</b>
Location:		GPS Easting:	<b>2909614.458</b>
Drain Area:	<b>South</b>	GPS Accuracy:	<b>Sub-Meter</b>
Cover Shape:	<b>Circular</b>	Evidence of Surcharge:	<b>No</b>
Cover Size:	<b>22.5</b>	Potential for Runoff:	<b>None</b>
Comments:

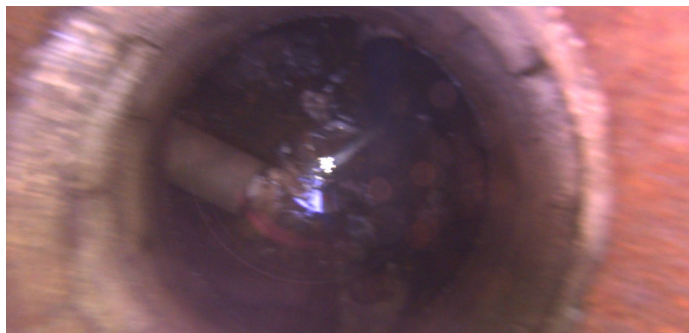
Code: **MGP**  
Description: **General Photo**

Distance (ft): **.0**  
Structural Grade: **0**  
O&M Grade: **0**  
Clock Start/From:  
Clock To:  
1st Value:  
2nd Value:  
Value Percent:  
Step: **NO**  
Remarks: **ACCESS MH**

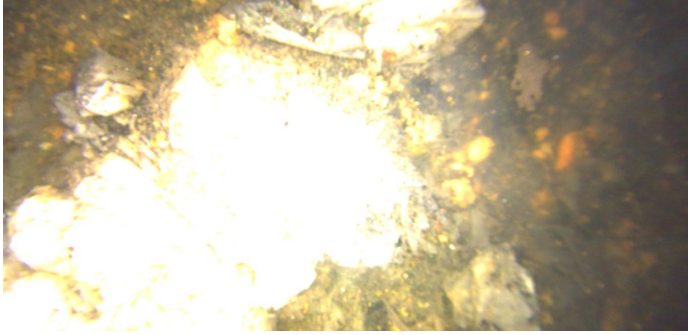
Code:	<b>MGO</b>
Description:	<b>General Observation</b>
Distance (ft):	<b>2.9</b>
Structural Grade:	<b>0</b>
O&M Grade:	<b>0</b>
Clock Start/From:	
Clock To:	
1st Value:	
2nd Value:	
Value Percent:	
Step:	<b>NO</b>
Remarks:	<b>END SUVEY</b>
