Manhole Inspection Report

Date:	05/09/2018	Weather:		Coding:	RZMACP
MH#:	M-805-068	Owner:	NA	Len. Surveyed:	4.5
P.O.#:		Surveyor:	Jen Costello	Rim to Invert:	5.1
Customer:		Cert. #:	U-907-5518	Wall Material:	Concrete (reinforced)

Street:	South of 5th St. In Alley, South End.	Project:	Hobart, IN
City:	Hobart, IN	GPS Northing:	2909617.279
Location:		GPS Easting:	2909617.279
Drain Area:	Southeast	GPS Accuracy:	Sub-Meter
Cover Shape:	Circular	Evidence of Surcharge:	No
Cover Size:	22.5	Potential for Runoff:	None
Comments:

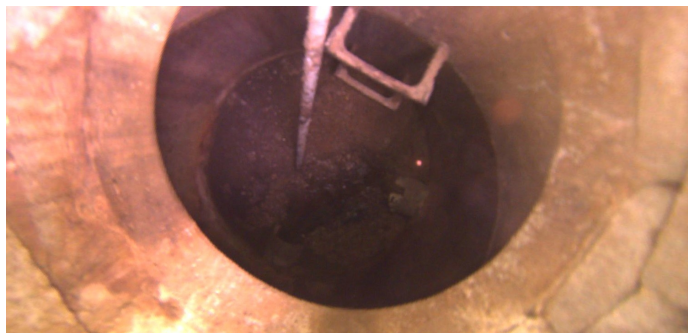
Code: **MGO**
Description: **General Observation**

Distance (ft): **.0**
Structural Grade: **0**
O&M Grade: **0**
Clock Start/From:
Clock To:
1st Value:
2nd Value:
Value Percent:
Step: **NO**
Remarks: **access MH**

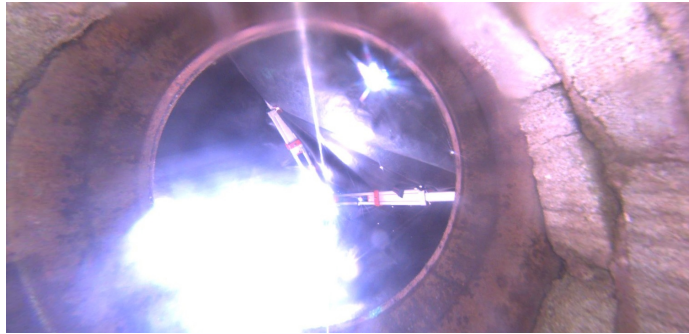
Code:	MGO
Description:	General Observation
Distance (ft):	1.5
Structural Grade:	0
O&M Grade:	0
Clock Start/From:	
Clock To:	
1st Value:	
2nd Value:	
Value Percent:	
Step:	NO
Remarks:	UNDERSIDE OF FRAME

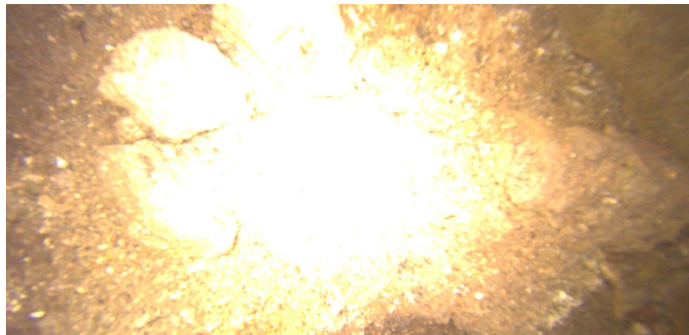
Code:	MGO
Description:	General Observation
Distance (ft):	4.5
Structural Grade:	0
O&M Grade:	0
Clock Start/From:	
Clock To:	
1st Value:	
2nd Value:	
Value Percent:	
Step:	NO
Remarks:	END SURVEY
