# Manhole Inspection Report

| MH#: | <b>M-806-001</b> | Owner: | <b>NA</b> | Len. Surveyed: | <b>6.8</b> |

| Street: | <b>Luther St. 121' North of 10th St.</b> | Project: | <b>Hobart, IN</b> |

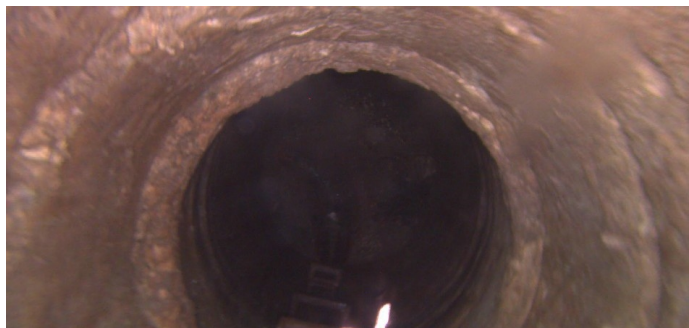
Code: **MGP**  
Description: **General Photo**

Distance (ft): **.0**  
Structural Grade: **0**  
O&M Grade: **0**  
Clock Start/From:  
Clock To:  
1st Value:  
2nd Value:  
Value Percent:  
Step: **NO**  
Remarks:

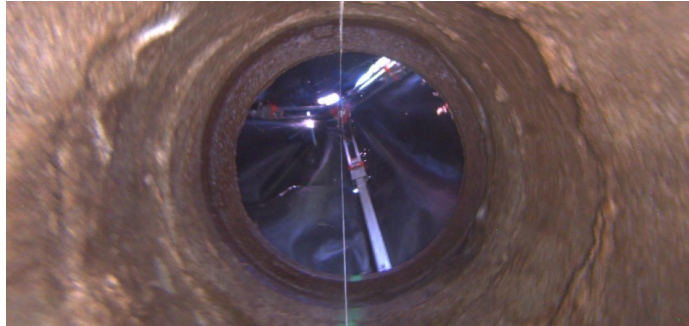
Code: **MGP**  
Description: **General Photo**

Distance (ft): **2.6**  
Structural Grade: **0**  
O&M Grade: **0**  
Clock Start/From:  
Clock To:  
1st Value:  
2nd Value:  
Value Percent:  
Step: **NO**  
Remarks:

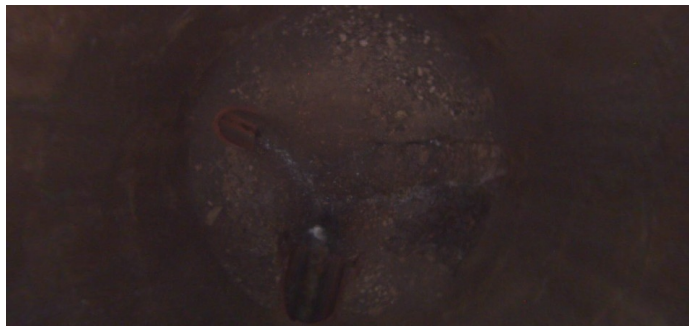
Code: **DAZ**  
Description: **Deposits Attached Other**

Distance (ft): **3.1**  
Structural Grade: **0**  
O&M Grade: **2**  
Clock Start/From: **12**  
Clock To: **12**  
1st Value:  
2nd Value:  
Value Percent: **5.000**  
Step: **NO**  
Remarks: **Mixed materials**

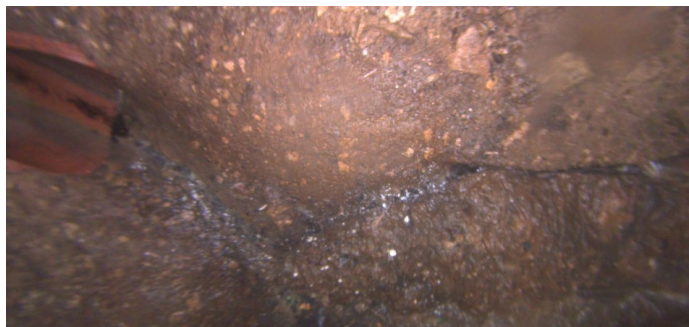
Code: **MGO**  
Description: **General Observation**

Distance (ft): **5.9**  
Structural Grade: **0**  
O&M Grade: **0**  
Clock Start/From:  
Clock To:  
1st Value:  
2nd Value:  
Value Percent:  
Step: **NO**  
Remarks: **Ins. Comp.**
