Manhole Inspection Report

Date:	04/20/2018	Weather:		Coding:	RZMACP
MH#:	M-806-002	Owner:	NA	Len. Surveyed:	6.7
P.O.#:		Surveyor:	John Kuglmaier	Rim to Invert:	7.0
Customer:		Cert. #:	U-1215-07002349	Wall Material:	Concrete (reinforced)

Street:	Luther St. 410' North of 10th St.	Project:	Hobart, IN
City:	Hobart, IN	GPS Northing:	2908309.69
Location:		GPS Easting:	2908309.69
Drain Area:	Southeast	GPS Accuracy:	Sub-Meter
Cover Shape:	Circular	Evidence of Surcharge:	No
Cover Size:	22.5	Potential for Runoff:	None
Comments:

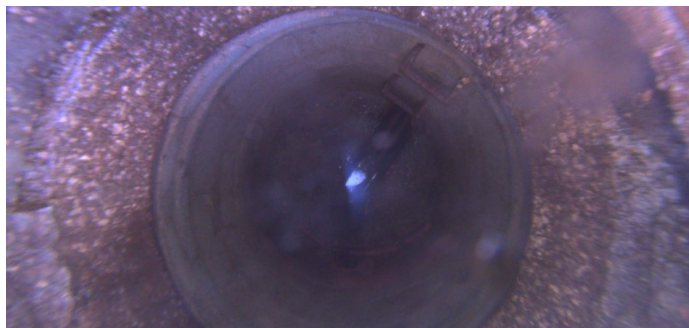
Code: **MGP**
Description: **General Photo**

Distance (ft): **.0**
Structural Grade: **0**
O&M Grade: **0**
Clock Start/From:
Clock To:
1st Value:
2nd Value:
Value Percent:
Step: **NO**
Remarks:

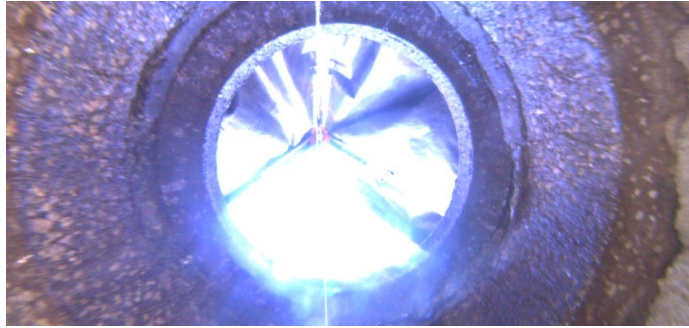
Code: **MGP**
Description: **General Photo**

Distance (ft): **2.8**
Structural Grade: **0**
O&M Grade: **0**
Clock Start/From:
Clock To:
1st Value:
2nd Value:
Value Percent:
Step: **NO**
Remarks:

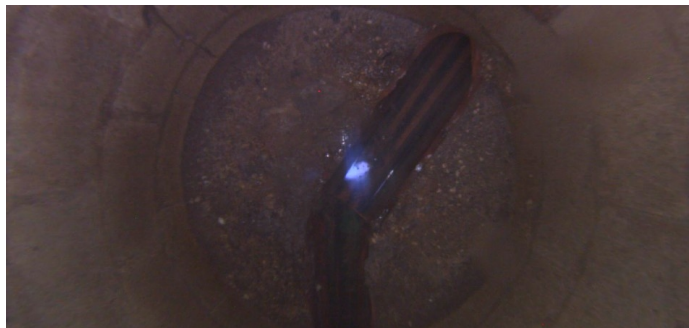
Code: **DAZ**
Description: **Deposits Attached Other**

Distance (ft): **3.4**
Structural Grade: **0**
O&M Grade: **2**
Clock Start/From: **12**
Clock To: **12**
1st Value:
2nd Value:
Value Percent: **10.000**
Step: **NO**
Remarks: **Mixed materials**

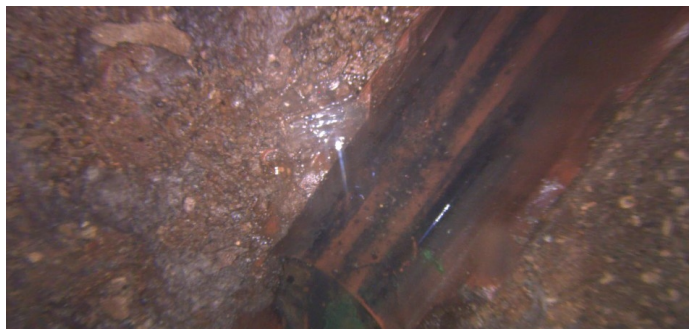
Code: **MGO**
Description: **General Observation**

Distance (ft): **5.8**
Structural Grade: **0**
O&M Grade: **0**
Clock Start/From:
Clock To:
1st Value:
2nd Value:
Value Percent:
Step: **NO**
Remarks: **Ins. Comp.**
