Manhole Inspection Report

Date:	04/20/2018	Weather:		Coding:	RZMACP
MH#:	M-806-003	Owner:	NA	Len. Surveyed:	7.3
P.O.#:		Surveyor:	John Kuglmaier	Rim to Invert:	7.3
Customer:		Cert. #:	U-1215-07002349	Wall Material:	Concrete (reinforced)

Street:	Luther St. 3rd Manhole North of 10t	Project:	Hobart, IN
City:	Hobart, IN	GPS Northing:	2908158.692
Location:		GPS Easting:	2908158.692
Drain Area:	Southeast	GPS Accuracy:	Sub-Meter
Cover Shape:	Circular	Evidence of Surcharge:	No
Cover Size:	22.5	Potential for Runoff:	None
Comments:

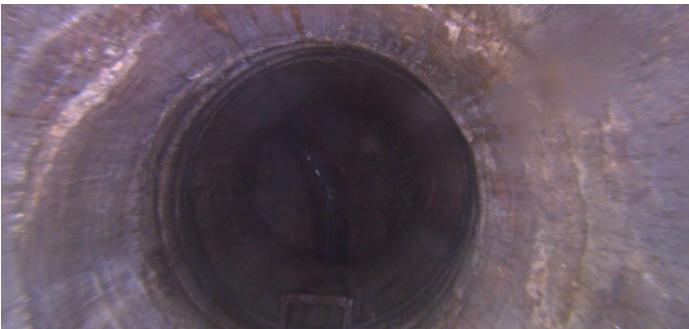
Code: **MGP**
 Description: **General Photo**

Distance (ft): **.0**
 Structural Grade: **0**
 O&M Grade: **0**
 Clock Start/From:
 Clock To:
 1st Value:
 2nd Value:
 Value Percent:
 Step: **NO**
 Remarks:

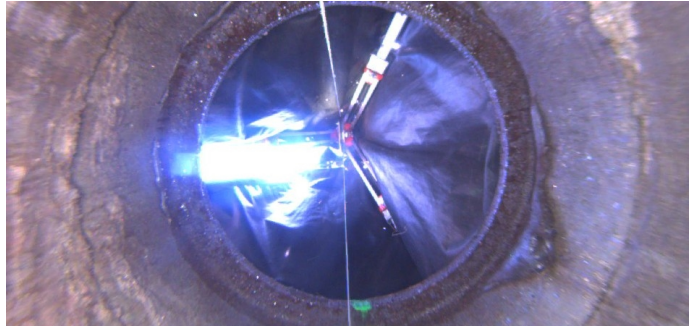
Code: **MGP**
Description: **General Photo**

Distance (ft): **2.3**
Structural Grade: **0**
O&M Grade: **0**
Clock Start/From:
Clock To:
1st Value:
2nd Value:
Value Percent:
Step: **NO**
Remarks:

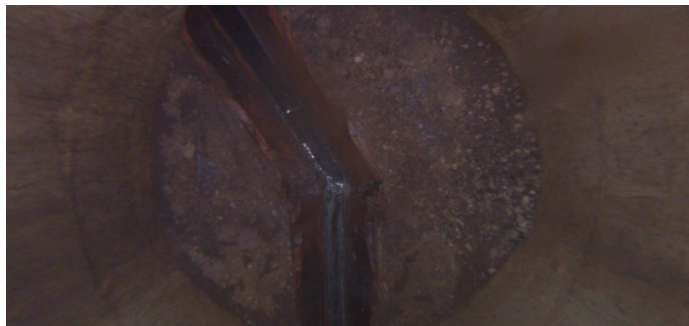
Code: **DAZ**
Description: **Deposits Attached Other**

Distance (ft): **4.4**
Structural Grade: **0**
O&M Grade: **2**
Clock Start/From: **12**
Clock To: **12**
1st Value:
2nd Value:
Value Percent: **5.000**
Step: **NO**
Remarks: **Mixed materials**

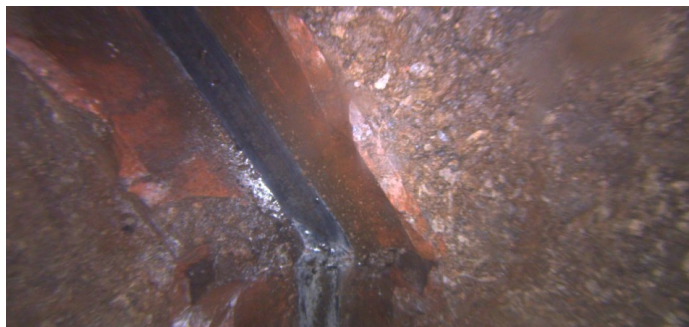
Code: **MGO**
Description: **General Observation**

Distance (ft): **6.4**
Structural Grade: **0**
O&M Grade: **0**
Clock Start/From:
Clock To:
1st Value:
2nd Value:
Value Percent:
Step: **NO**
Remarks: **Ins. Comp.**
