Manhole Inspection Report

Date:	04/20/2018	Weather:		Coding:	RZMACP
MH#:	M-806-004	Owner:	NA	Len. Surveyed:	8.2
P.O.#:		Surveyor:	John Kuglmaier	Rim to Invert:	8.0
Customer:		Cert. #:	U-1215-07002349	Wall Material:	Concrete (reinforced)

Street:	On Luther St. 473' Southwest of 8th	Project:	Hobart, IN
City:	Hobart, IN	GPS Northing:	0.0
Location:		GPS Easting:	0.0
Drain Area:	Southeast	GPS Accuracy:	Nearest Meter
Cover Shape:	Circular	Evidence of Surcharge:	Yes
Cover Size:	22.5	Potential for Runoff:	None
Comments:

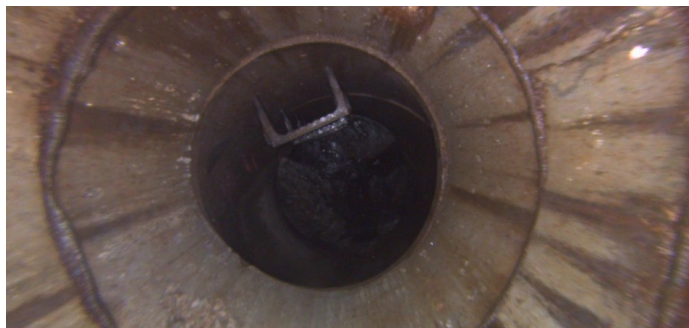
Code: **MGP**
Description: **General Photo**

Distance (ft): **.0**
Structural Grade: **0**
O&M Grade: **0**
Clock Start/From:
Clock To:
1st Value:
2nd Value:
Value Percent:
Step: **NO**
Remarks:

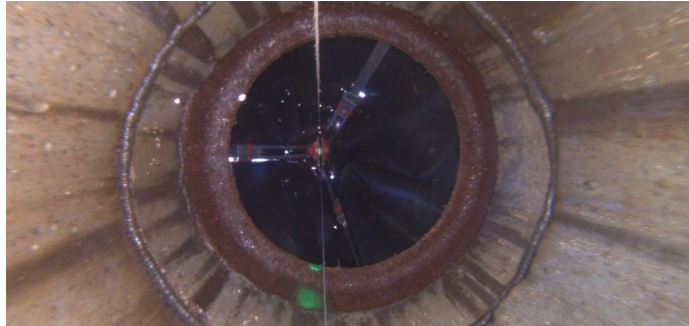
Code: **MGP**
Description: **General Photo**

Distance (ft): **2.6**
Structural Grade: **0**
O&M Grade: **0**
Clock Start/From:
Clock To:
1st Value:
2nd Value:
Value Percent:
Step: **NO**
Remarks:

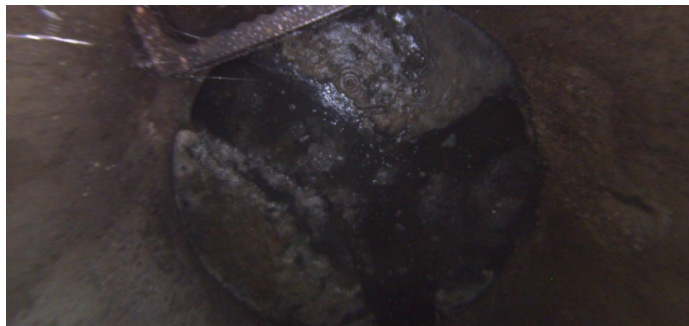
Code: **DAZ**
Description: **Deposits Attached Other**

Distance (ft): **5.5**
Structural Grade: **0**
O&M Grade: **3**
Clock Start/From: **12**
Clock To: **12**
1st Value:
2nd Value:
Value Percent: **15.000**
Step: **NO**
Remarks: **Mixed materials**

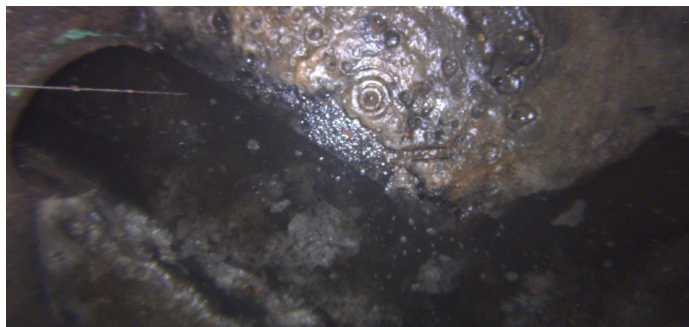
Code: **MGO**
Description: **General Observation**

Distance (ft): **7.2**
Structural Grade: **0**
O&M Grade: **0**
Clock Start/From:
Clock To:
1st Value:
2nd Value:
Value Percent:
Step: **NO**
Remarks: **Ins. Comp.**
