Manhole Inspection Report

Date:	04/20/2018	Weather:		Coding:	RZMACP
MH#:	M-806-005	Owner:	NA	Len. Surveyed:	8.1
P.O.#:		Surveyor:	John Kuglmaier	Rim to Invert:	7.9
Customer:		Cert. #:	U-1215-07002349	Wall Material:	Concrete (reinforced)

Street:	Luther St. 299' South of 8th St.	Project:	Hobart, IN
City:	Hobart, IN	GPS Northing:	2908291.458
Location:		GPS Easting:	2908291.458
Drain Area:	Southeast	GPS Accuracy:	Sub-Meter
Cover Shape:	Circular	Evidence of Surcharge:	No
Cover Size:	22.5	Potential for Runoff:	None
Comments:

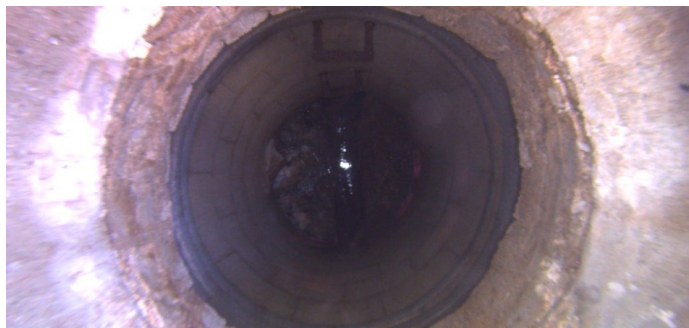
Code: **MGP**
Description: **General Photo**

Distance (ft): **.0**
Structural Grade: **0**
O&M Grade: **0**
Clock Start/From:
Clock To:
1st Value:
2nd Value:
Value Percent:
Step: **NO**
Remarks:

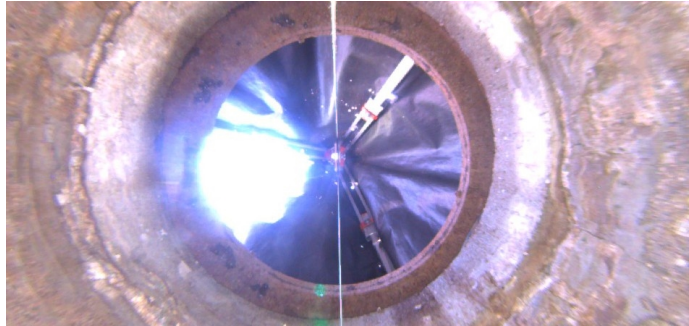
Code: **MGP**
Description: **General Photo**

Distance (ft): **2.7**
Structural Grade: **0**
O&M Grade: **0**
Clock Start/From:
Clock To:
1st Value:
2nd Value:
Value Percent:
Step: **NO**
Remarks:

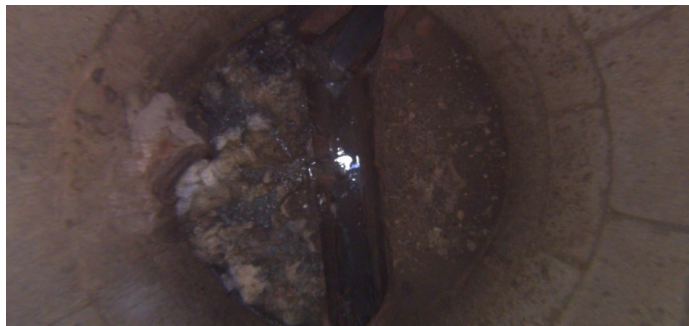
Code: **DAZ**
Description: **Deposits Attached Other**

Distance (ft): **4.6**
Structural Grade: **0**
O&M Grade: **2**
Clock Start/From: **12**
Clock To: **12**
1st Value:
2nd Value:
Value Percent: **10.000**
Step: **NO**
Remarks: **Mixed materials**

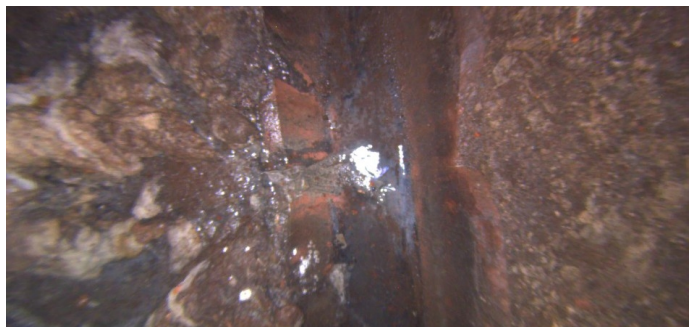
Code: **MGO**
Description: **General Observation**

Distance (ft): **6.8**
Structural Grade: **0**
O&M Grade: **0**
Clock Start/From:
Clock To:
1st Value:
2nd Value:
Value Percent:
Step: **NO**
Remarks: **Ins. Comp.**
