Manhole Inspection Report

Date:	04/20/2018	Weather:		Coding:	RZMACP
MH#:	M-806-006	Owner:	NA	Len. Surveyed:	4.7
P.O.#:		Surveyor:	John Kuglmaier	Rim to Invert:	5.7
Customer:		Cert. #:	U-1215-07002349	Wall Material:	Concrete (reinforced)

Street:	Luther St. and 8th St.	Project:	Hobart, IN
City:	Hobart, IN	GPS Northing:	2908319.607
Location:		GPS Easting:	2908319.607
Drain Area:	Southeast	GPS Accuracy:	Sub-Meter
Cover Shape:	Circular	Evidence of Surcharge:	No
Cover Size:	22.5	Potential for Runoff:	None
Comments:

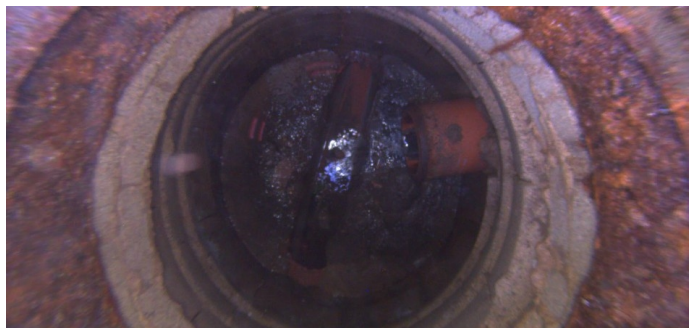
Code: **MGP**
Description: **General Photo**

Distance (ft): **.0**
Structural Grade: **0**
O&M Grade: **0**
Clock Start/From:
Clock To:
1st Value:
2nd Value:
Value Percent:
Step: **NO**
Remarks:

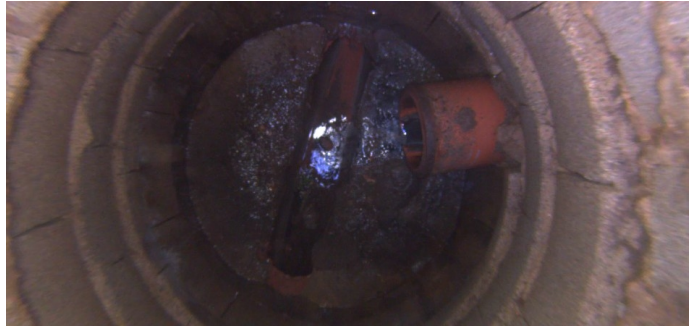
Code: **IS**
Description: **Infil Stain**

Distance (ft): **.7**
Structural Grade: **0**
O&M Grade: **0**
Clock Start/From: **12**
Clock To: **12**
1st Value:
2nd Value:
Value Percent:
Step: **NO**
Remarks:

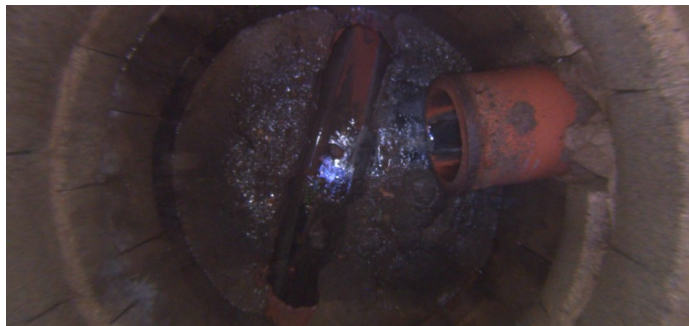
Code: **DAZ**
Description: **Deposits Attached Other**

Distance (ft): **1.4**
Structural Grade: **0**
O&M Grade: **2**
Clock Start/From: **12**
Clock To: **12**
1st Value:
2nd Value:
Value Percent: **10.000**
Step: **NO**
Remarks: **Mixed materials**

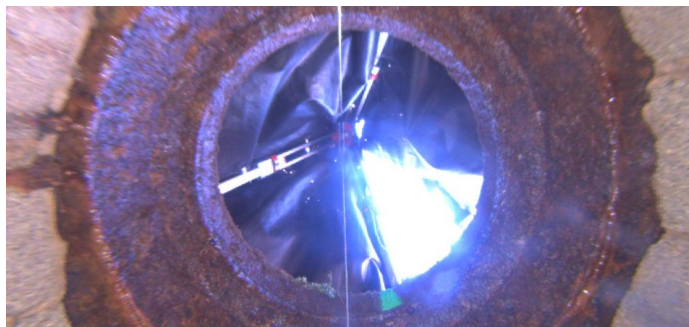
Code: **MGP**
Description: **General Photo**

Distance (ft): **2.6**
Structural Grade: **0**
O&M Grade: **0**
Clock Start/From:
Clock To:
1st Value:
2nd Value:
Value Percent:
Step: **NO**
Remarks:

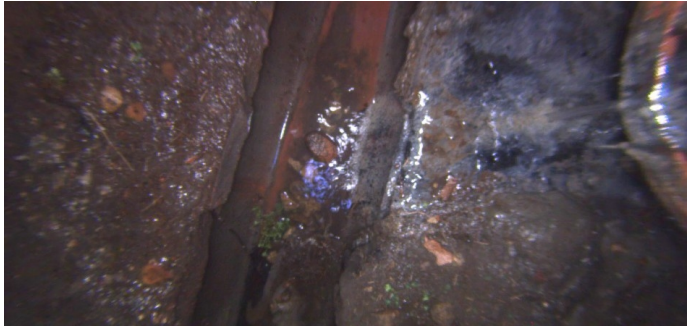
Code:	MGO
Description:	General Observation
Distance (ft):	3.7
Structural Grade:	0
O&M Grade:	0
Clock Start/From:	
Clock To:	
1st Value:	
2nd Value:	
Value Percent:	
Step:	NO
Remarks:	Ins. Comp.
