Manhole Inspection Report

Date:	04/20/2018	Weather:		Coding:	RZMACP
MH#:	M-806-007	Owner:	NA	Len. Surveyed:	11.2
P.O.#:		Surveyor:	John Kuglmaier	Rim to Invert:	10.8
Customer:		Cert. #:	U-1215-07002349	Wall Material:	Concrete (reinforced)

Street:	8th St. 223' East of Memory Ln.	Project:	Hobart, IN
City:	Hobart, IN	GPS Northing:	2908206.846
Location:		GPS Easting:	2908206.846
Drain Area:	Southeast	GPS Accuracy:	Sub-Meter
Cover Shape:	Circular	Evidence of Surcharge:	No
Cover Size:	22.5	Potential for Runoff:	None
Comments:

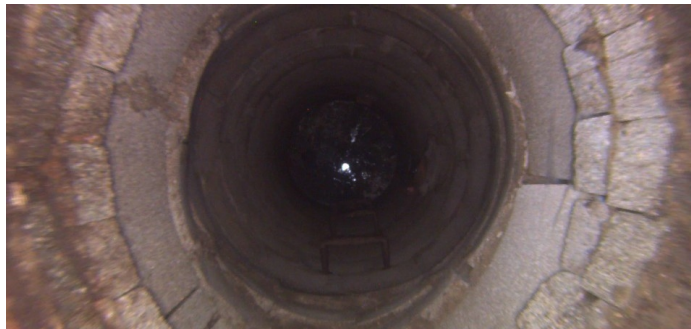
Code: **MGP**
Description: **General Photo**

Distance (ft): **.0**
Structural Grade: **0**
O&M Grade: **0**
Clock Start/From:
Clock To:
1st Value:
2nd Value:
Value Percent:
Step: **NO**
Remarks:

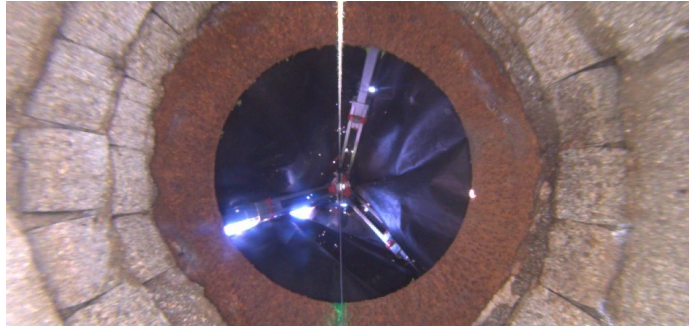
Code: **MGP**
Description: **General Photo**

Distance (ft): **2.5**
Structural Grade: **0**
O&M Grade: **0**
Clock Start/From:
Clock To:
1st Value:
2nd Value:
Value Percent:
Step: **NO**
Remarks:

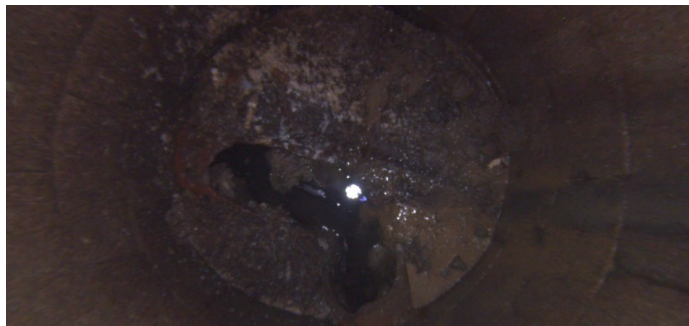
Code: **DAZ**
Description: **Deposits Attached Other**

Distance (ft): **7.6**
Structural Grade: **0**
O&M Grade: **3**
Clock Start/From: **12**
Clock To: **12**
1st Value:
2nd Value:
Value Percent: **15.000**
Step: **NO**
Remarks: **Mixed materials**

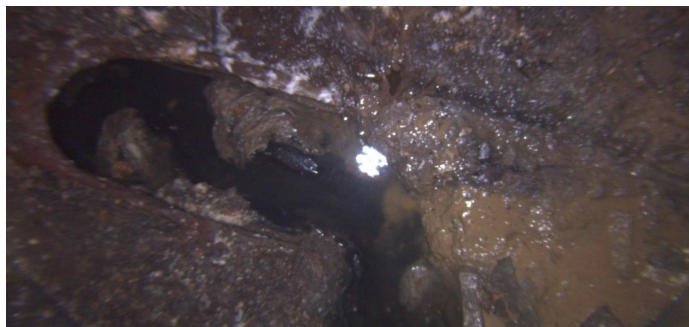
Code: **MGO**
Description: **General Observation**

Distance (ft): **9.5**
Structural Grade: **0**
O&M Grade: **0**
Clock Start/From:
Clock To:
1st Value:
2nd Value:
Value Percent:
Step: **NO**
Remarks: **Ins. Comp.**
