Manhole Inspection Report

Date:	04/20/2018	Weather:		Coding:	RZMACP
MH#:	M-806-008	Owner:	NA	Len. Surveyed:	3.3
P.O.#:		Surveyor:	Jen Costello	Rim to Invert:	3.3
Customer:		Cert. #:	U-907-5518	Wall Material:	Concrete (reinforced)

Street:	North of 8th St. 237' East of Memor	Project:	Hobart, IN
City:	Hobart, IN	GPS Northing:	2908218.068
Location:		GPS Easting:	2908218.068
Drain Area:	Southeast	GPS Accuracy:	Sub-Meter
Cover Shape:	Circular	Evidence of Surcharge:	No
Cover Size:	22.5	Potential for Runoff:	None
Comments:

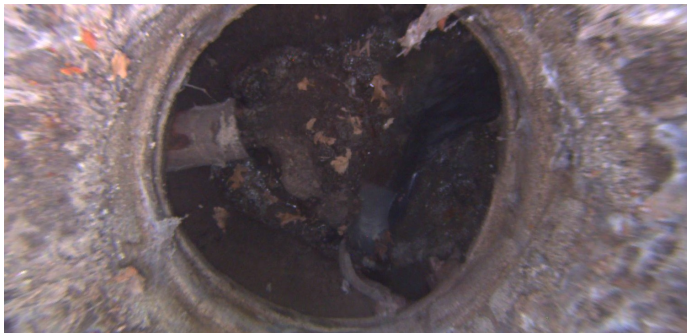
Code: **MGO**
Description: **General Observation**

Distance (ft): **.0**
Structural Grade: **0**
O&M Grade: **0**
Clock Start/From:
Clock To:
1st Value:
2nd Value:
Value Percent:
Step: **NO**
Remarks: **access MH**

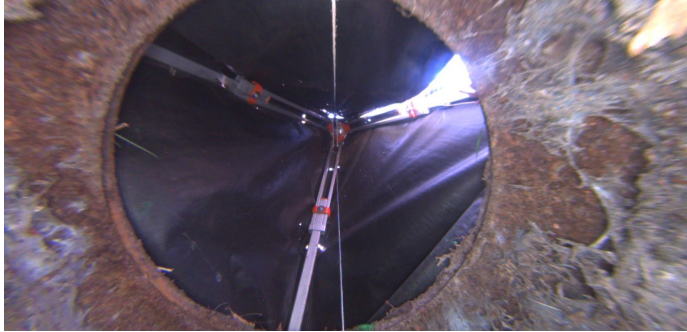
Code:	MGO
Description:	General Observation
Distance (ft):	1.4
Structural Grade:	0
O&M Grade:	0
Clock Start/From:	
Clock To:	
1st Value:	
2nd Value:	
Value Percent:	
Step:	NO
Remarks:	UNDERSIDE OF FRAME

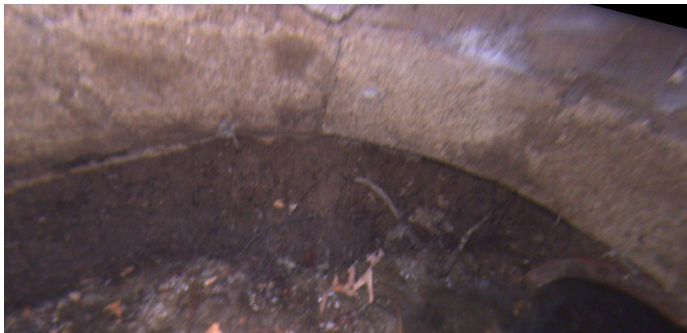
Code:	FL
Description:	Fracture Longitudinal
Distance (ft):	2.1
Structural Grade:	3
O&M Grade:	0
Clock Start/From:	12
Clock To:	
1st Value:	
2nd Value:	
Value Percent:	
Step:	NO
Remarks:

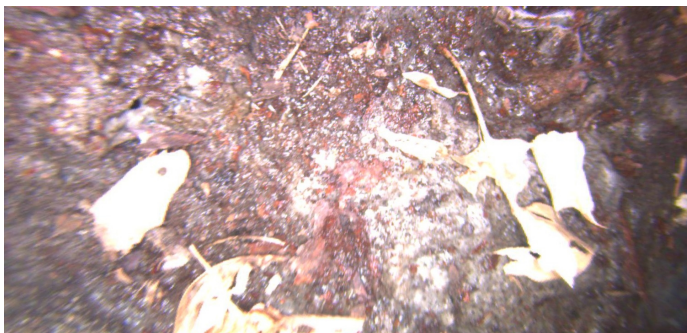
Code:	DSF
Description:	Deposits Settled Fine
Distance (ft):	3.3
Structural Grade:	0
O&M Grade:	2
Clock Start/From:	12
Clock To:	12
1st Value:	
2nd Value:	
Value Percent:	10.000
Step:	NO
Remarks:

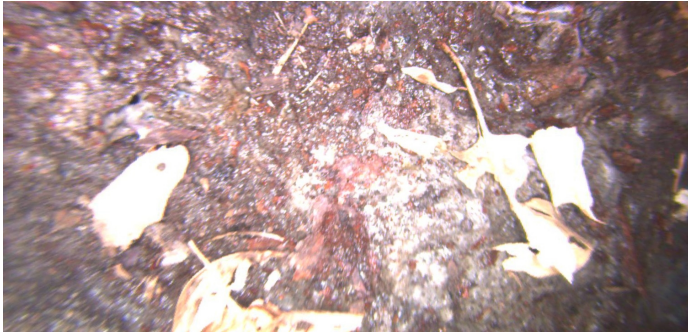
Code: **MGO**
Description: **General Observation**

Distance (ft): **3.3**
Structural Grade: **0**
O&M Grade: **0**
Clock Start/From:
Clock To:
1st Value:
2nd Value:
Value Percent:
Step: **NO**
Remarks: **END SURVEY**
