Manhole Inspection Report

Date:	04/20/2018	Weather:		Coding:	RZMACP
MH#:	M-806-009	Owner:	NA	Len. Surveyed:	13.8
P.O.#:		Surveyor:	John Kuglmaier	Rim to Invert:	15.4
Customer:		Cert. #:	U-1215-07002349	Wall Material:	Concrete (reinforced)

Street:	North of 8th St. 162' East of Memor	Project:	Hobart, IN
City:	Hobart, IN	GPS Northing:	2908167.633
Location:		GPS Easting:	2908167.633
Drain Area:	Southeast	GPS Accuracy:	Sub-Meter
Cover Shape:	Circular	Evidence of Surcharge:	No
Cover Size:	22.5	Potential for Runoff:	None
Comments:

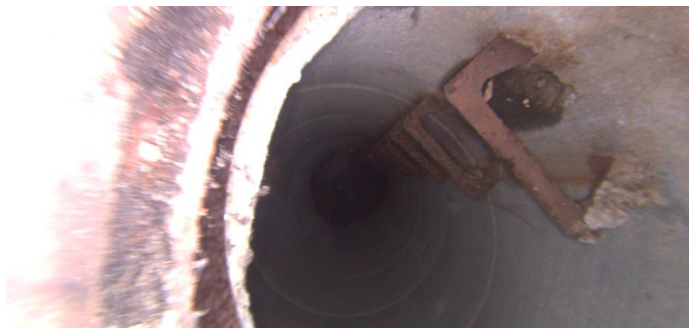
Code: **MGP**
Description: **General Photo**

Distance (ft): **.0**
Structural Grade: **0**
O&M Grade: **0**
Clock Start/From:
Clock To:
1st Value:
2nd Value:
Value Percent:
Step: **NO**
Remarks:

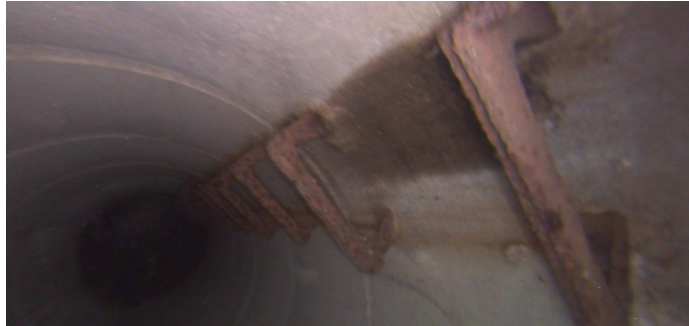
Code: **IS**
Description: **Infil Stain**

Distance (ft): **1.2**
Structural Grade: **0**
O&M Grade: **0**
Clock Start/From: **2**
Clock To:
1st Value:
2nd Value:
Value Percent:
Step: **NO**
Remarks:

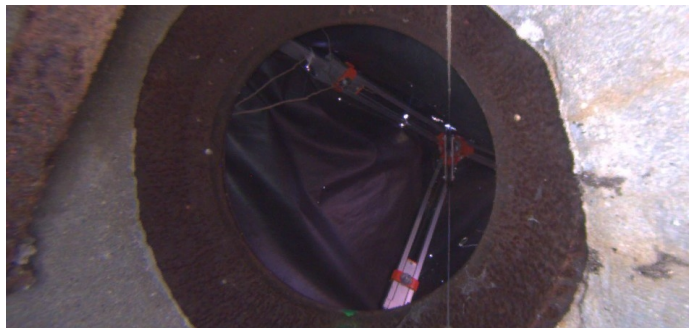
Code: **MGP**
Description: **General Photo**

Distance (ft): **2.2**
Structural Grade: **0**
O&M Grade: **0**
Clock Start/From:
Clock To:
1st Value:
2nd Value:
Value Percent:
Step: **NO**
Remarks:

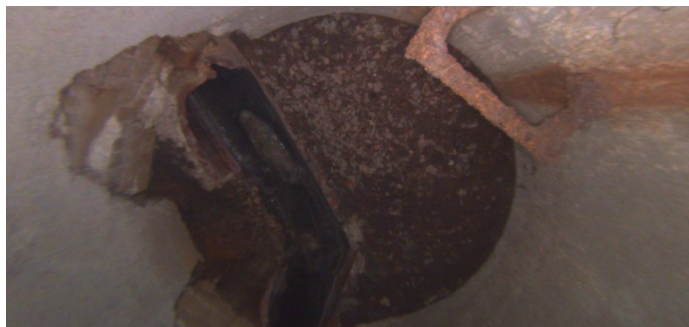
Code: **DAZ**
Description: **Deposits Attached Other**

Distance (ft): **12.4**
Structural Grade: **0**
O&M Grade: **2**
Clock Start/From: **12**
Clock To: **12**
1st Value:
2nd Value:
Value Percent: **10.000**
Step: **NO**
Remarks: **Mixed materials**

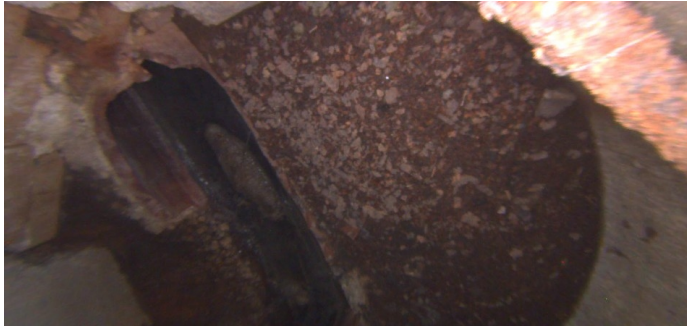
Code:	MGO
Description:	General Observation
Distance (ft):	13.4
Structural Grade:	0
O&M Grade:	0
Clock Start/From:	
Clock To:	
1st Value:	
2nd Value:	
Value Percent:	
Step:	NO
Remarks:	Ins. Comp.
