Manhole Inspection Report

Date:	04/28/2018	Weather:		Coding:	RZMACP
MH#:	M-806-015	Owner:	NA	Len. Surveyed:	6.9
P.O.#:		Surveyor:	Jen Costello	Rim to Invert:	6.4
Customer:		Cert. #:	U-907-5518	Wall Material:	Concrete (reinforced)

Street:	8th St. 280' East of Linda St.	Project:	Hobart, IN
City:	Hobart, IN	GPS Northing:	41.52523041
Location:		GPS Easting:	-87.24880981
Drain Area:	Southeast	GPS Accuracy:	Nearest Meter
Cover Shape:	Circular	Evidence of Surcharge:	No
Cover Size:	22.5	Potential for Runoff:	None
Comments:

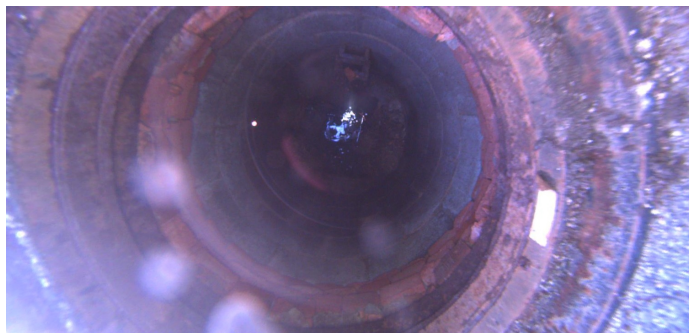
Code: **MGO**
Description: **General Observation**

Distance (ft): **.0**
Structural Grade: **0**
O&M Grade: **0**
Clock Start/From:
Clock To:
1st Value:
2nd Value:
Value Percent:
Step: **NO**
Remarks: **ACCESS MH**

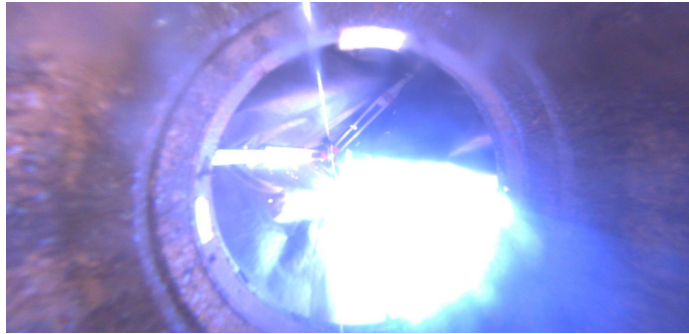
Code:	MGP
Description:	General Photo
Distance (ft):	1.9
Structural Grade:	0
O&M Grade:	0
Clock Start/From:	
Clock To:	
1st Value:	
2nd Value:	
Value Percent:	
Step:	NO
Remarks:	UNDERSIDE OF FRAME

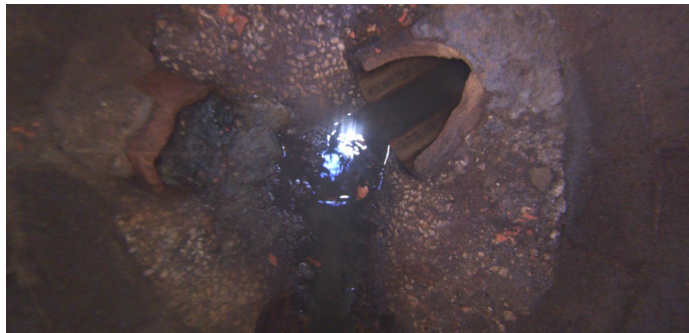
Code:	SAP
Description:	Surface Aggregate Projecting
Distance (ft):	4.9
Structural Grade:	3
O&M Grade:	0
Clock Start/From:	12
Clock To:	12
1st Value:	
2nd Value:	
Value Percent:	
Step:	NO
Remarks:

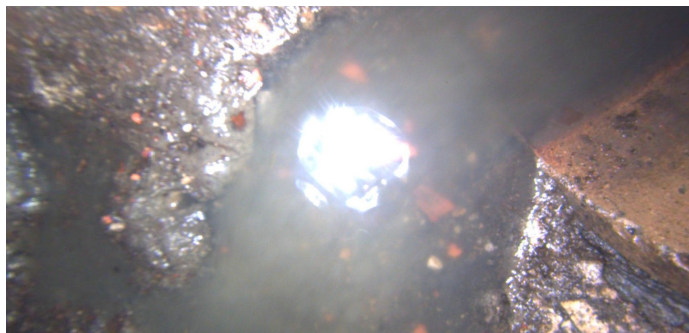
Code:	MGO
Description:	General Observation
Distance (ft):	6.9
Structural Grade:	0
O&M Grade:	0
Clock Start/From:	
Clock To:	
1st Value:	
2nd Value:	
Value Percent:	
Step:	NO
Remarks:	END SURVEY
