Manhole Inspection Report

Date:	04/28/2018	Weather:		Coding:	RZMACP
MH#:	M-806-016	Owner:	NA	Len. Surveyed:	14.2
P.O.#:		Surveyor:	Jen Costello	Rim to Invert:	14.8
Customer:		Cert. #:	U-907-5518	Wall Material:	Concrete (reinforced)

Street:	8th St. 280' East of Linda St.	Project:	Hobart, IN
City:	Hobart, IN	GPS Northing:	41.52528381
Location:		GPS Easting:	-87.24895477
Drain Area:	Southeast	GPS Accuracy:	Nearest Meter
Cover Shape:	Circular	Evidence of Surcharge:	No
Cover Size:	22.5	Potential for Runoff:	None
Comments:

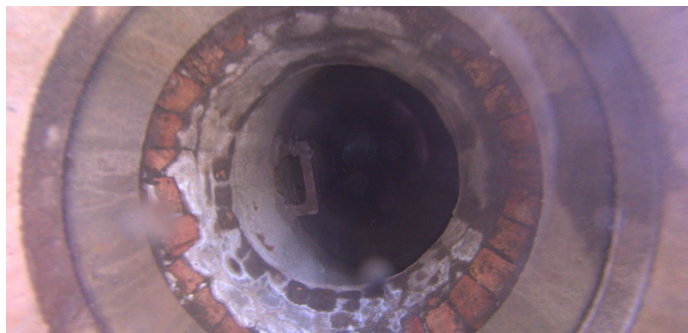
Code: **MGO**
Description: **General Observation**

Distance (ft): **.0**
Structural Grade: **0**
O&M Grade: **0**
Clock Start/From:
Clock To:
1st Value:
2nd Value:
Value Percent:
Step: **NO**
Remarks: **ACCESS MH**

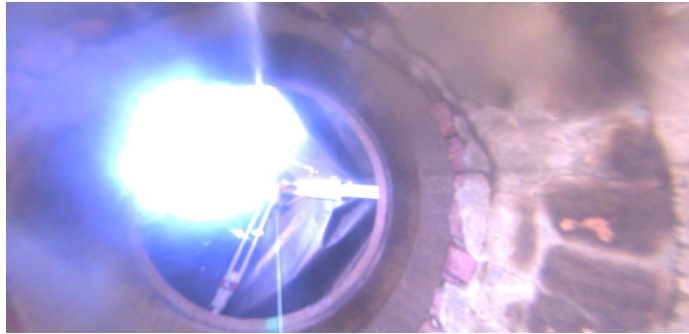
Code:	MGP
Description:	General Photo
Distance (ft):	2.6
Structural Grade:	0
O&M Grade:	0
Clock Start/From:	
Clock To:	
1st Value:	
2nd Value:	
Value Percent:	
Step:	NO
Remarks:	UNDERSIDE OF FRAME

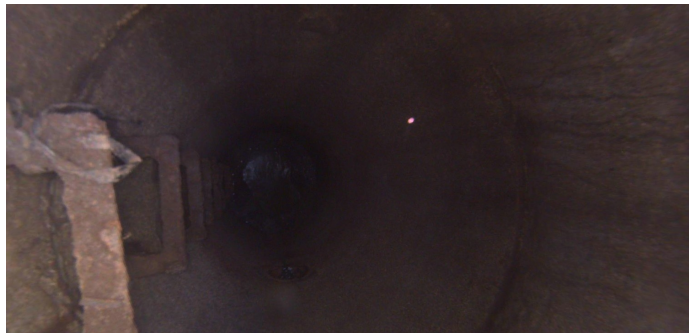
Code:	SAV
Description:	Surface Aggregate Visible
Distance (ft):	2.6
Structural Grade:	3
O&M Grade:	0
Clock Start/From:	12
Clock To:	12
1st Value:	
2nd Value:	
Value Percent:	
Step:	NO
Remarks:

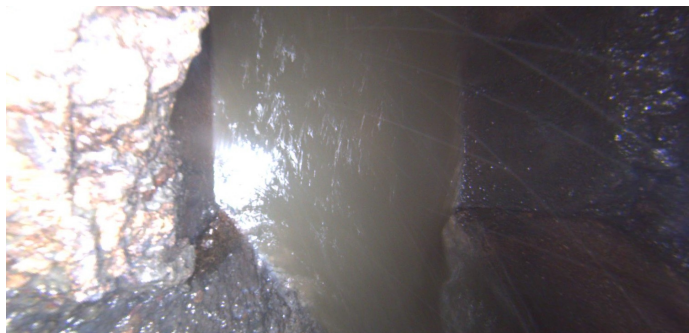
Code:	MGO
Description:	General Observation
Distance (ft):	14.2
Structural Grade:	0
O&M Grade:	0
Clock Start/From:	
Clock To:	
1st Value:	
2nd Value:	
Value Percent:	
Step:	NO
Remarks:	END SURVEY

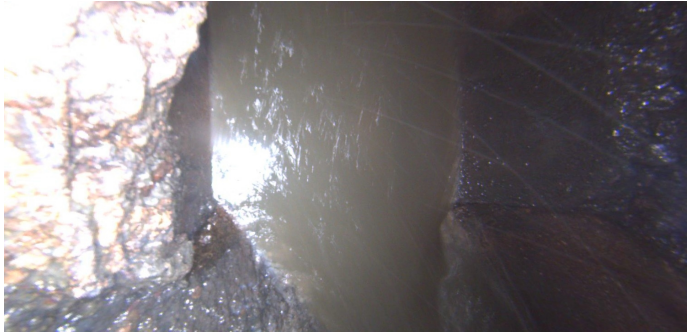
Code:	SAV
Description:	Surface Aggregate Visible
Distance (ft):	14.2
Structural Grade:	3
O&M Grade:	0
Clock Start/From:	12
Clock To:	12
1st Value:	
2nd Value:	
Value Percent:	
Step:	NO
Remarks:
