# Manhole Inspection Report

Date:	<b>04/20/2018</b>	Weather:		Coding:	<b>RZMACP</b>
MH#:	<b>M-806-021</b>	Owner:	<b>NA</b>	Len. Surveyed:	<b>11.9</b>
P.O.#:		Surveyor:	<b>John Kuglmaier</b>	Rim to Invert:	<b>12.1</b>
Customer:		Cert. #:	<b>U-1215-07002349</b>	Wall Material:	<b>Concrete (reinforced)</b>

Street:	<b>Gilberts Ct. 220' South of 6th St.</b>	Project:	<b>Hobart, IN</b>
City:	<b>Hobart, IN</b>	GPS Northing:	<b>2907967.184</b>
Location:		GPS Easting:	<b>2907967.184</b>
Drain Area:	<b>Southeast</b>	GPS Accuracy:	<b>Sub-Meter</b>
Cover Shape:	<b>Circular</b>	Evidence of Surcharge:	<b>Yes</b>
Cover Size:	<b>22.5</b>	Potential for Runoff:	<b>None</b>
Comments:

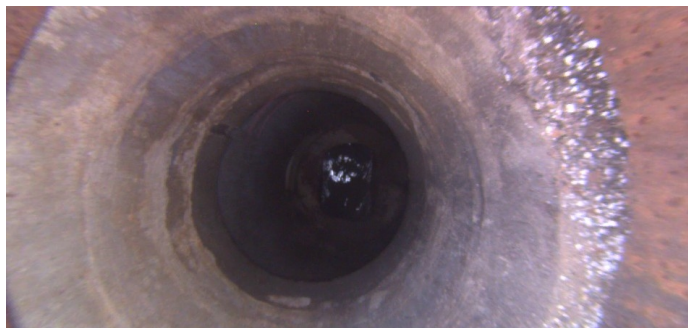
Code: **MGP**  
 Description: **General Photo**

Distance (ft): **.0**  
 Structural Grade: **0**  
 O&M Grade: **0**  
 Clock Start/From:  
 Clock To:  
 1st Value:  
 2nd Value:  
 Value Percent:  
 Step: **NO**  
 Remarks:

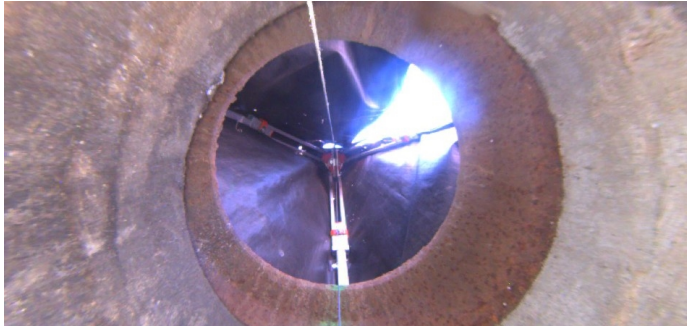
Code: **MGP**  
Description: **General Photo**

Distance (ft): **2.6**  
Structural Grade: **0**  
O&M Grade: **0**  
Clock Start/From:  
Clock To:  
1st Value:  
2nd Value:  
Value Percent:  
Step: **NO**  
Remarks:

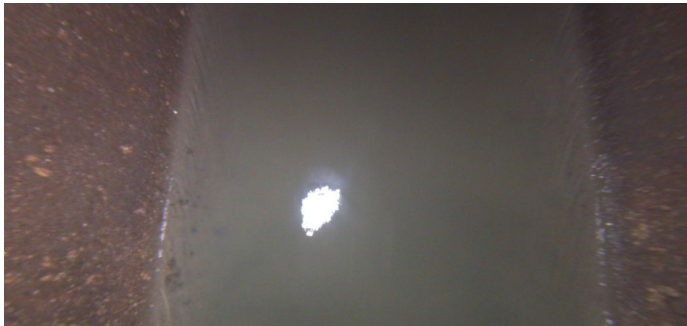
Code: **MGO**  
Description: **General Observation**

Distance (ft): **11.0**  
Structural Grade: **0**  
O&M Grade: **0**  
Clock Start/From:  
Clock To:  
1st Value:  
2nd Value:  
Value Percent:  
Step: **NO**  
Remarks: **Ins. Comp.**
