Manhole Inspection Report

Date:	04/28/2018	Weather:		Coding:	RZMACP
MH#:	M-806-024	Owner:	NA	Len. Surveyed:	7.0
P.O.#:		Surveyor:	Jen Costello	Rim to Invert:	6.4
Customer:		Cert. #:	U-907-5518	Wall Material:	Brick

Street:	Intersection of Linda St. and Main St	Project:	Hobart, IN
City:	Hobart, IN	GPS Northing:	41.52617645
Location:		GPS Easting:	-87.24990845
Drain Area:	South	GPS Accuracy:	Nearest Meter
Cover Shape:	Circular	Evidence of Surcharge:	No
Cover Size:	22.5	Potential for Runoff:	None
Comments:

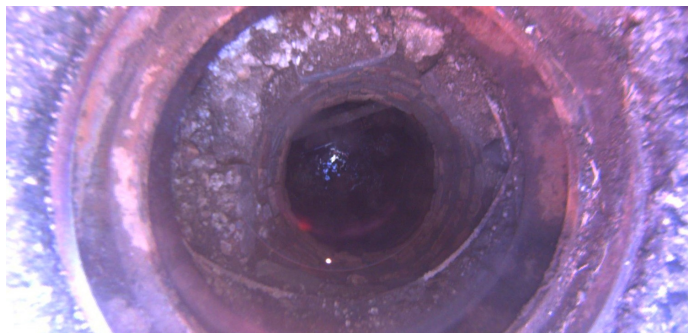
Code: **MGO**
Description: **General Observation**

Distance (ft): **.0**
Structural Grade: **0**
O&M Grade: **0**
Clock Start/From:
Clock To:
1st Value:
2nd Value:
Value Percent:
Step: **NO**
Remarks: **ACCESS MH**

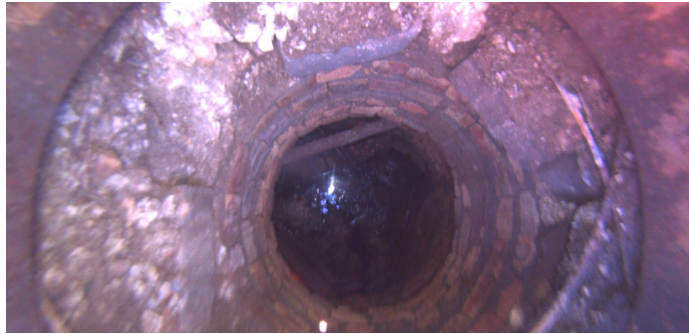
Code:	DAE
Description:	Deposits Attached Encrustation
Distance (ft):	.7
Structural Grade:	0
O&M Grade:	2
Clock Start/From:	12
Clock To:	12
1st Value:	
2nd Value:	
Value Percent:	5.000
Step:	NO
Remarks:

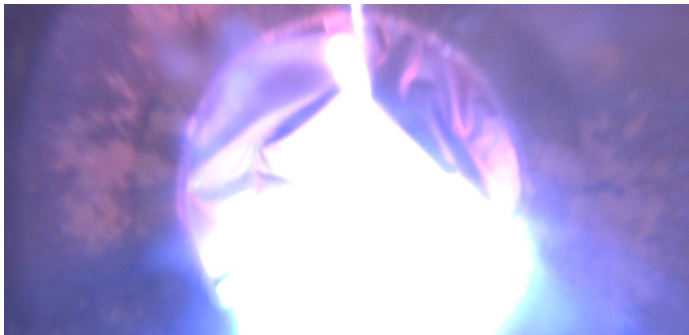
Code:	MGP
Description:	General Photo
Distance (ft):	2.1
Structural Grade:	0
O&M Grade:	0
Clock Start/From:	
Clock To:	
1st Value:	
2nd Value:	
Value Percent:	
Step:	NO
Remarks:	UNDERSIDE OF FRAME

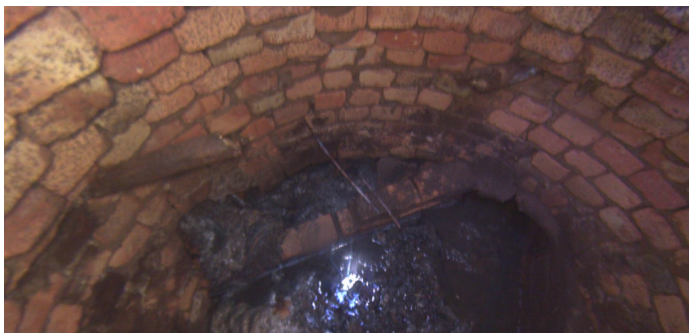
Code:	MGO
Description:	General Observation
Distance (ft):	4.2
Structural Grade:	0
O&M Grade:	0
Clock Start/From:	
Clock To:	
1st Value:	
2nd Value:	
Value Percent:	
Step:	NO
Remarks:	BROKEN STEPO

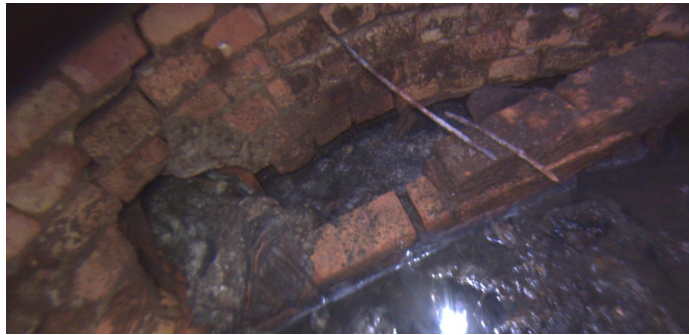
Code: **FS**
Description: **Fracture Spiral**

Distance (ft): **5.6**
Structural Grade: **3**
O&M Grade: **0**
Clock Start/From: **10**
Clock To: **11**
1st Value:
2nd Value:
Value Percent:
Step: **NO**
Remarks:

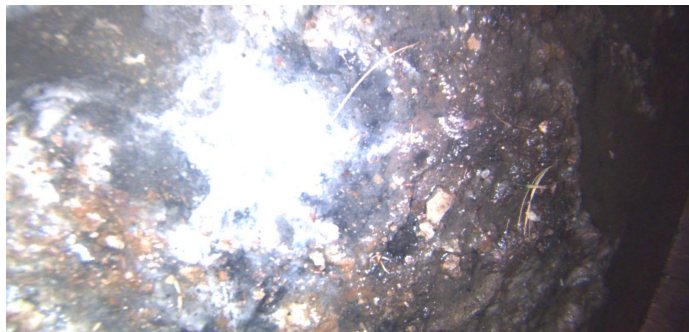
Code: **MGO**
Description: **General Observation**

Distance (ft): **6.9**
Structural Grade: **0**
O&M Grade: **0**
Clock Start/From:
Clock To:
1st Value:
2nd Value:
Value Percent:
Step: **NO**
Remarks: **END SURVEY**
