# Manhole Inspection Report

Date:	<b>04/21/2018</b>	Weather:		Coding:	<b>RZMACP</b>
MH#:	<b>M-806-027</b>	Owner:	<b>NA</b>	Len. Surveyed:	<b>5.2</b>
P.O.#:		Surveyor:	<b>John Kuglmaier</b>	Rim to Invert:	<b>5.1</b>
Customer:		Cert. #:	<b>U-1215-07002349</b>	Wall Material:	<b>Concrete (reinforced)</b>

Street:	<b>8th St. 109' East of Luther St.</b>	Project:	<b>Hobart, IN</b>
City:	<b>Hobart, IN</b>	GPS Northing:	<b>0.0</b>
Location:		GPS Easting:	<b>0.0</b>
Drain Area:	<b>Southeast</b>	GPS Accuracy:	<b>Nearest Meter</b>
Cover Shape:	<b>Circular</b>	Evidence of Surcharge:	<b>No</b>
Cover Size:	<b>22.5</b>	Potential for Runoff:	<b>None</b>
Comments:

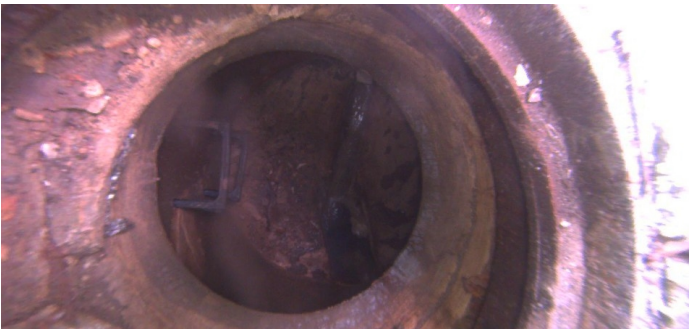
Code: **MGP**  
 Description: **General Photo**

Distance (ft): **.0**  
 Structural Grade: **0**  
 O&M Grade: **0**  
 Clock Start/From:  
 Clock To:  
 1st Value:  
 2nd Value:  
 Value Percent:  
 Step: **NO**  
 Remarks:

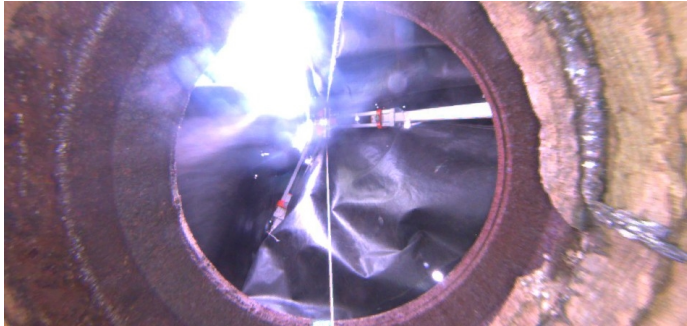
Code: **MGP**  
Description: **General Photo**

Distance (ft): **2.4**  
Structural Grade: **0**  
O&M Grade: **0**  
Clock Start/From:  
Clock To:  
1st Value:  
2nd Value:  
Value Percent:  
Step: **NO**  
Remarks:

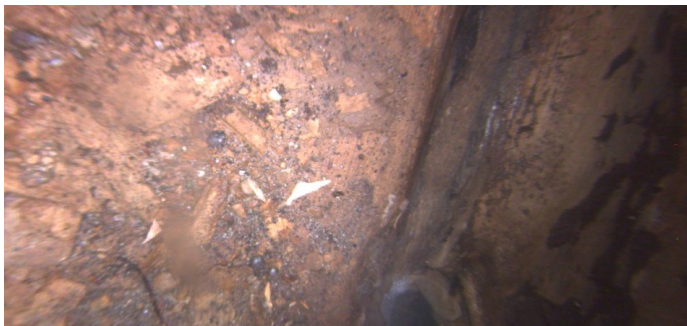
Code: **MGO**  
Description: **General Observation**

Distance (ft): **4.2**  
Structural Grade: **0**  
O&M Grade: **0**  
Clock Start/From:  
Clock To:  
1st Value:  
2nd Value:  
Value Percent:  
Step: **NO**  
Remarks: **Ins. Comp.**
